Area-wide geotechnical information summary for CERA zoning review panel

This document contains all the area-wide geotechnical information which was considered by CERA as part of the process for making flat-land zoning decisions, and the subsequent zoning review.

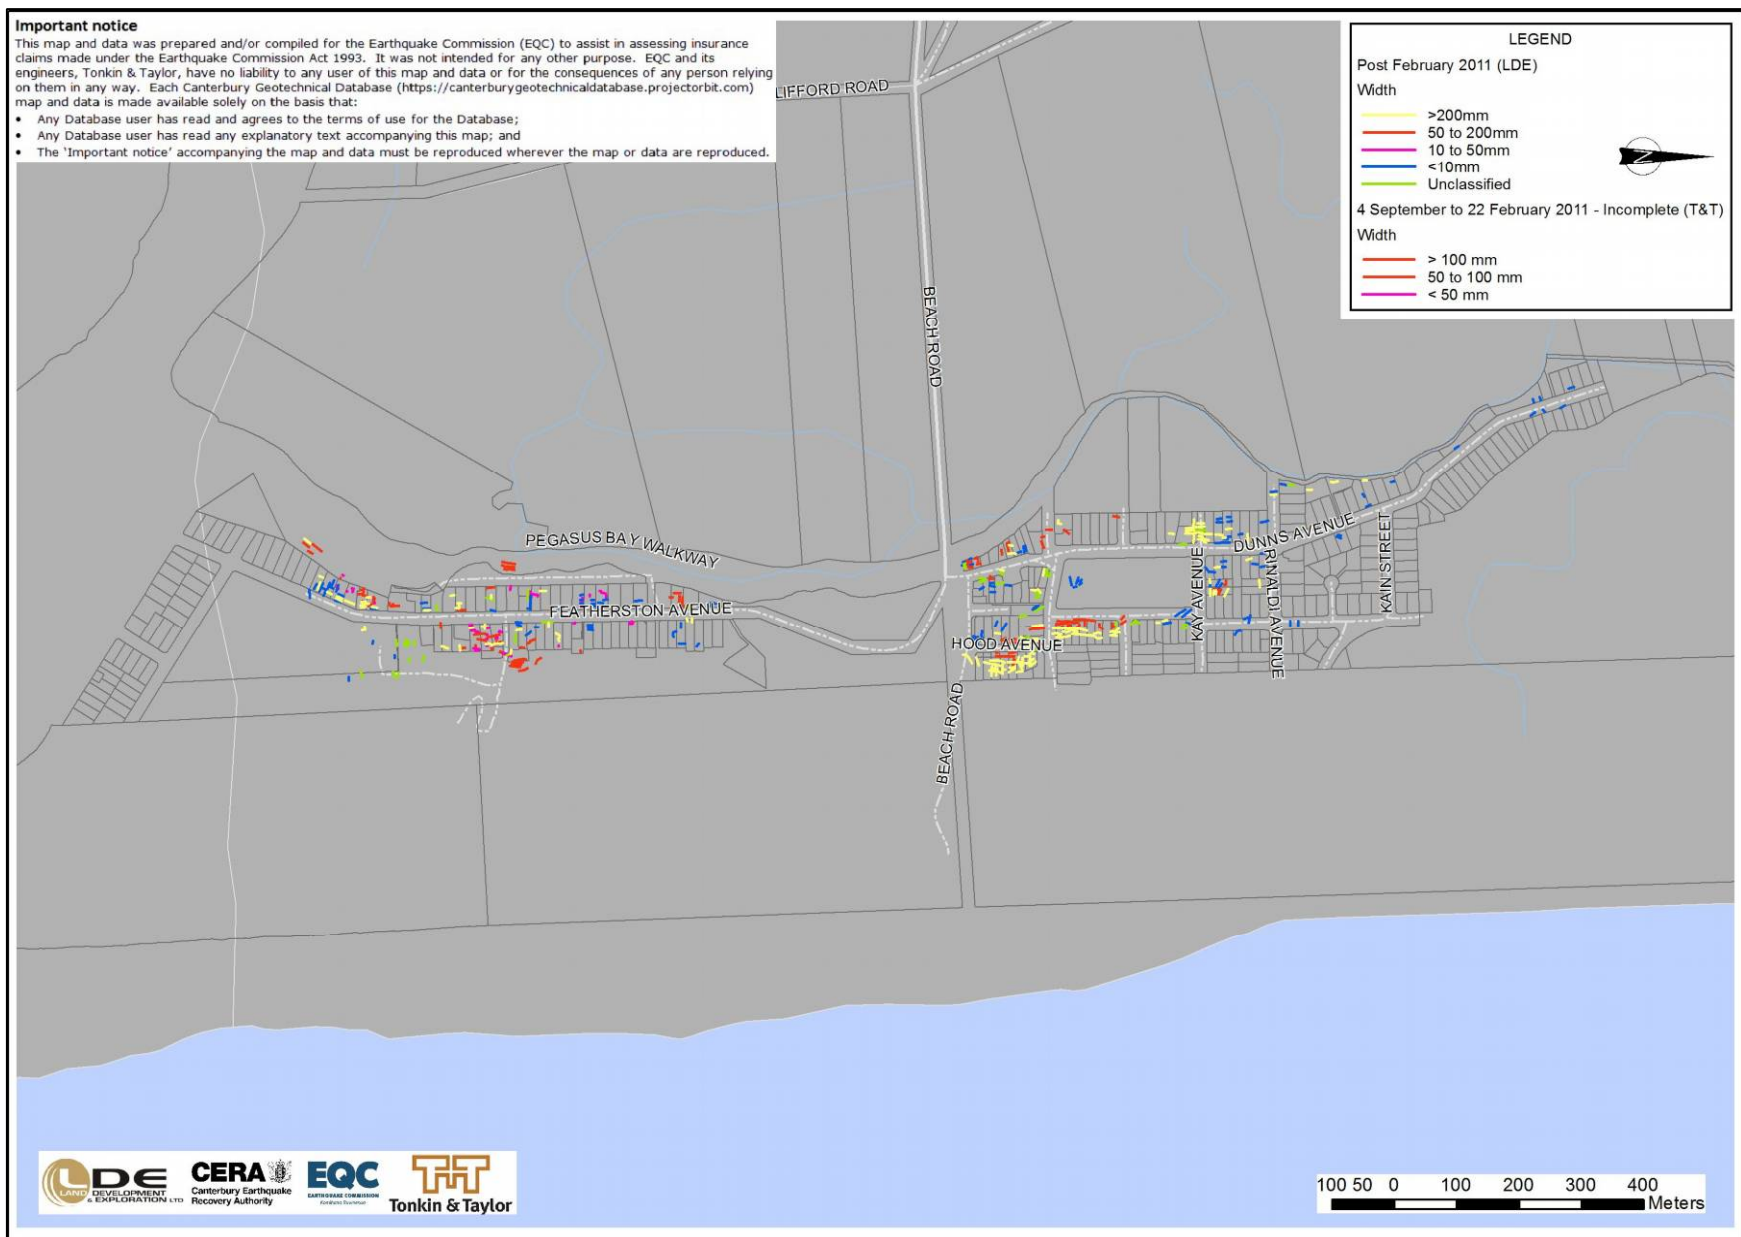
Figure 2 – Observed ground crack locations

Crack locations were mapped in order to infer the general direction, magnitude and extent of the lateral ground movements. The mapping objectives changed in response to the varying situation following the two earthquakes. Observations after the 4 Sept 2010 Earthquake were principally for insurance claim settlements. The crack widths were recorded in property-by-property observations, but cracks were not tracked across property boundaries and only a portion of properties were mapped before the 22 Feb 2011 Earthquake. Cracks were mapped at a scale of 1:5000 to 1:10000 for about two weeks following the 22 Feb 2011 Earthquake in order to rapidly identify the extent of lateral spreading following the earthquake. The individual crack widths were not recorded. From early March 2011, cracks were generally mapped at a scale of 1:2000 and classified according to their maximum width. Cracks were tracked through properties in order to identify regional patterns.

The crack mapping is incomplete and only observations made by the mapping teams are presented. In particular, the mapping following the 4 Sept 2010 Earthquake was incomplete before the 22 Feb 2011 Earthquake occurred and subsequent mapping remains incomplete within the residential 'red zone' areas. Also, cracks in roads were often not able to be mapped because many were filled and the roads resealed before a mapping team arrived.

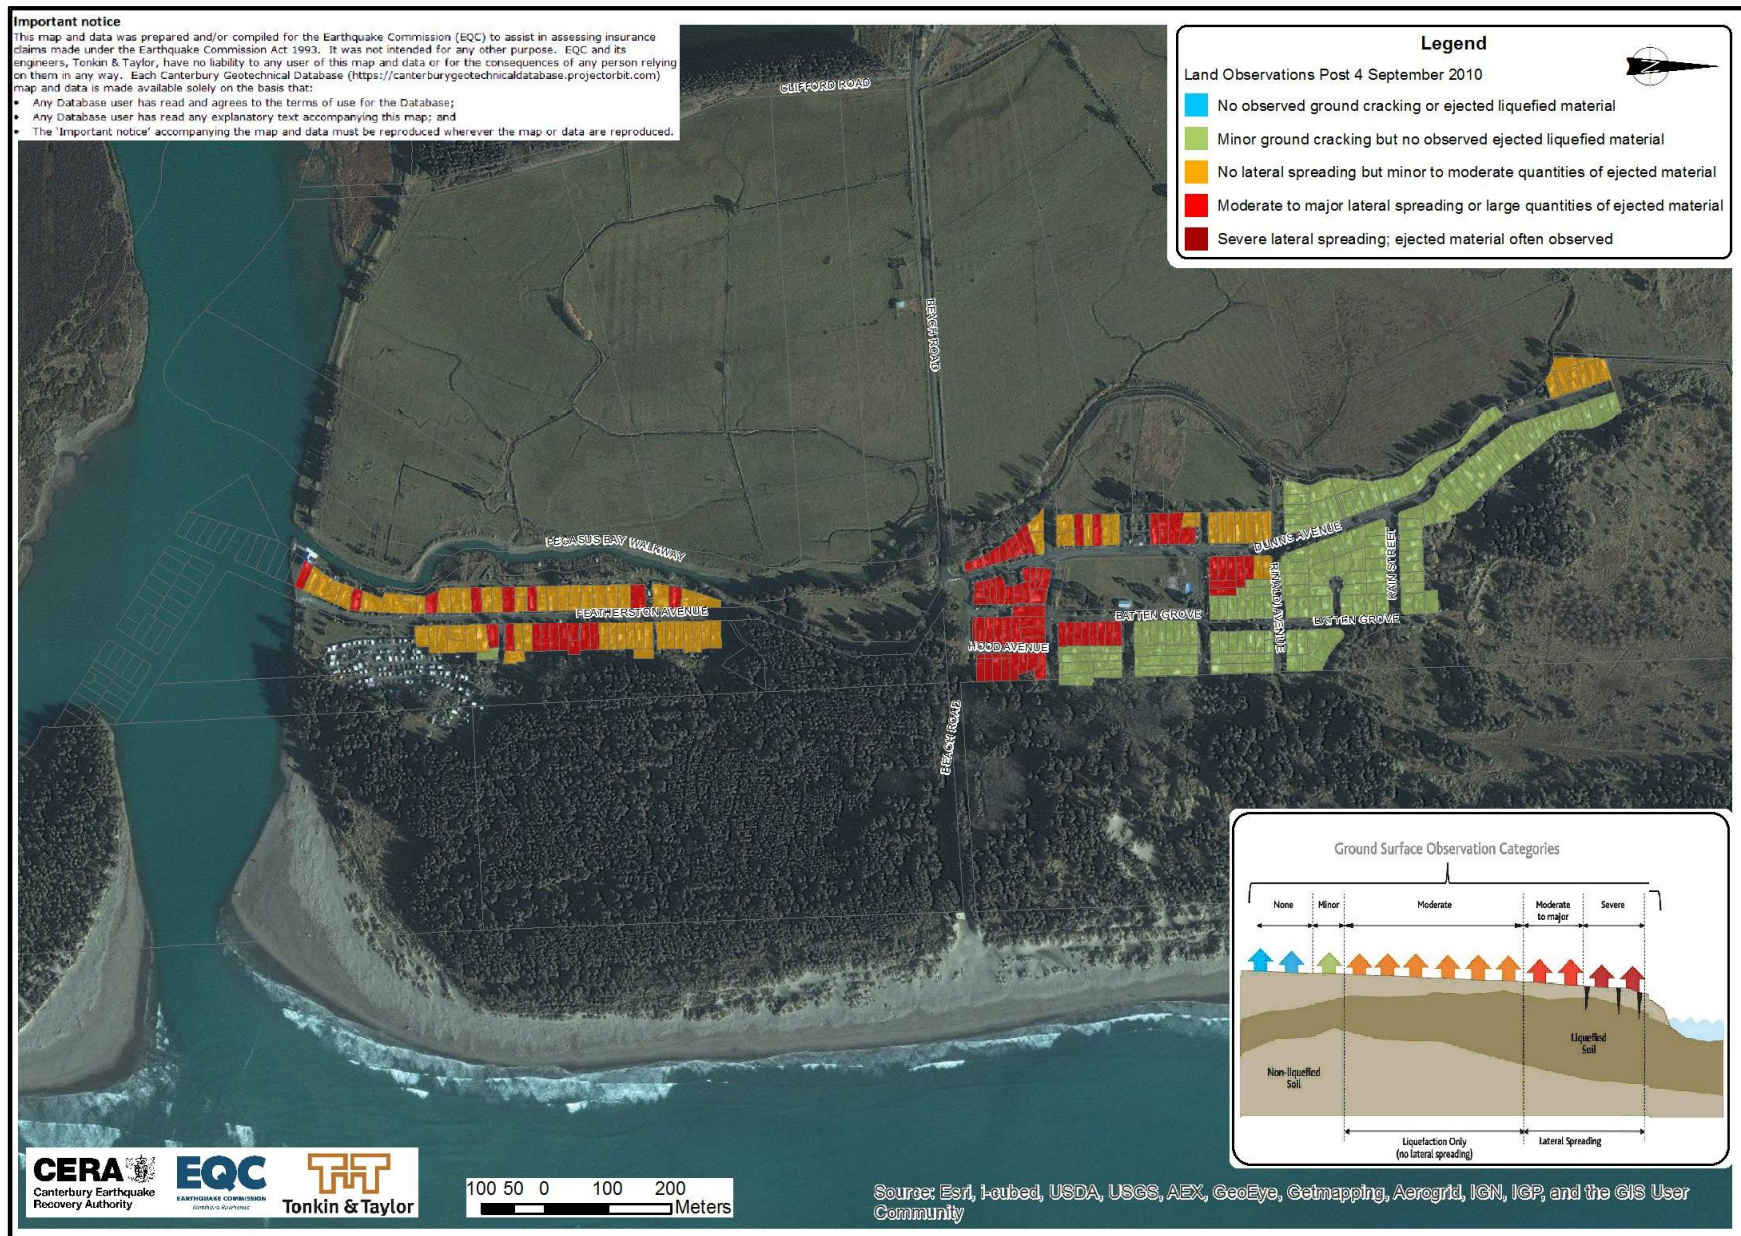
Figure 3 – Ground surface observations of liquefaction and lateral spreading following 4th September 2010 earthquake (from property-level ground mapping)

The quantities of material ejected due to liquefaction and observations of lateral spreading were collated from on-foot rapid inspection of individual properties following each significant earthquake. The observations were categorized according to the quantity of ejected material observed on the ground surface and according to the presence or absence of evidence of lateral spreading. Each of these three categories was further subdivided according to the severity. The colour coding used on these maps has completely different meaning to colours used by CERA for land zoning and DBH for technical categories.

The observations were collected for the Earthquake Commission and were only made in residential areas. The mapping only identified liquefaction and lateral spreading that was visible at the surface at the time of inspection. Liquefaction may have occurred at depth without obvious evidence at the surface and evidence of liquefaction may have been removed before the inspection. (Removed material may be identifiable within the aerial photographs that were taken within a day or two of the earthquake.)

The properties were not all inspected between each pair of consecutive earthquakes (e.g. between 4 Sept 2010 and 22 Feb 2011) so the extent of the land deformations is most likely incomplete. Also, some observations following the 22 Feb 2011 and 13 Jun 2011 earthquakes could have been induced by preceding earthquakes.

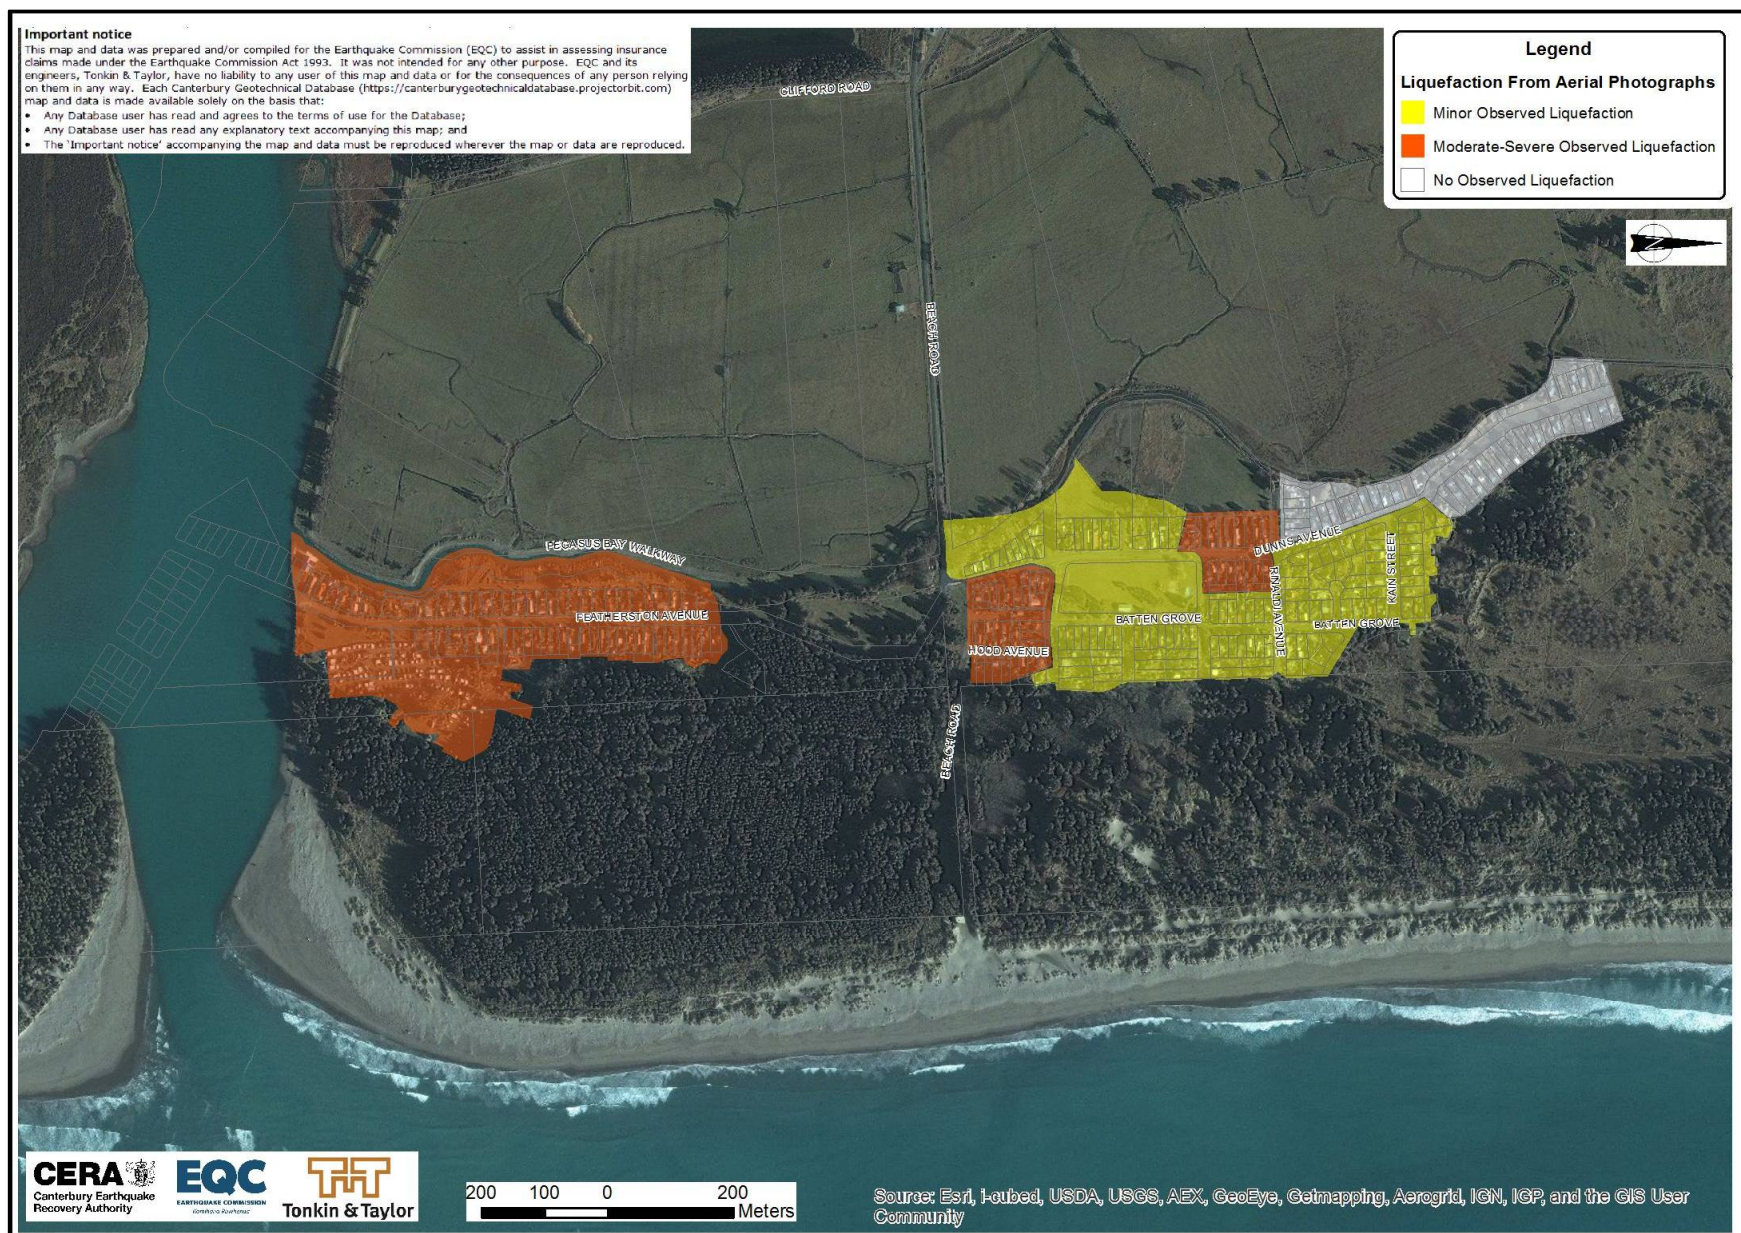
Figure 4 – Ground surface observations of liquefaction and lateral spreading following 22nd February 2011 earthquake (from air-photo interpretation)

A regional-scale map showing the extents of ejected liquefaction material interpreted from aerial photographs. The quantity of ejected liquefaction material deposited on the streets was visually identified using the aerial photographs. The region boundaries were aligned with road centre-lines and property boundaries rather than the boundaries of the individual surface features being mapped.

MODERATE to SEVERE: Roads had either ejected material or wet patches wider than a typical vehicle width. Ejected material in grass or on roads. Groups of 2-3 ejected material 'boils' within properties or parks.

MINOR: Roads had either ejected material or wet patches narrower than a typical vehicle. One or two ejected material 'boils' within a property or park.

NONE: None of the above features were observed.

The photographs were of varying quality and light conditions. Shadows from low sun angles in some areas and sets of photographs may have been misidentified as ejected liquefaction material. Water from burst pipes or springs could also be misidentified as ejected material. Conversely, ejected material may have been obscured from view or removed before the photographs were taken. Photographs were not available for all areas of the city. These maps should be used in conjunction with the associated Aerial Photograph and property-scale observations to form a complete picture of the extent and severity of the liquefaction.

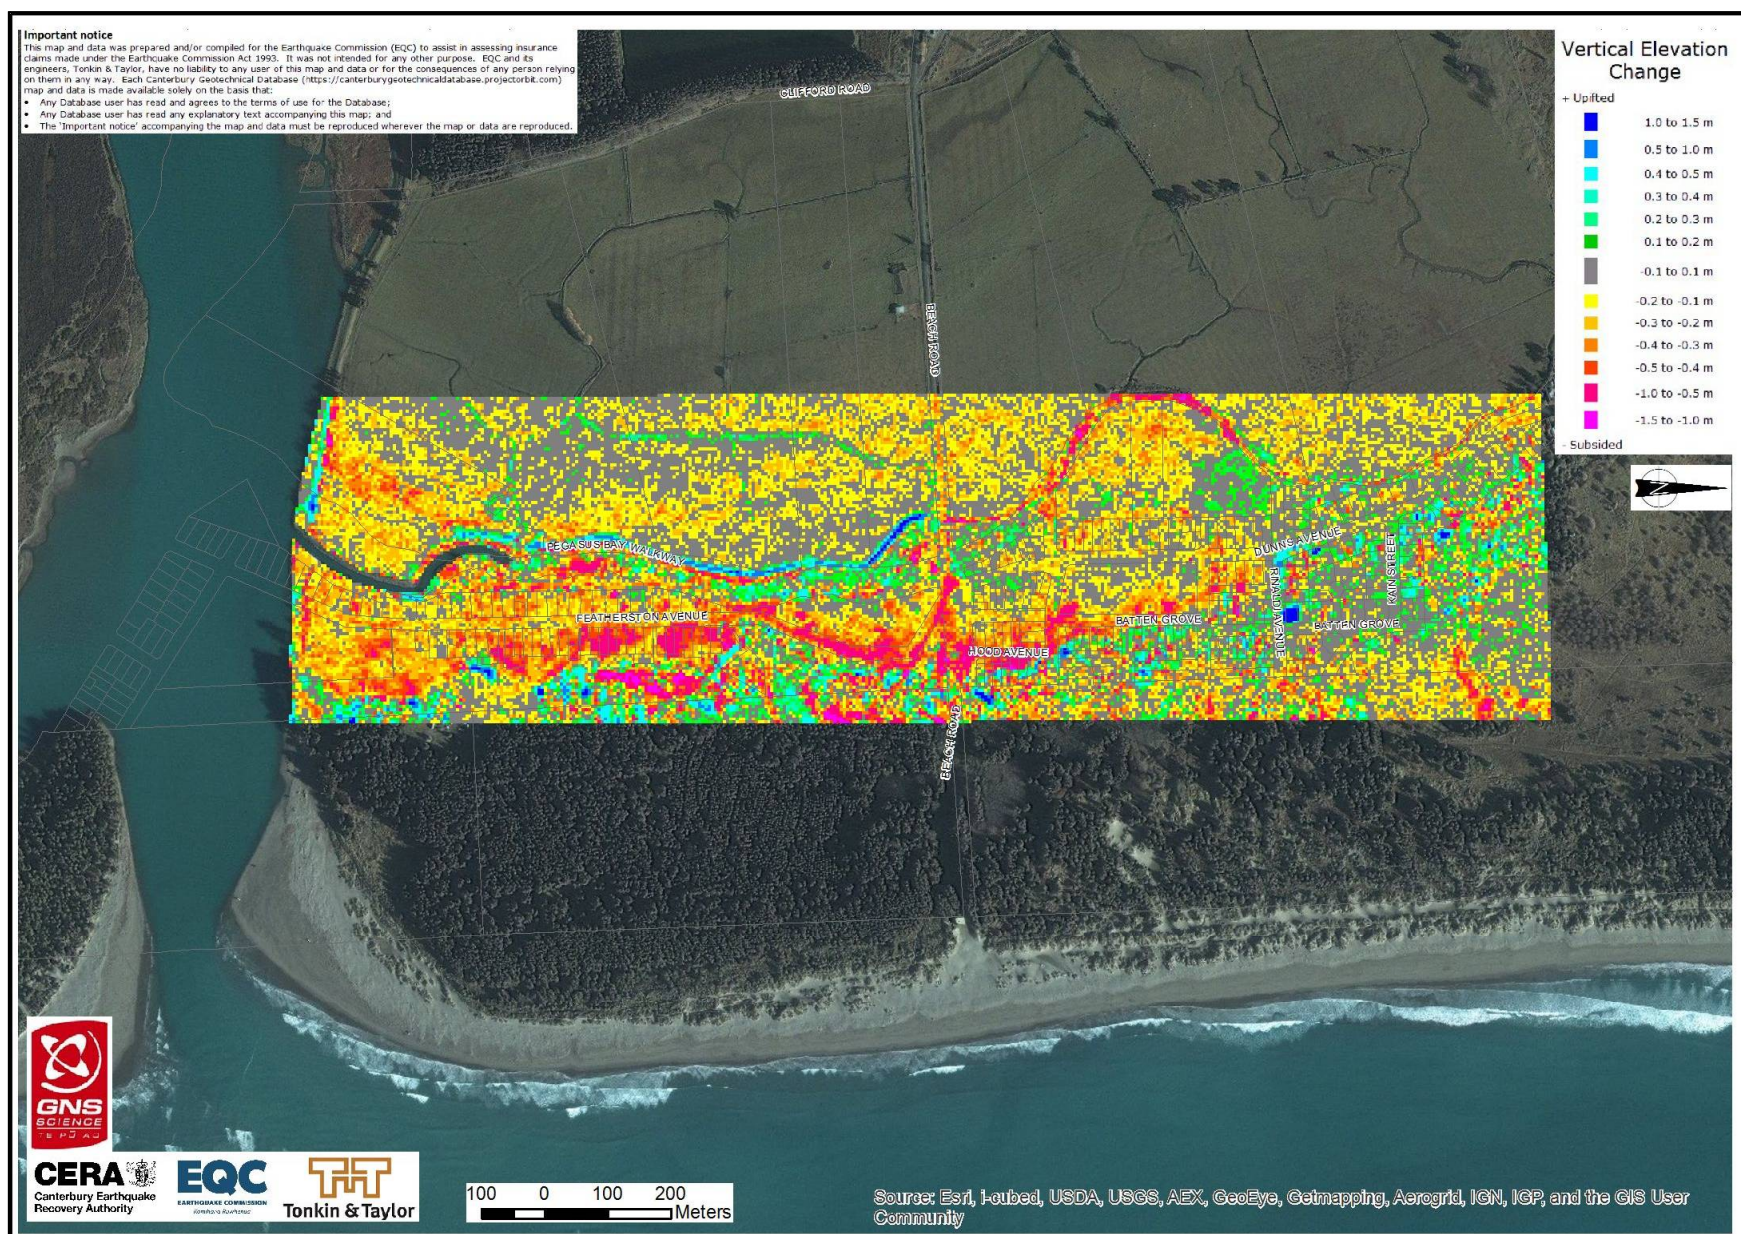
Figure 8 – Change in ground elevation between LiDAR in July 2005 and February 2012, with regional tectonic component of ground displacement removed

Vertical elevation changes between LiDAR sets that approximate the vertical ground movements during significant earthquakes. Elevation changes were calculated as differences between pairs of Digital Elevation Models (DEM). Local vertical movements were calculated as differences between the 'observed' elevation differences and the regional tectonic displacement from GNS Science dislocation models of the vertical tectonic movements during each earthquake.

All of the movements are differences between DEMs and are inherently less accurate than their source DEM's. The pre-earthquake source DEM is less accurate than the post-earthquake DEMs. Some of the DEMs have visually distinguishable lines or ripples within the colour bands that are almost certainly artefacts from the data acquisition and subsequent processing rather than from physical vertical movements. Notable examples are several approximately NNE-SSW swathes visible in the Feb 2011 difference set and an almost E-W line at 43.48°S in the 13 Jun 2011 difference set.
