Area-wide geotechnical information summary for CERA zoning review panel

This document contains all the area-wide geotechnical information which was considered by CERA as part of the process for making flat-land zoning decisions, and the subsequent zoning review.

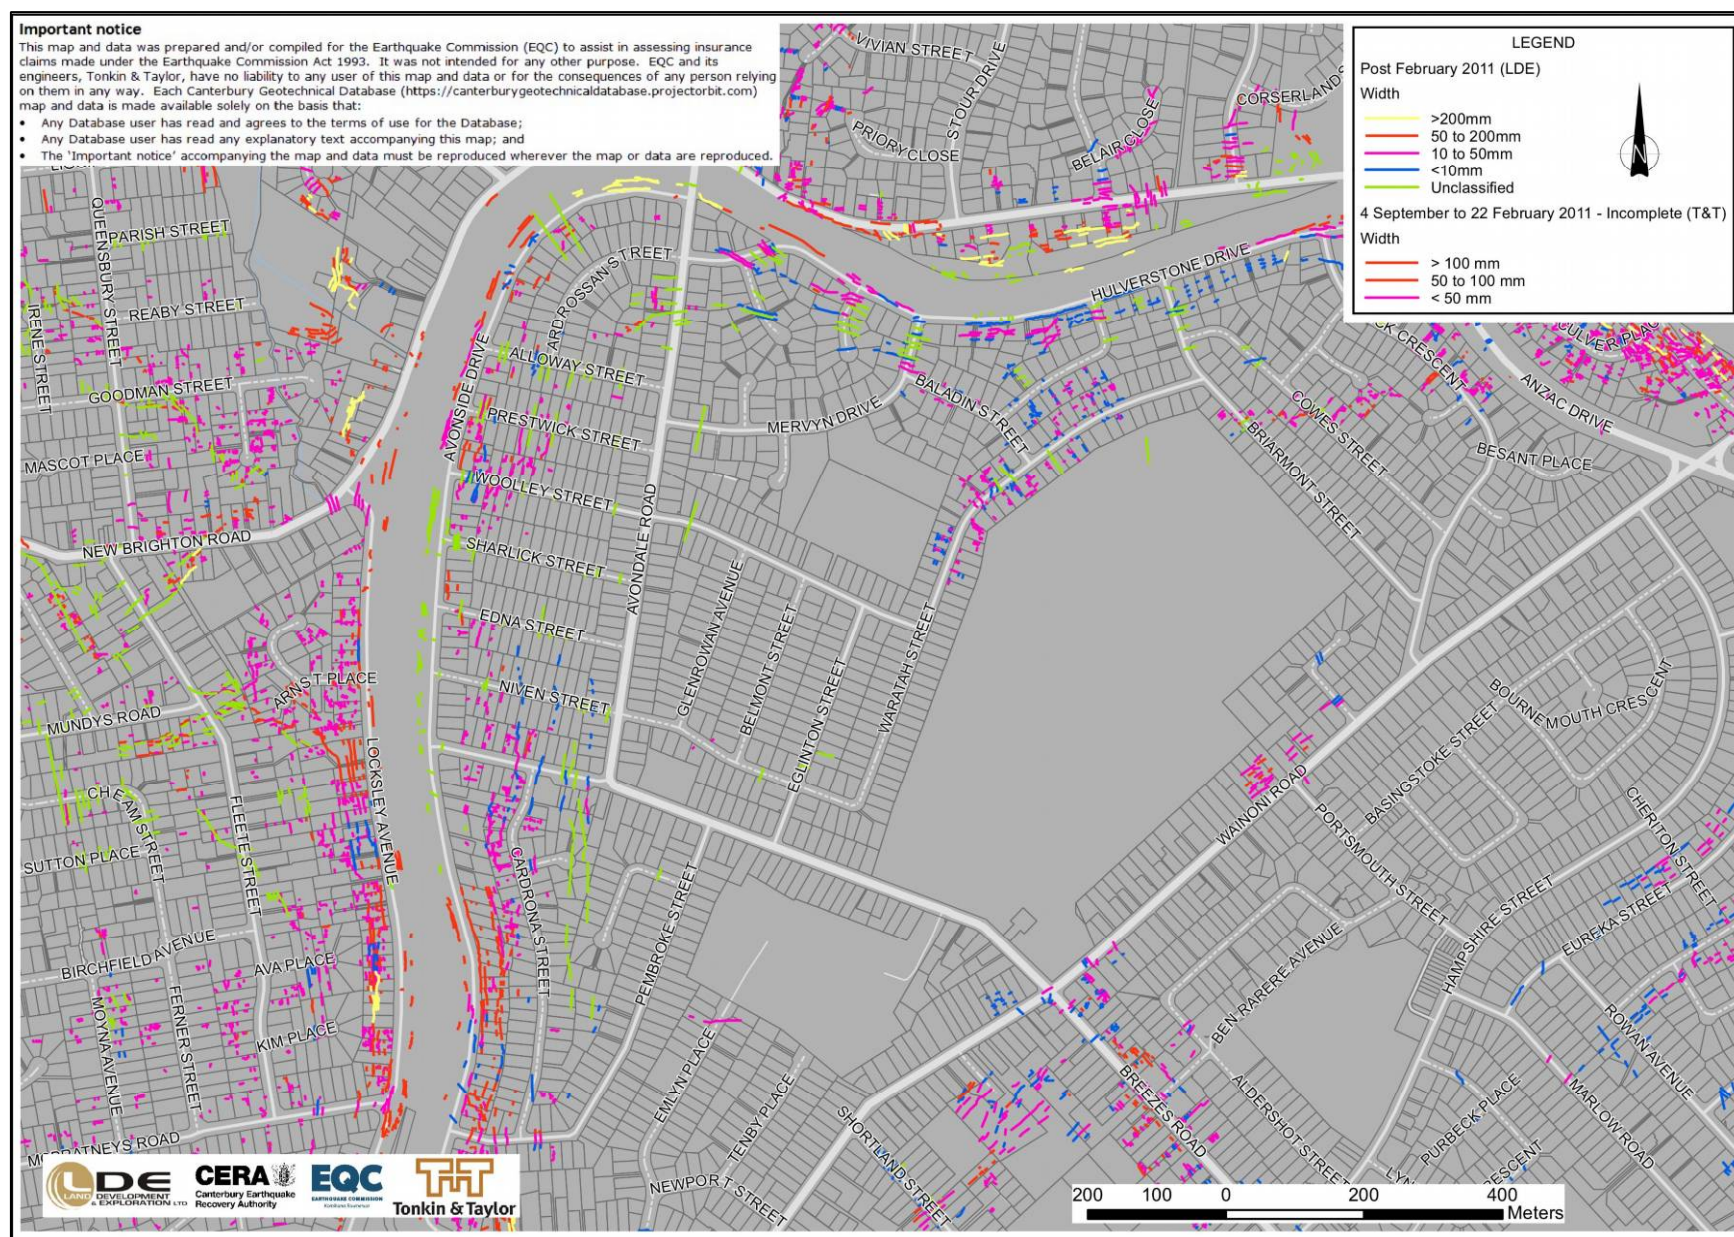
Figure 2 – Observed ground crack locations

Crack locations were mapped in order to infer the general direction, magnitude and extent of the lateral ground movements. The mapping objectives changed in response to the varying situation following the two earthquakes. Observations after the 4 Sept 2010 Earthquake were principally for insurance claim settlements. The crack widths were recorded in property-by-property observations, but cracks were not tracked across property boundaries and only a portion of properties were mapped before the 22 Feb 2011 Earthquake. Cracks were mapped at a scale of 1:5000 to 1:10000 for about two weeks following the 22 Feb 2011 Earthquake in order to rapidly identify the extent of lateral spreading following the earthquake. The individual crack widths were not recorded. From early March 2011, cracks were generally mapped at a scale of 1:2000 and classified according to their maximum width. Cracks were tracked through properties in order to identify regional patterns.

The crack mapping is incomplete and only observations made by the mapping teams are presented. In particular, the mapping following the 4 Sept 2010 Earthquake was incomplete before the 22 Feb 2011 Earthquake occurred and subsequent mapping remains incomplete within the residential 'red zone' areas. Also, cracks in roads were often not able to be mapped because many were filled and the roads resealed before a mapping team arrived.

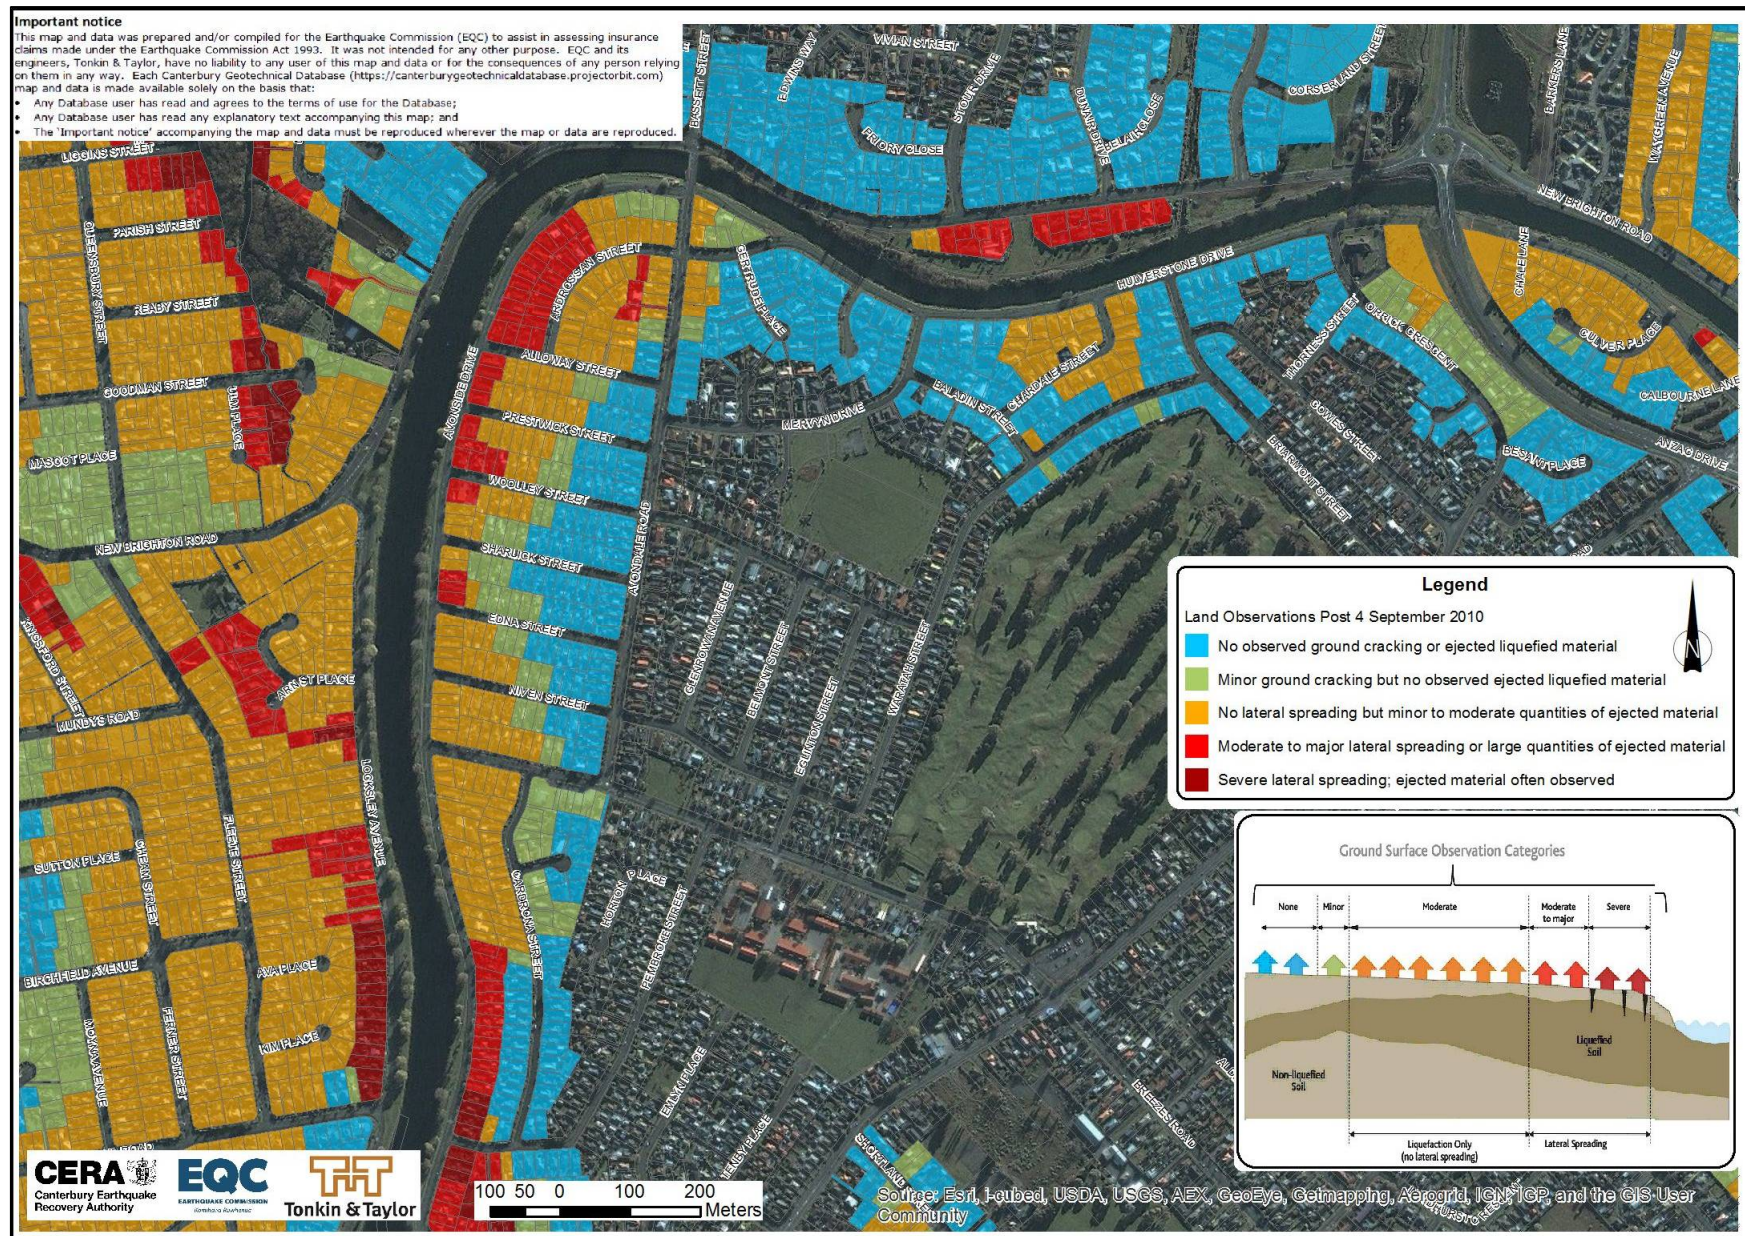
Figure 3 – Ground surface observations of liquefaction and lateral spreading following 4th September 2010 earthquake (from property-level ground mapping)

The quantities of material ejected due to liquefaction and observations of lateral spreading were collated from on-foot rapid inspection of individual properties following each significant earthquake. The observations were categorized according to the quantity of ejected material observed on the ground surface and according to the presence or absence of evidence of lateral spreading. Each of these three categories was further subdivided according to the severity. The colour coding used on these maps has completely different meaning to colours used by CERA for land zoning and DBH for technical categories.

The observations were collected for the Earthquake Commission and were only made in residential areas. The mapping only identified liquefaction and lateral spreading that was visible at the surface at the time of inspection. Liquefaction may have occurred at depth without obvious evidence at the surface and evidence of liquefaction may have been removed before the inspection. (Removed material may be identifiable within the aerial photographs that were taken within a day or two of the earthquake.)

The properties were not all inspected between each pair of consecutive earthquakes (e.g. between 4 Sept 2010 and 22 Feb 2011) so the extent of the land deformations is most likely incomplete. Also, some observations following the 22 Feb 2011 and 13 Jun 2011 earthquakes could have been induced by preceding earthquakes.

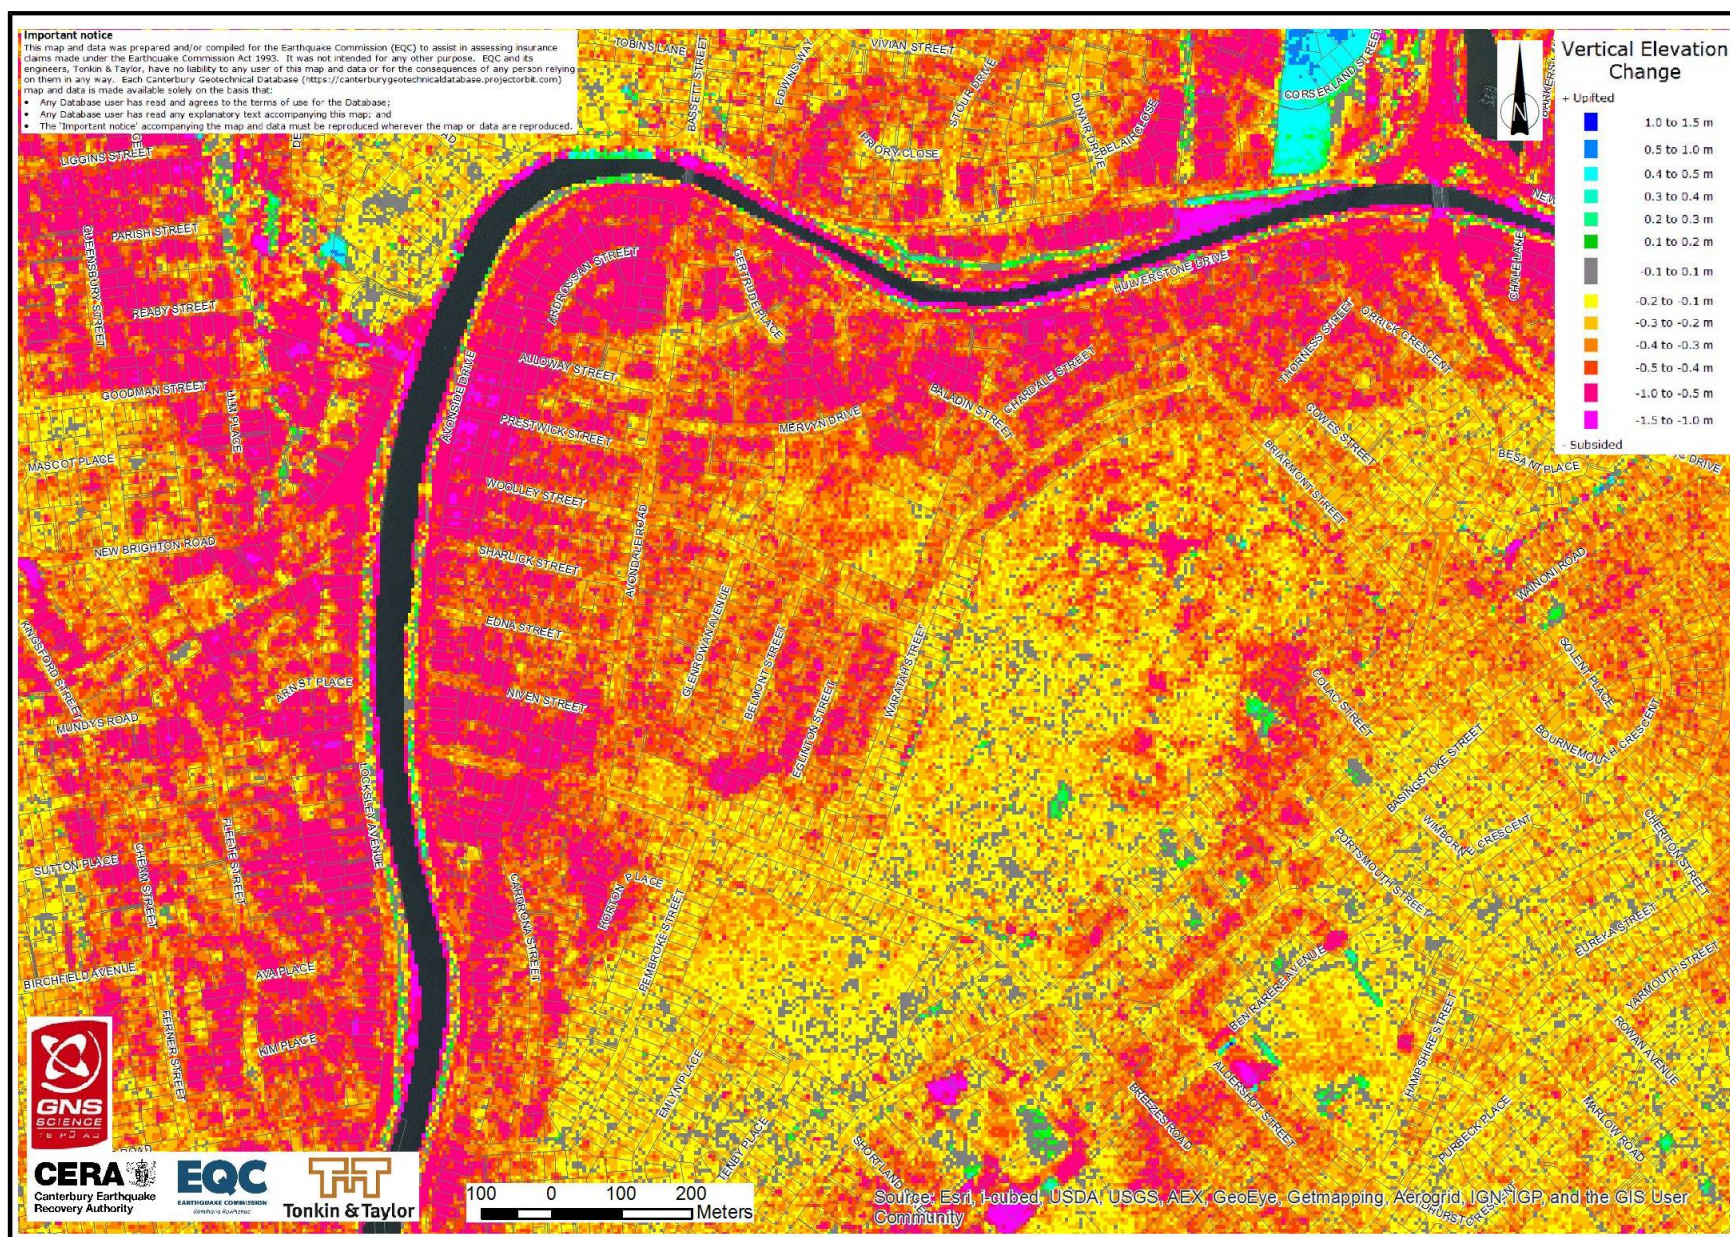
Figure 8 – Change in ground elevation between LiDAR in July 2003 and February 2012, with regional tectonic component of ground displacement removed

Vertical elevation changes between LiDAR sets that approximate the vertical ground movements during significant earthquakes. Elevation changes were calculated as differences between pairs of Digital Elevation Models (DEM). Local vertical movements were calculated as the differences between the 'observed' elevation differences and the regional tectonic displacement from GNS Science dislocation models of the vertical tectonic movements during each earthquake.

All of the movements are differences between DEMs and are inherently less accurate than their source DEM's. The pre-earthquake source DEM is less accurate than the post-earthquake DEMs. Some of the DEMs have visually distinguishable lines or ripples within the colour bands that are almost certainly artefacts from the data acquisition and subsequent processing rather than from physical vertical movements. Notable examples are several approximately NNE-SSW swathes visible in the Feb 2011 difference set and an almost E-W line at 43.48°S in the 13 Jun 2011 difference set.
