## Area-wide geotechnical information summary for CERA zoning review panel

This document contains all the area-wide geotechnical information which was considered by CERA as part of the process for making flat-land zoning decisions, and the subsequent zoning review.

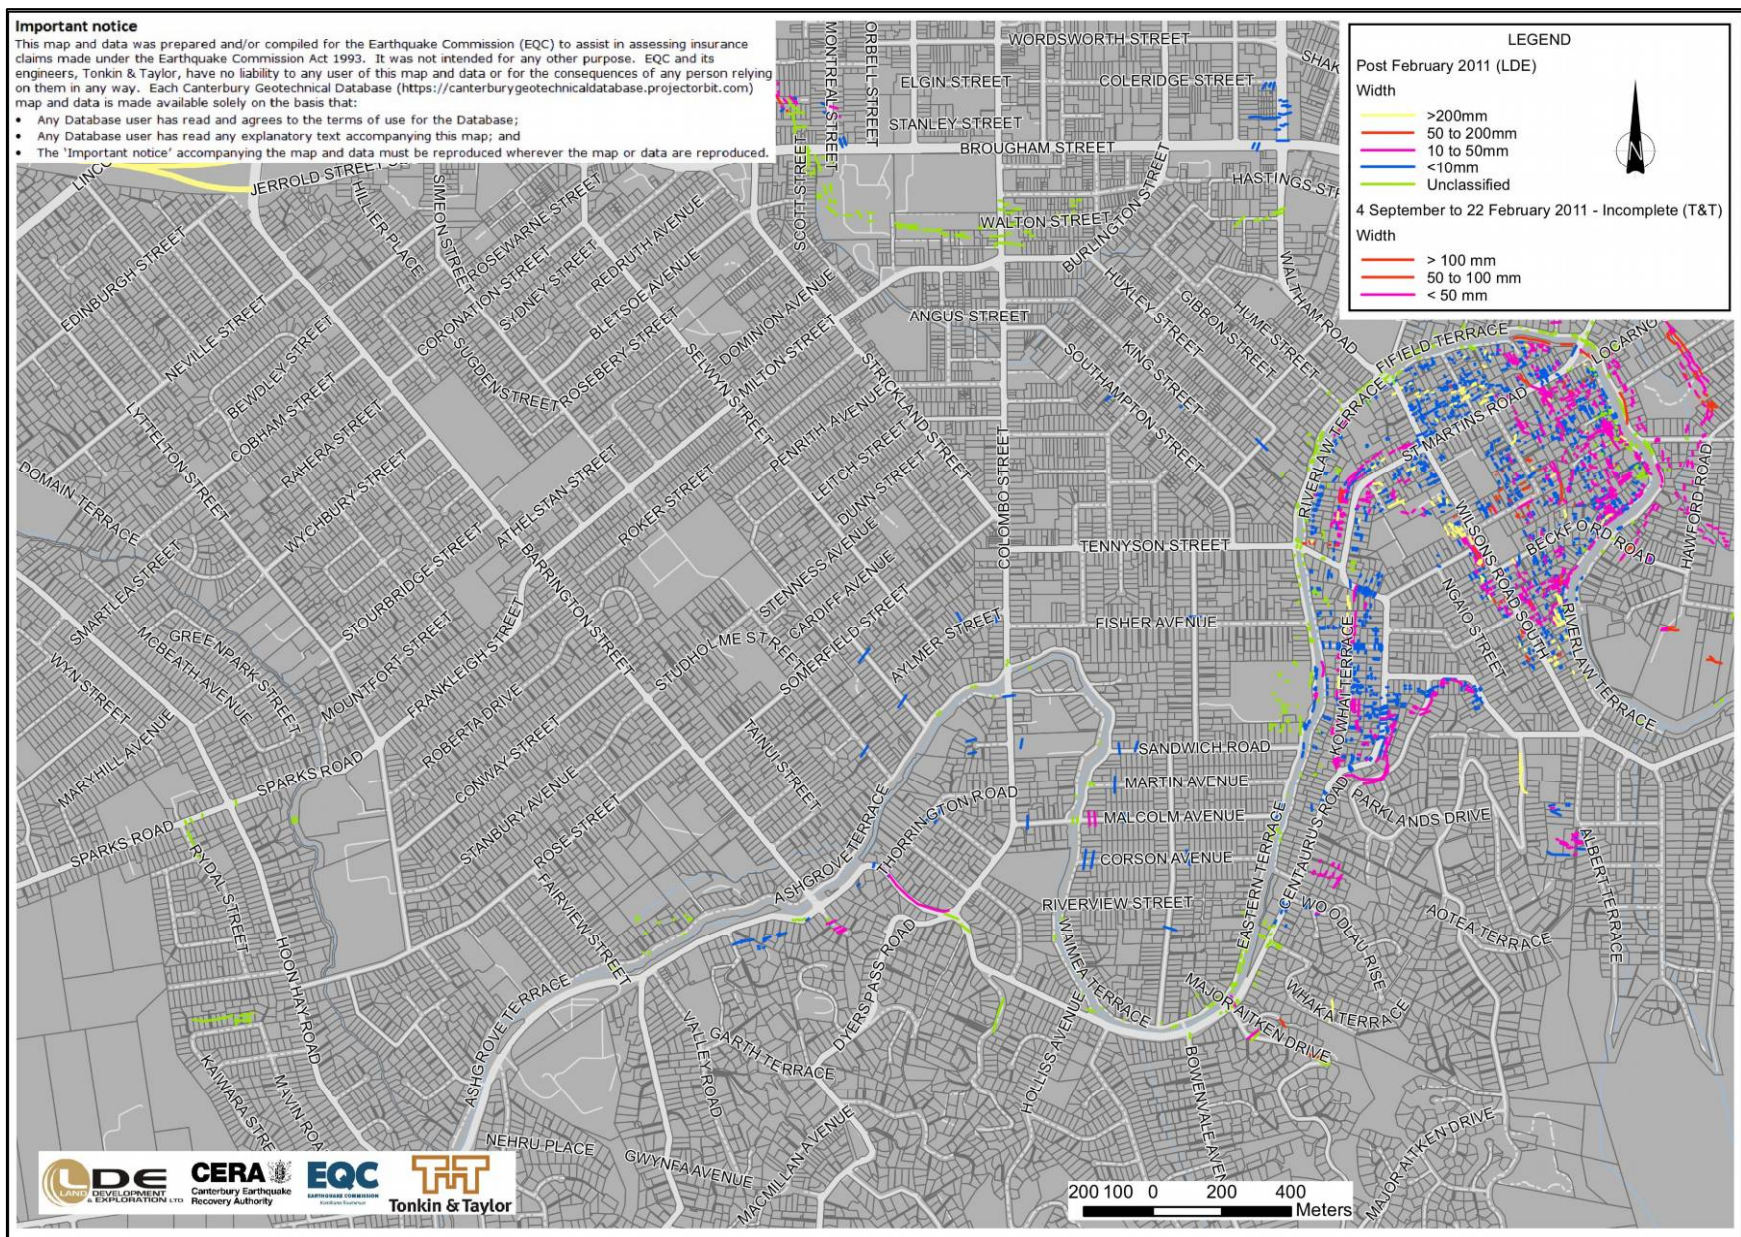
Figure 2 – Observed ground crack locations

Crack locations were mapped in order to infer the general direction, magnitude and extent of the lateral ground movements. The mapping objectives changed in response to the varying situation following the two earthquakes. Observations after the 4 Sept 2010 Earthquake were principally for insurance claim settlements. The crack widths were recorded in property-by-property observations, but cracks were not tracked across property boundaries and only a portion of properties were mapped before the 22 Feb 2011 Earthquake. Cracks were mapped at a scale of 1:5000 to 1:10000 for about two weeks following the 22 Feb 2011 Earthquake in order to rapidly identify the extent of lateral spreading following the earthquake. The individual crack widths were not recorded. From early March 2011, cracks were generally mapped at a scale of 1:2000 and classified according to their maximum width. Cracks were tracked through properties in order to identify regional patterns.

The crack mapping is incomplete and only observations made by the mapping teams are presented. In particular, the mapping following the 4 Sept 2010 Earthquake was incomplete before the 22 Feb 2011 Earthquake occurred and subsequent mapping remains incomplete within the residential 'red zone' areas. Also, cracks in roads were often not able to be mapped because many were filled and the roads resealed before a mapping team arrived.

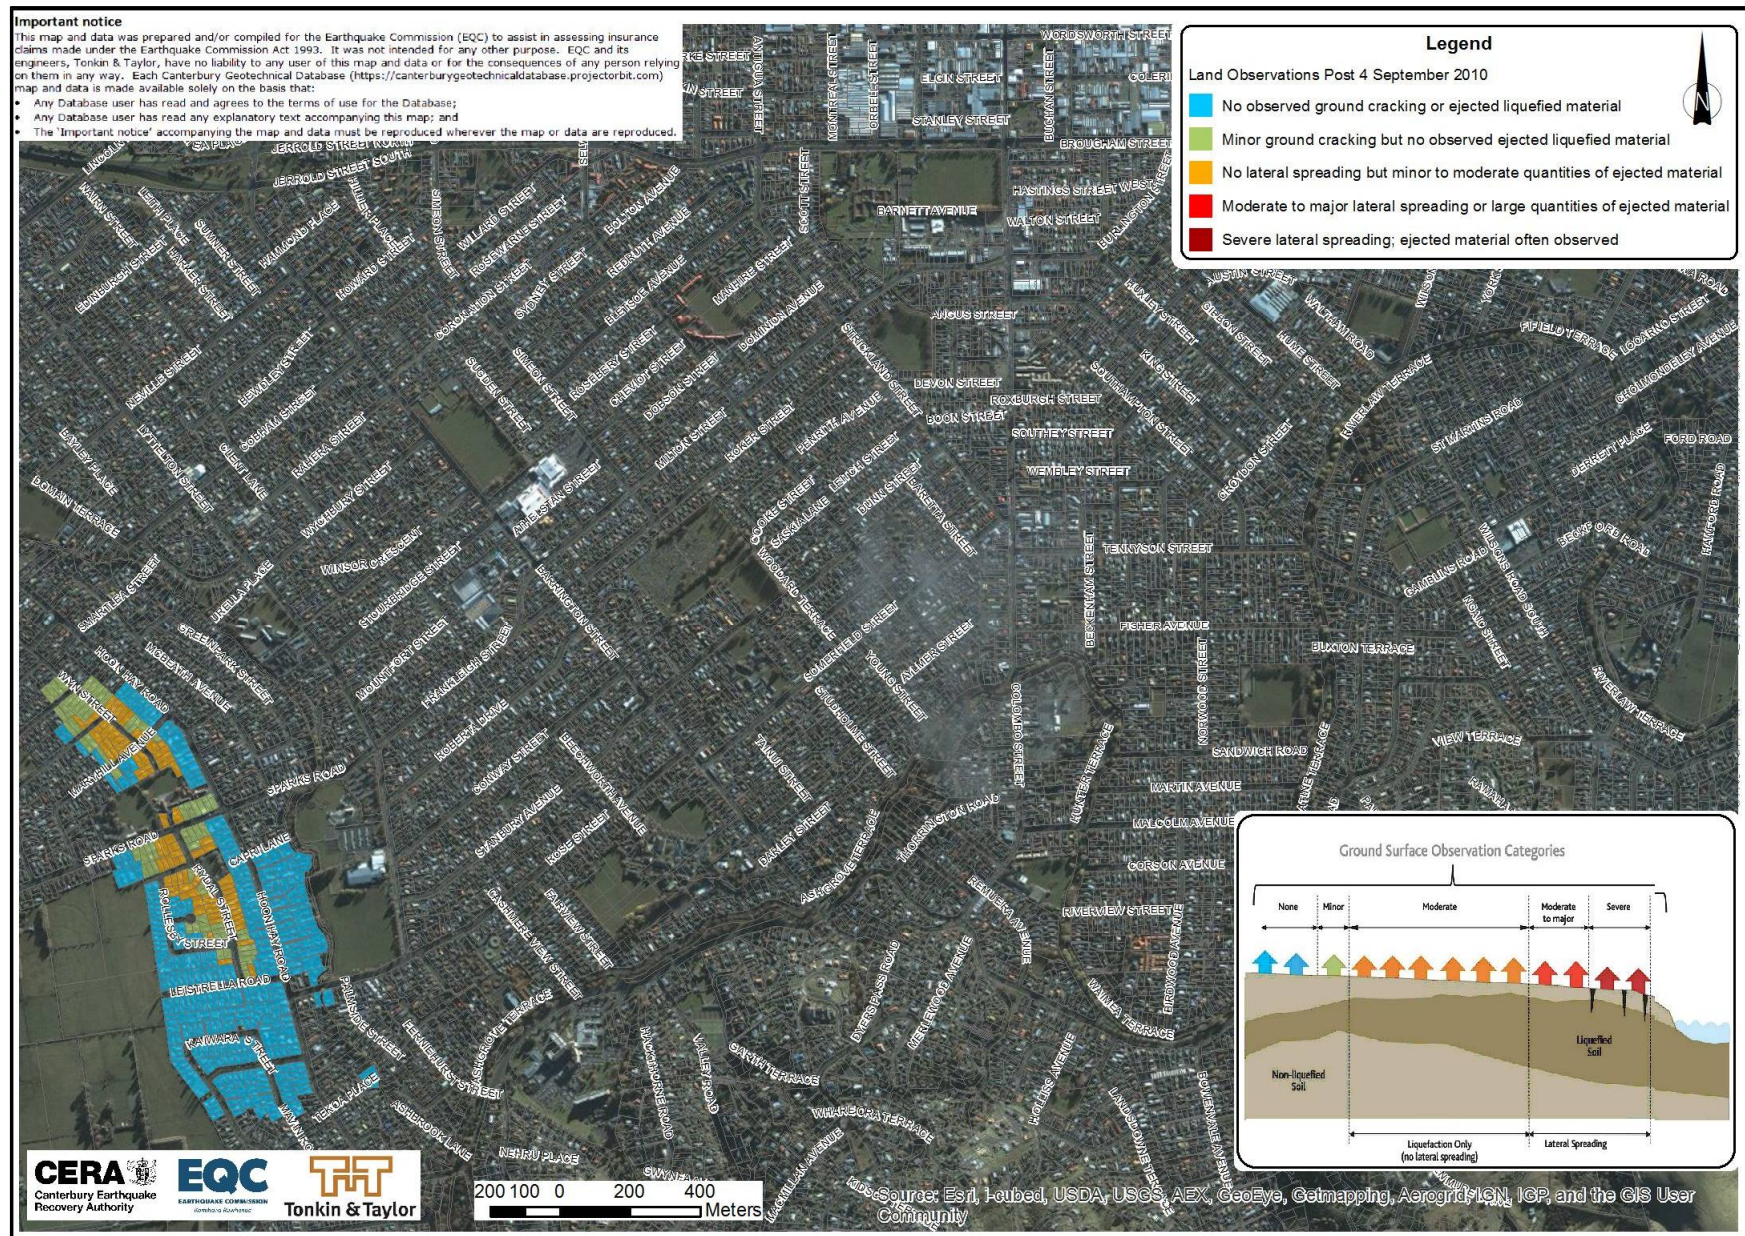
Figure 3 – Ground surface observations of liquefaction and lateral spreading following 4<sup>th</sup> September 2010 earthquake (from property-level ground mapping)

The quantities of material ejected due to liquefaction and observations of lateral spreading were collated from on-foot rapid inspection of individual properties following each significant earthquake. The observations were categorized according to the quantity of ejected material observed on the ground surface and according to the presence or absence of evidence of lateral spreading. Each of these three categories was further subdivided according to the severity. The colour coding used on these maps has completely different meaning to colours used by CERA for land zoning and DBH for technical categories.

The observations were collected for the Earthquake Commission and were only made in residential areas. The mapping only identified liquefaction and lateral spreading that was visible at the surface at the time of inspection. Liquefaction may have occurred at depth without obvious evidence at the surface and evidence of liquefaction may have been removed before the inspection. (Removed material may be identifiable within the aerial photographs that were taken within a day or two of the earthquake.)

The properties were not all inspected between each pair of consecutive earthquakes (e.g. between 4 Sept 2010 and 22 Feb 2011) so the extent of the land deformations is most likely incomplete. Also, some observations following the 22 Feb 2011 and 13 Jun 2011 earthquakes could have been induced by preceding earthquakes.

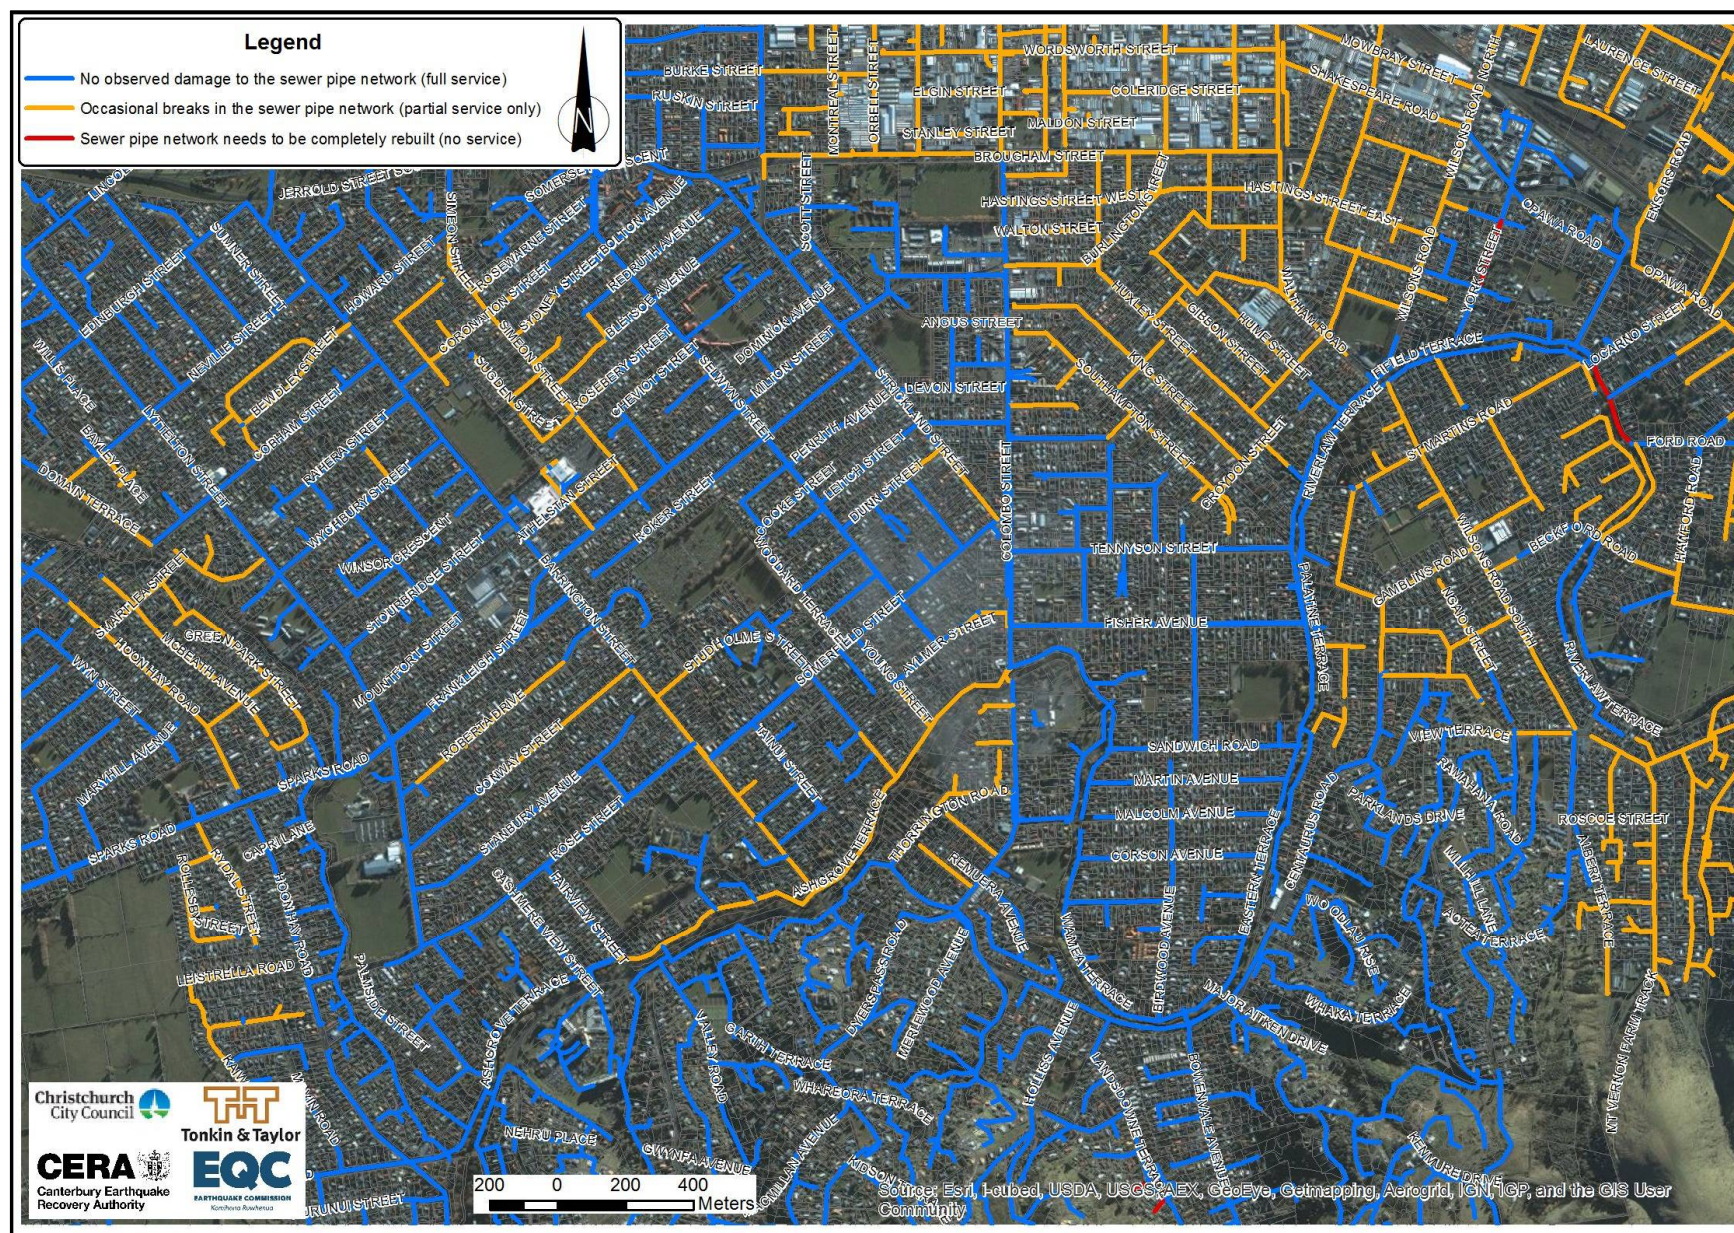
Figure 6 – Status of wastewater network as assessed at 20<sup>th</sup> April 2011 (NOW SUPERSEDED)

Since this map was compiled there has been significant additional assessment of the infrastructure network, so this map is now superseded. It is included only to show the best available information at the time of the zoning decisions. For an up to date assessment of the infrastructure network, SCIRT or the City Council should be consulted.

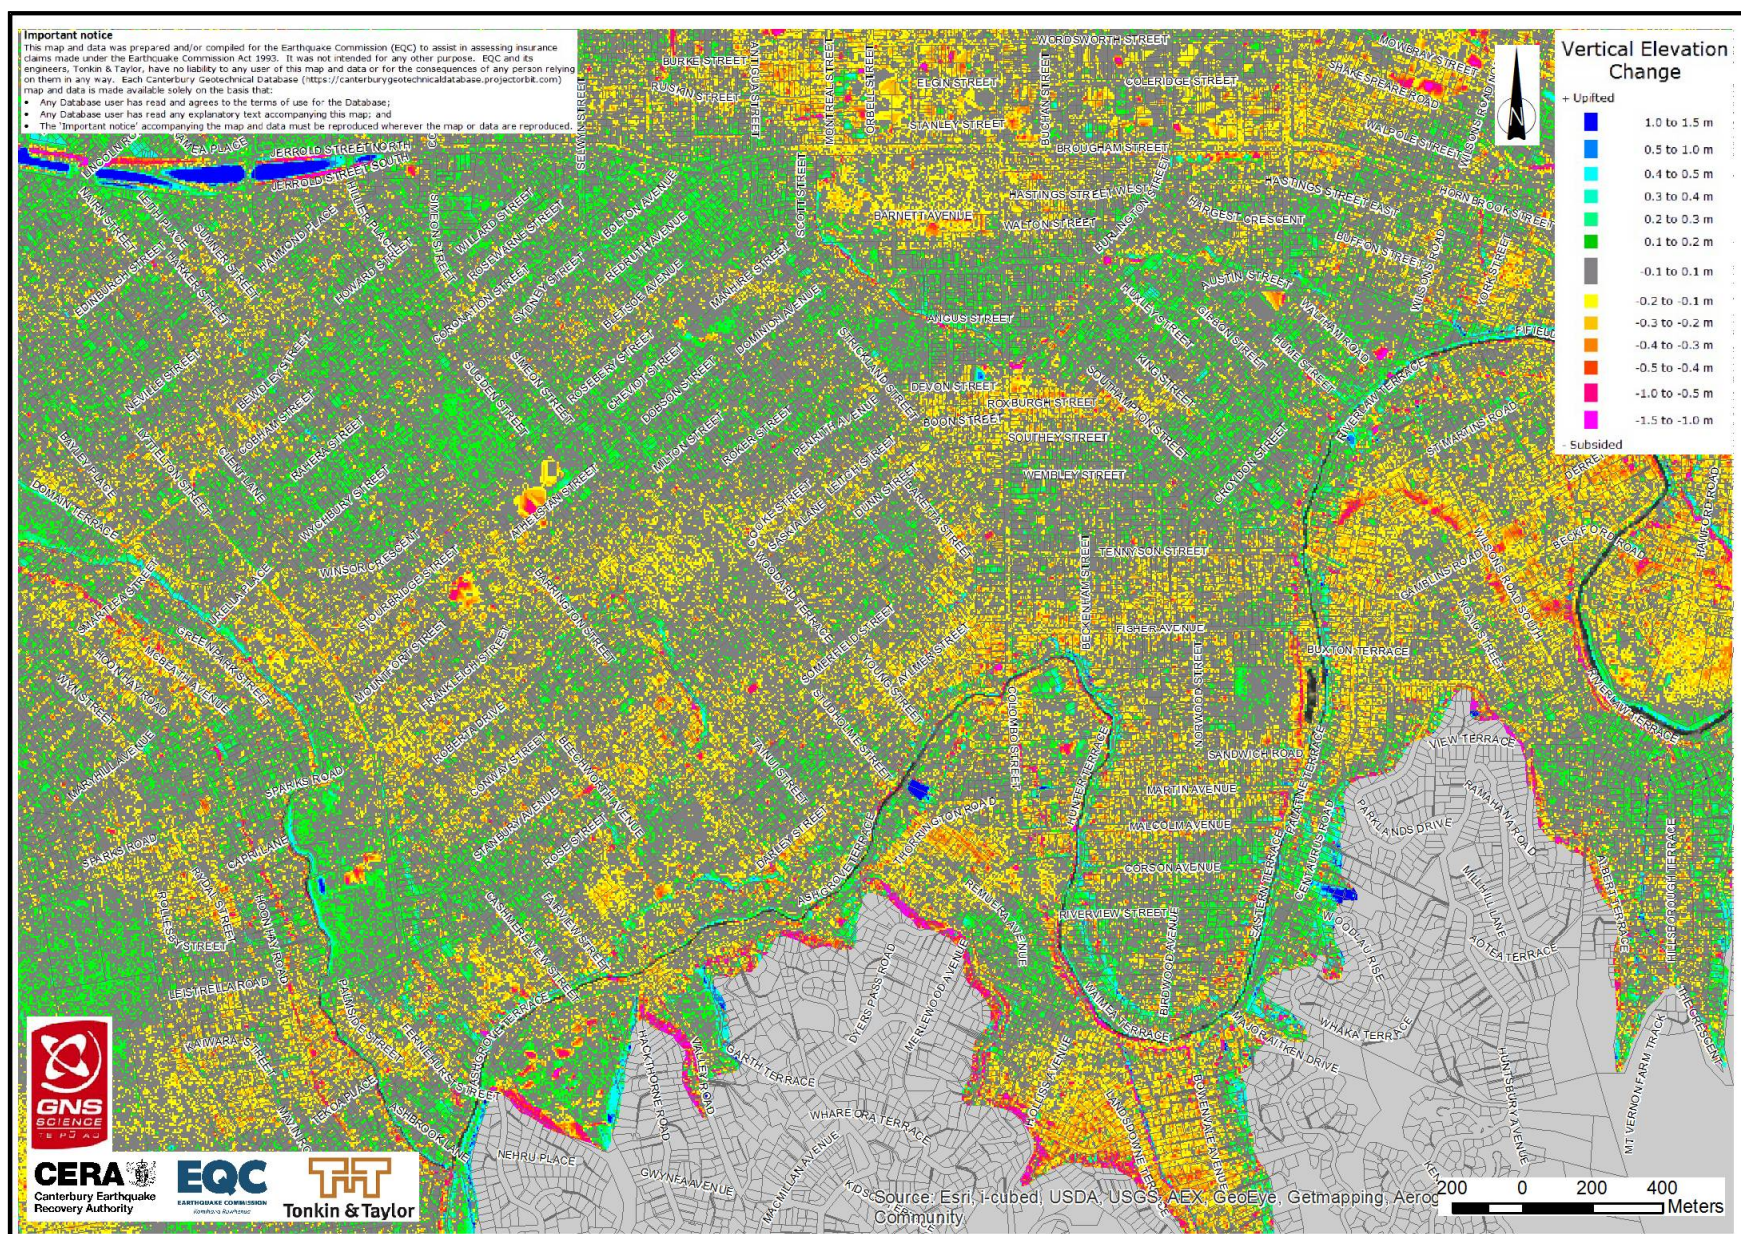
Figure 8 – Change in ground elevation between LiDAR in July 2003 and September 2011 with regional tectonic component of ground displacement removed

Vertical elevation changes between LiDAR sets that approximate the vertical ground movements during significant earthquakes. Elevation changes were calculated as differences between pairs of Digital Elevation Models (DEM). Local vertical movements were calculated as the differences between the 'observed' elevation differences and the regional tectonic displacement from GNS Science dislocation models of the vertical tectonic movements during each earthquake.

All of the movements are differences between DEMs and are inherently less accurate than their source DEM's. The pre-earthquake source DEM is less accurate than the post-earthquake DEMs. Some of the DEMs have visually distinguishable lines or ripples within the colour bands that are almost certainly artefacts from the data acquisition and subsequent processing rather than from physical vertical movements. Notable examples are several approximately NNE-SSW swathes visible in the Feb 2011 difference set and an almost E-W line at 43.48°S in the 13 Jun 2011 difference set.
