**Majestic Church**  
**Structural Assessment &  
Strengthening Report**  
for building at  
**126 Manchester Street**  
**Christchurch**

**Re: Majestic Church – 126 Manchester Street, Christchurch  
Structural Assessment & Strengthening Report**

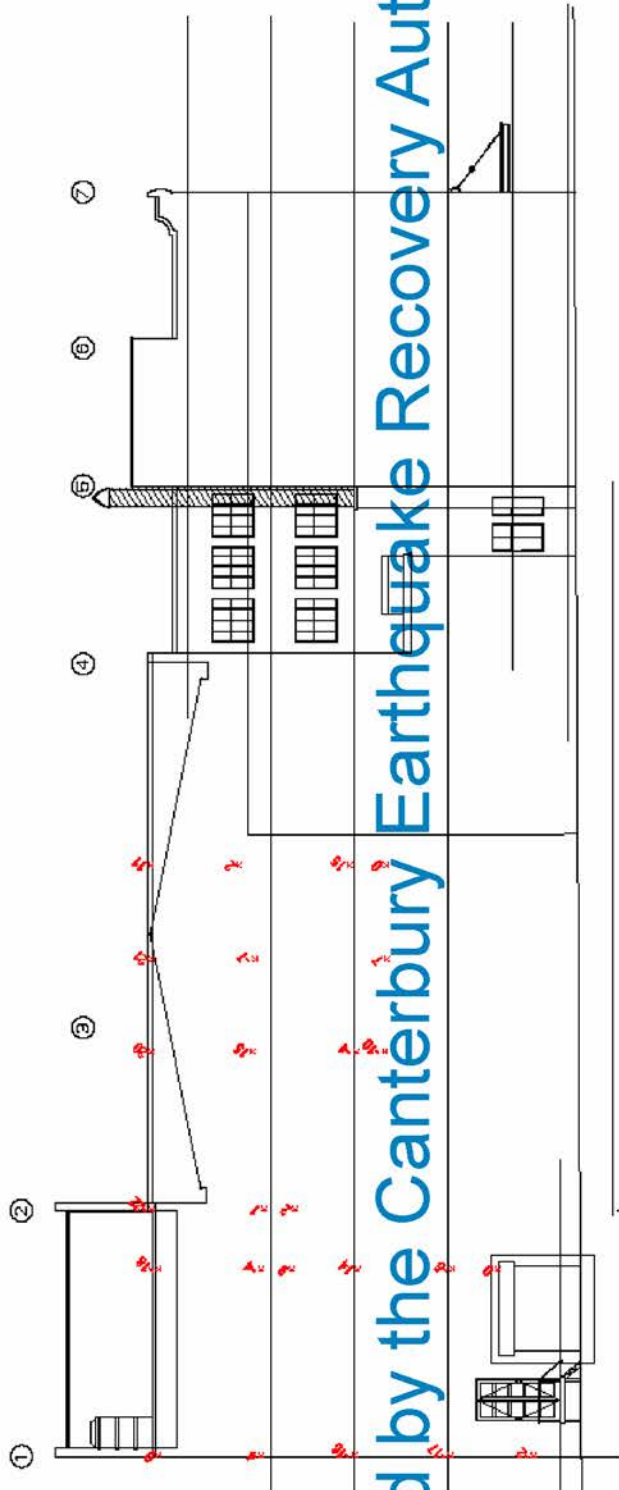
The most significant area that is out of verticality is the east wall which is out of plumb by 190mm over the height of the building and has an outward bow of 162mm relative to the two side walls. This is reflected in the proscenium wall which is also significantly bowed. The rear wall and proscenium wall are both deformed beyond repair and will require reconstruction.

**Notes:**  
 - Numbers indicate deviation from the vertical in mm  
 in relation to the bottom of the wall.  
 - Positive figures show wall leaning into building  
 - Negative figures show wall leaning out.  
 - Accuracy of measurements +/- 5mm

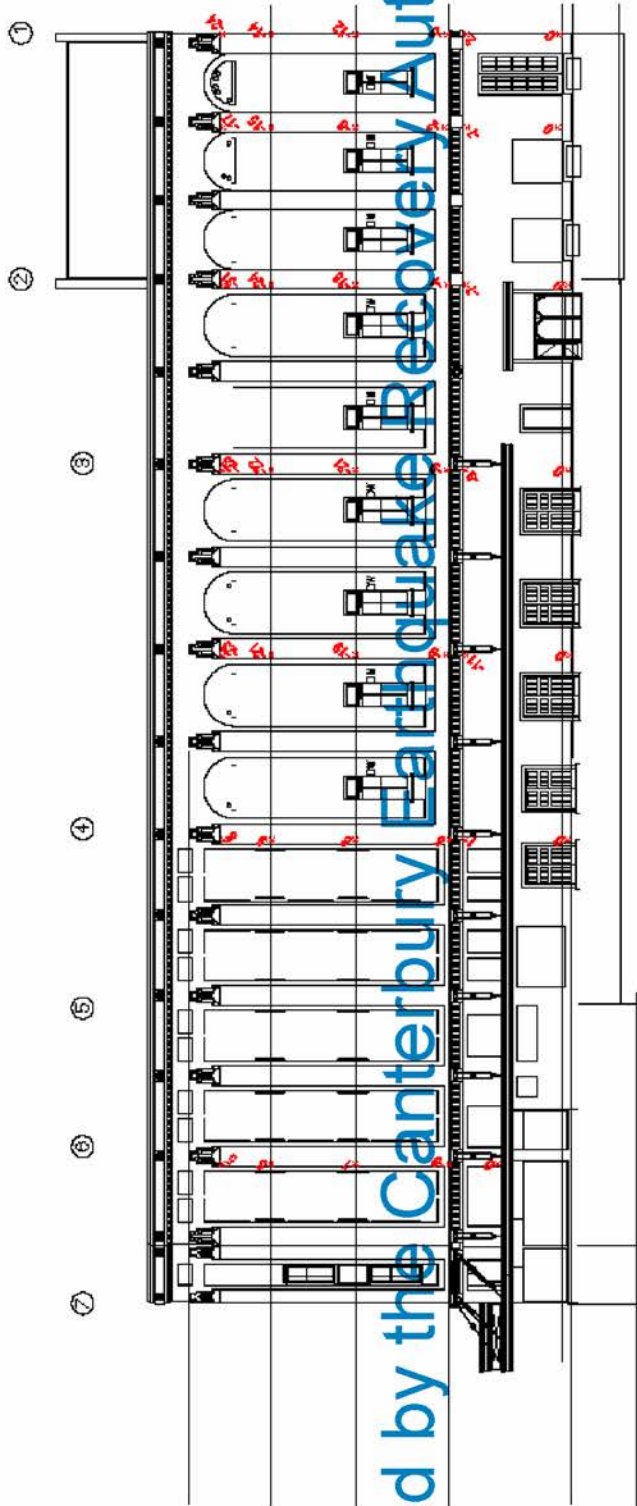
- Notes:**
- Numbers indicate deviation from the vertical in mm
  - In relation to the bottom of the wall
  - Positive figures show wall leaning into building
  - Negative figures show wall leaning out.
  - Accuracy of measurement  $\pm 5$  - 5mm

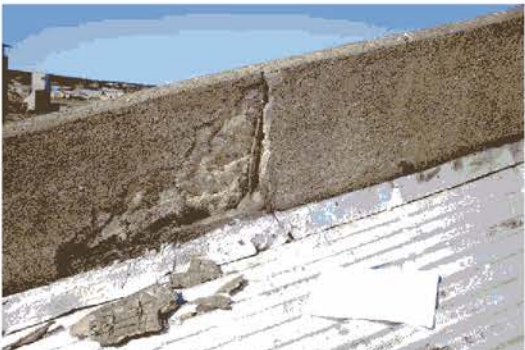
<p>Cracking to east wall stage parapet and wall</p>

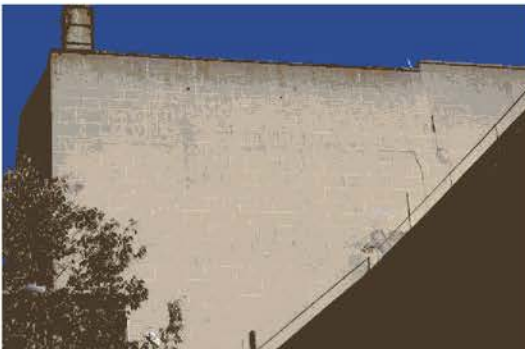
There were some notable cracks to the external concrete wall on the north side of the building as well as in the middle of the back wall of the stage. Water has penetrated these cracks, and corroded the reinforcing resulting in some cover concrete spalling off the building.

<p>Cracking to north wall</p>

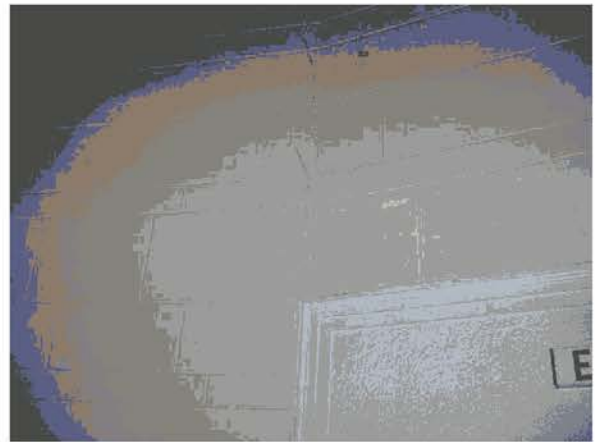
Cracking to rear wall of auditorium

- Cracked mortar joints to unreinforced masonry wall shall be raked out to a depth of 40mm and re-pointed.
- Small cracks (<1.0mm) to concrete walls and concrete frames shall be injected with epoxy grout.

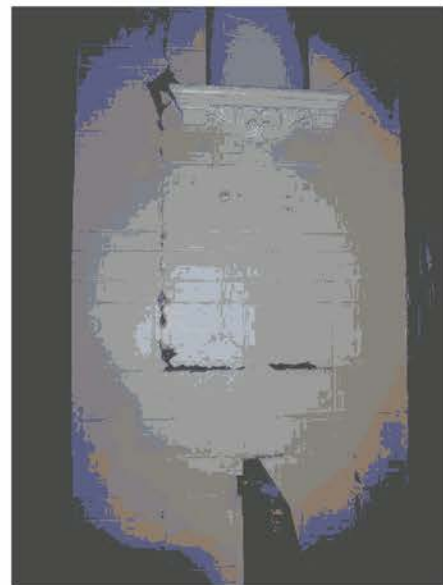
Cracking to side wall returns adjacent to galley stairs, at junction between masonry and concrete wall.

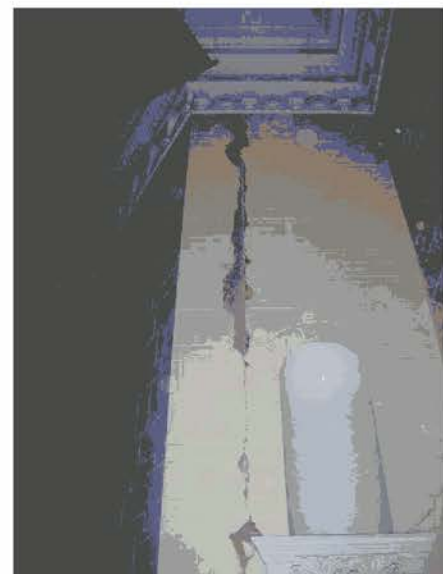
Cracking to side wall returns adjacent to galley stairs, at junction between masonry and concrete wall.

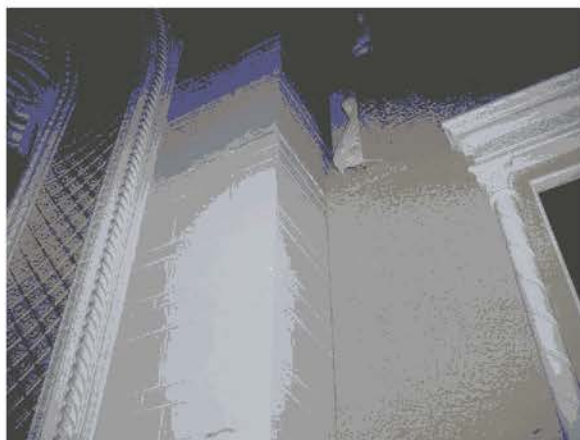
Cracking to concrete walls near stage at front of auditorium.

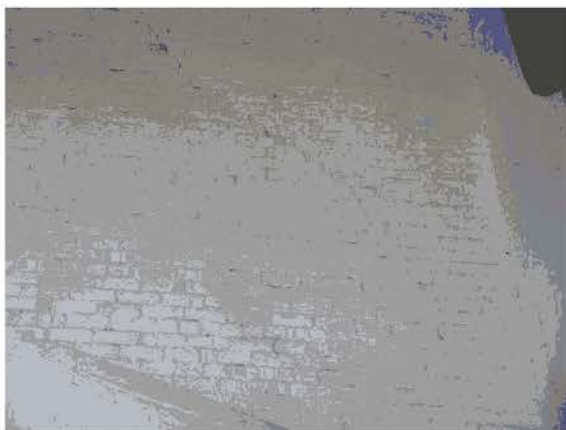
Cracking to brick infill panels in proscenium wall.

- Lathe and plaster ceiling will require checking for any loose plaster. Loose plaster will require removal and reinstatement.
- The east wall of the stage and proscenium wall is significantly bowed and is impractical and dangerous to repair. It is strongly recommended that the stage structure (rear wall, side walls and proscenium wall, including stage and basement) is removed and reconstructed.

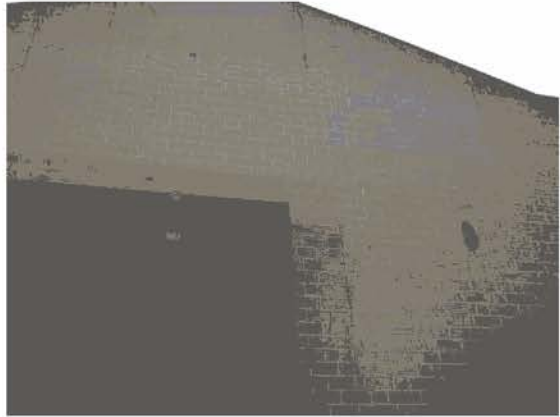
Exterior cracking to east rear wall of stage.

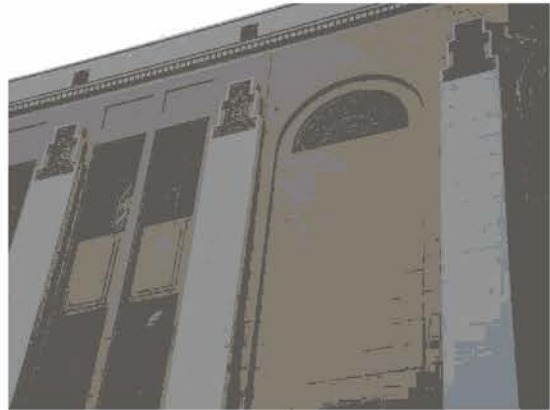
Cracking to south side exterior wall with separation occurring between auditorium and 3-storey area.

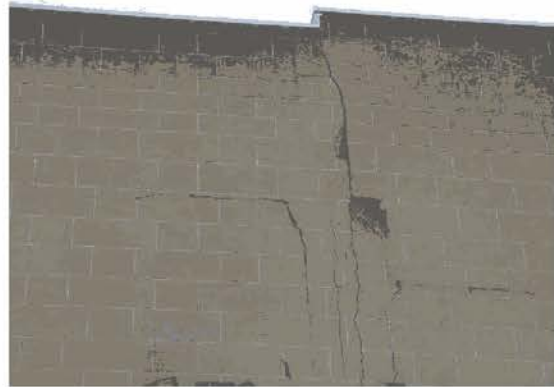
Cracking to north wall with separation between stage and auditorium wall.
