**ACCESSIBILITY AUDIT  
VICTORIA SQUARE  
AVON RIVER  
CHRISTCHURCH**

**EXISTING SQUARE  
SITE AUDIT**

**ACCESSIBILITY AUDIT  
VICTORIA SQUARE – EXISTING SITE AUDIT  
AVON RIVER, CHRISTCHURCH**

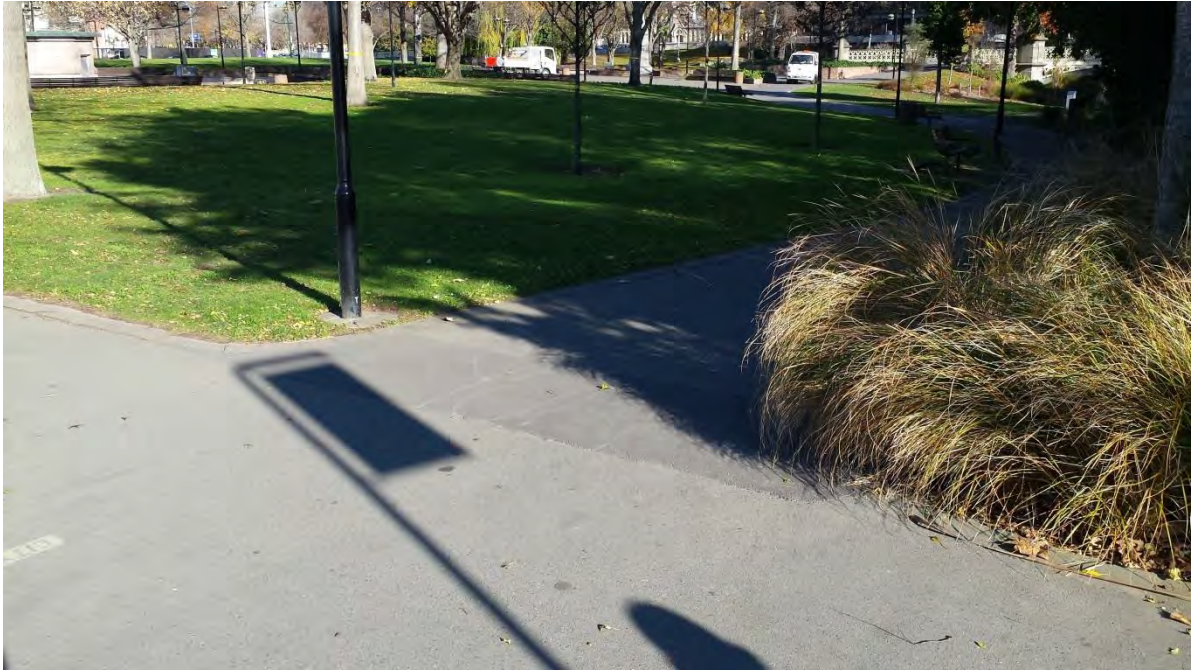
## 7.1.1 ENTRANCE

- The width of the entrance was 2.7m wide, with a gradient of 1:30
- The surface was asphalt, and would give adequate slip resistance when wet.

- Consider increasing the width of the entrance pathway to create further opportunities for accessible seating and refuge areas, provide increased space to manoeuvre for both pedestrians and cyclists, and reduce/eliminate the effect of parked service vehicles blocking the pathway as noted in other sections of this report.

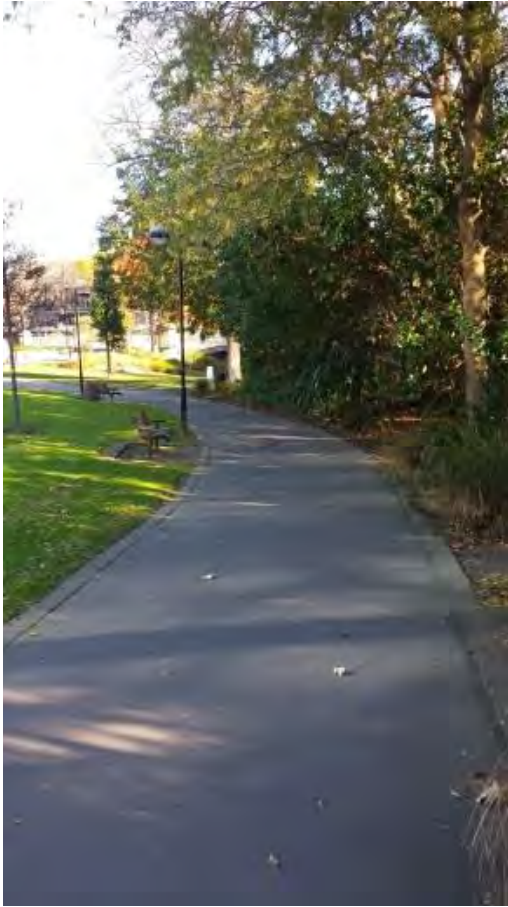
## 7.1.2 PATHWAY BEGINNING

- The average width of this pathway was 2.7m wide, with a gradient of 1:24
- The surface was asphalt, and would give adequate slip resistance when wet.

- Consider increasing the width of the pathway to create further opportunities for accessible seating and refuge areas, provide increased space to manoeuvre for both pedestrians and cyclists, and reduce/eliminate the effect of parked service vehicles blocking the pathway as noted in other sections of this report.

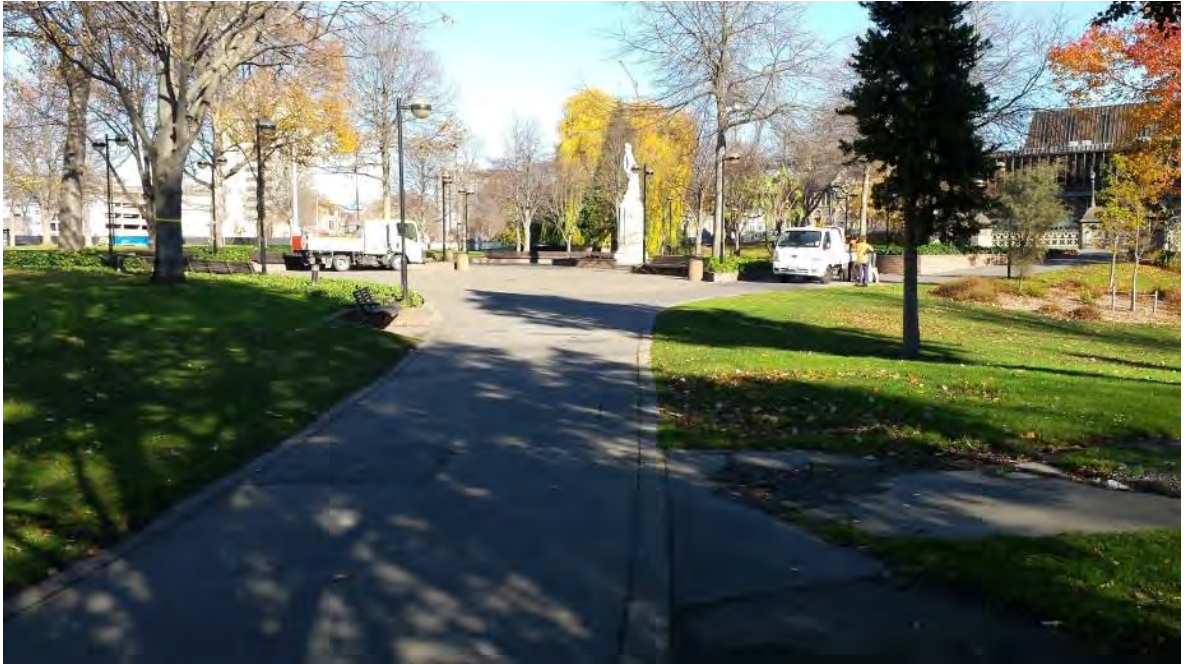
### 7.1.3 PATHWAY CONTINUED

- The average width of this pathway was 3.5m wide, with a gradient close to 1:50
- The surface was asphalt, and would give adequate slip resistance when wet.

- Include totem signage indicating the location of the punt stop.
- Consider increasing the width of the pathway to create further opportunities for accessible seating and refuge areas, provide increased space to manoeuvre for both pedestrians and cyclists, and reduce/eliminate the effect of parked service vehicles blocking the pathway as noted in other sections of this report.

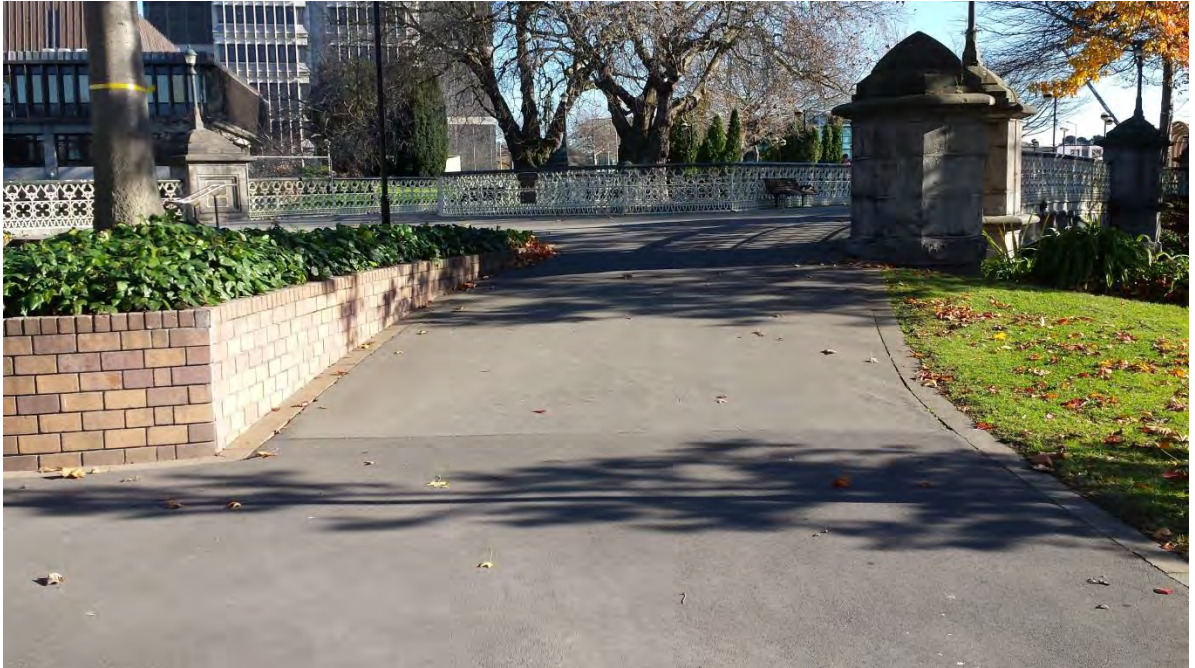
#### 7.1.4 RAMP TO HAMISH HAY BRIDGE

- The width of this ramp was 4.1m wide at its base, and 3.5m wide at its top.
- The surface was asphalt, and would give adequate slip resistance when wet.

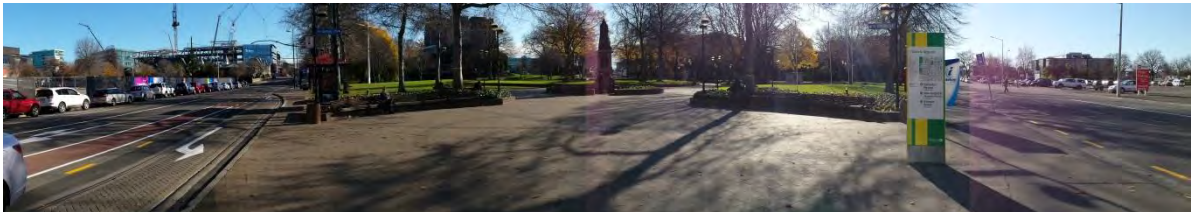
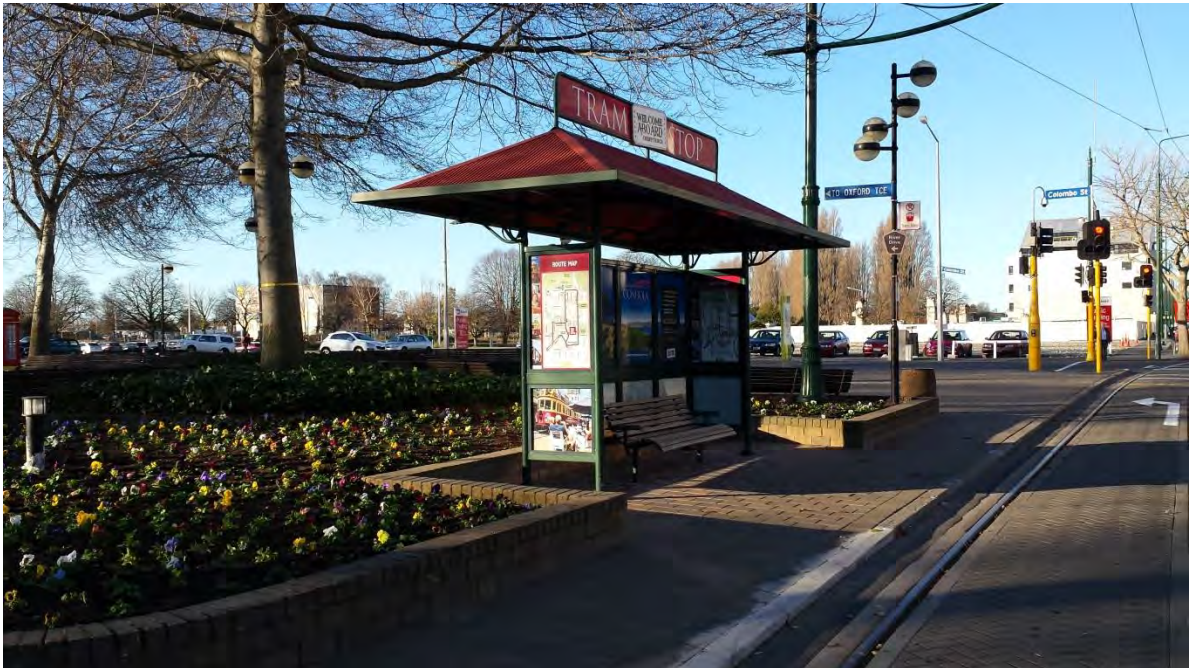
## 7.2.1 ENTRANCE

- The South East corner entrance an open, near level space with plenty of room for circulation.
- The secondary entrances to the South and East are 2.6m wide and near level.
- The surface was rough finished pavers, and would give adequate slip resistance when wet.
- The tram stop had a good wheelchair seating space at its West end.

- Widen the wheelchair space on the East end of the tram stop to be 800mm wide.
- Consider replacing the tram stop seating as per our seating recommendations later in this report.

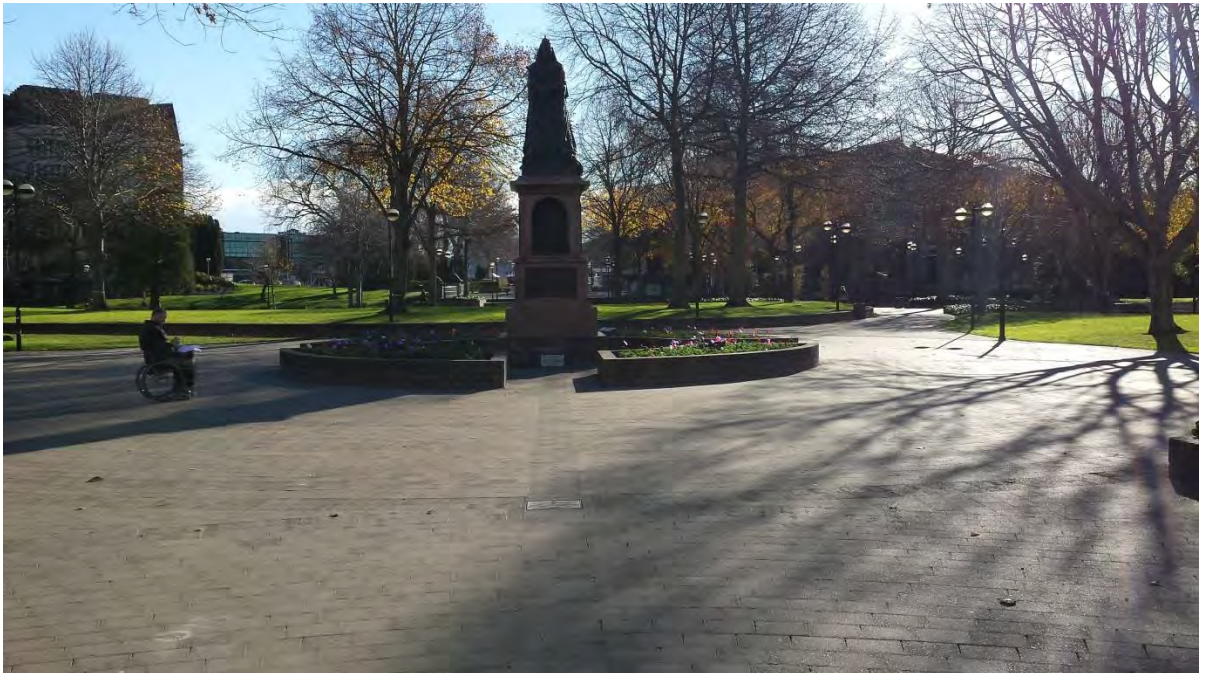
## 7.2.2 PEDESTRIAN ROUTE PAST VICTORIA STATUE

- The route is a wide open, near level space with plenty of room for circulation.
- The surface was rough finished pavers, and would give adequate slip resistance when wet.

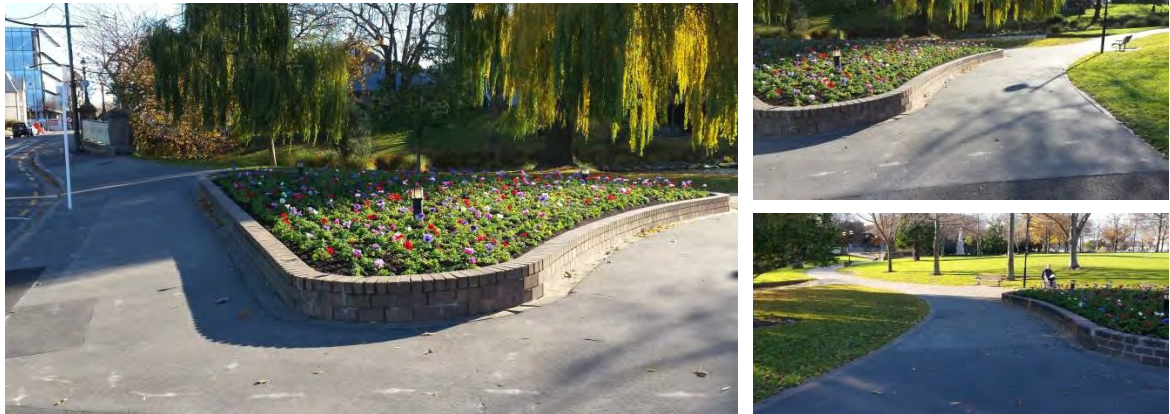
## 7.3.1 ENTRANCE

- The path to the east side of the entrance garden was 2.6m wide and had a smooth gradient of approximately 1:30.
- The surface was asphalt, and would give adequate slip resistance when wet.
- The path to the west side of the entrance was 2.6m wide.

- The footpaths cross fall was 1:15 in front of this entry point, significantly steeper than the recommended minimum of 1:50.
- The path to the west side of the entrance garden had a ramp gradient of approximately 1:16. No handrails were provided on this ramp.

- Consider raising the level of the path within the square so that both the east and west pathways at this entrance have a much smoother gradient, ideally 1:33 or gentler.
- Level off the footpath along the entrance ways to this route so that the cross fall is 1:50 or gentler.
- Consider increasing the width of the entrance pathways to create further opportunities for accessible seating and refuge areas, provide increased space to manoeuvre for both pedestrians and cyclists, and reduce/eliminate the effect of parked service vehicles blocking the pathway as noted in other sections of this report.

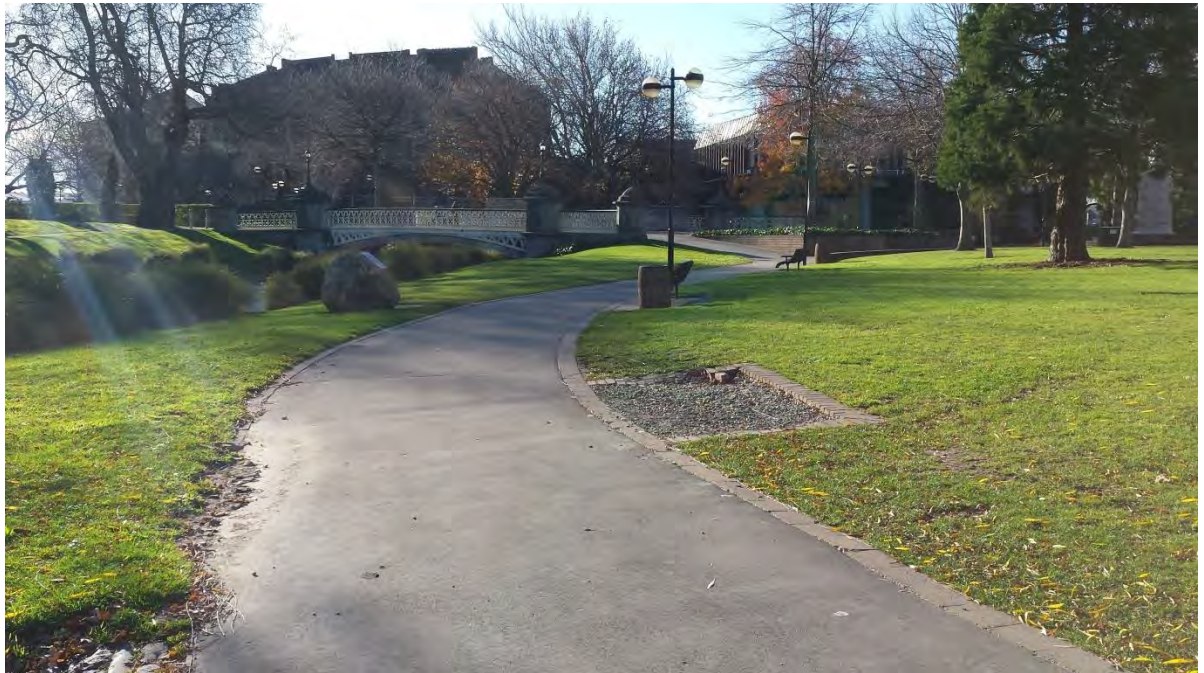
## 7.3.2 PATHWAY

- The average width of this pathway was 2.6m wide, with a gradient of 1:30
- The surface was asphalt, and would give adequate slip resistance when wet.

- The average cross fall on this pathway was 1:20, significantly steeper than the recommended minimum of 1:50.

- Raise this pathway to reduce the ramp gradients at each end of it, and ensure that once raised the gradient is at least as smooth as 1:33 (ideally 1:50) and ensure that the cross fall is no greater than 1:50.
- If the pathway is not to be raised then re-level this path so that the cross fall is no greater than 1:50.
- Consider increasing the width of the pathway to create further opportunities for accessible seating and refuge areas, provide increased space to manoeuvre for both pedestrians and cyclists, and reduce/eliminate the effect of parked service vehicles blocking the pathway as noted in other sections of this report.

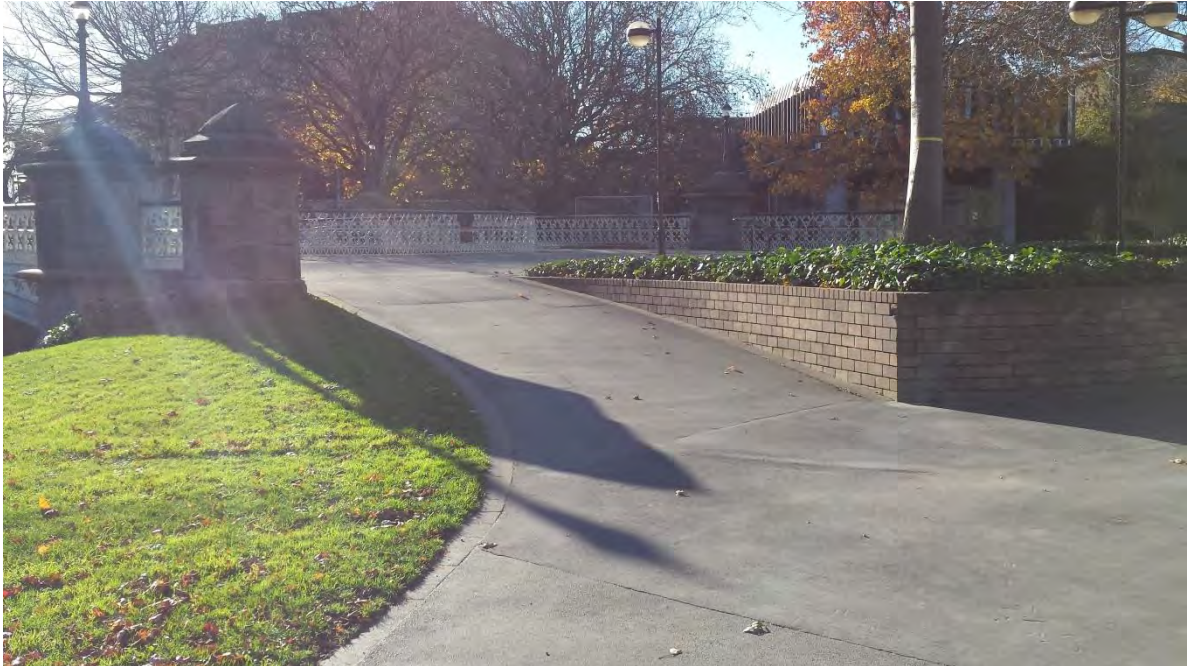
### 7.3.3 RAMP TO HAMISH HAY BRIDGE

- The width of this ramp was 3.3m wide at its base. The width at its top was not measured onsite but assumed to be around 3.0m wide.
- The surface was asphalt, and would give adequate slip resistance when wet.

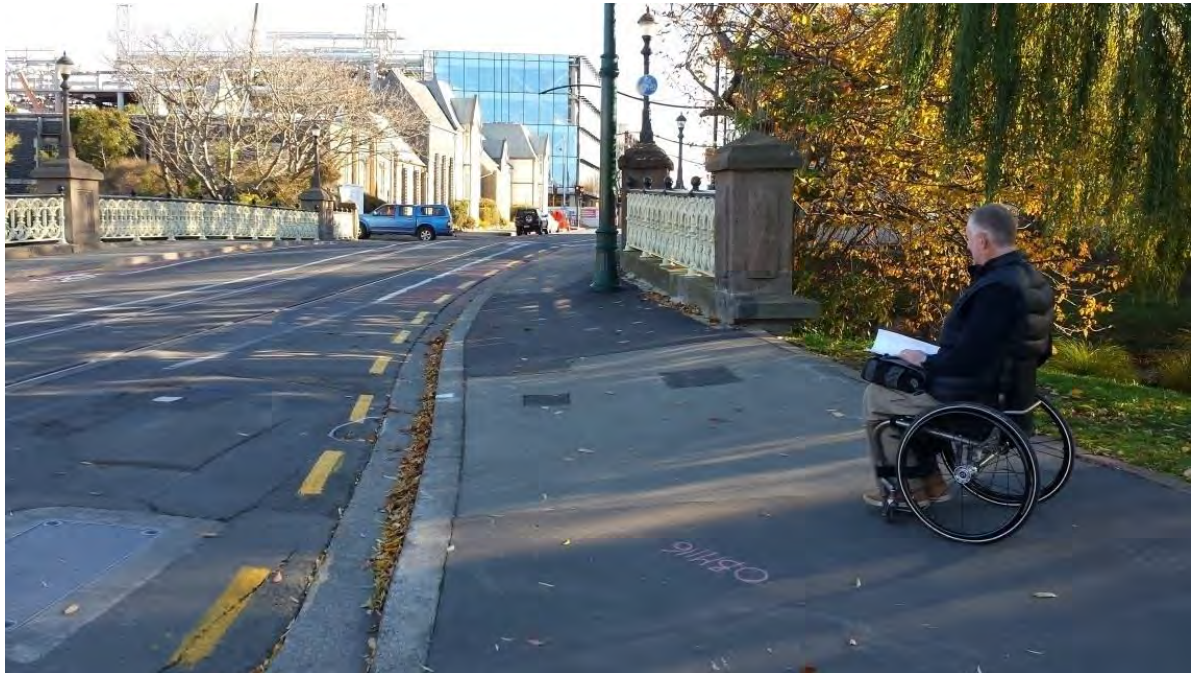
## 7.4.1 ARMAGH STREET BRIDGE

- The surface was asphalt, and would give adequate slip resistance when wet.

- The section of footpath over the bridge connecting to the beginning of route 3 had a very steep cross fall of 1:12, significantly steeper than the recommended minimum of 1:50. The clear width was also 1450mm at one point due to the positioning of a lighting pole within the footpath.
- The section of footpath connecting this entrance to that of route three had a longitudinal ramp gradient of approximately 1:15 in some sections. No handrails were provided on this ramp.

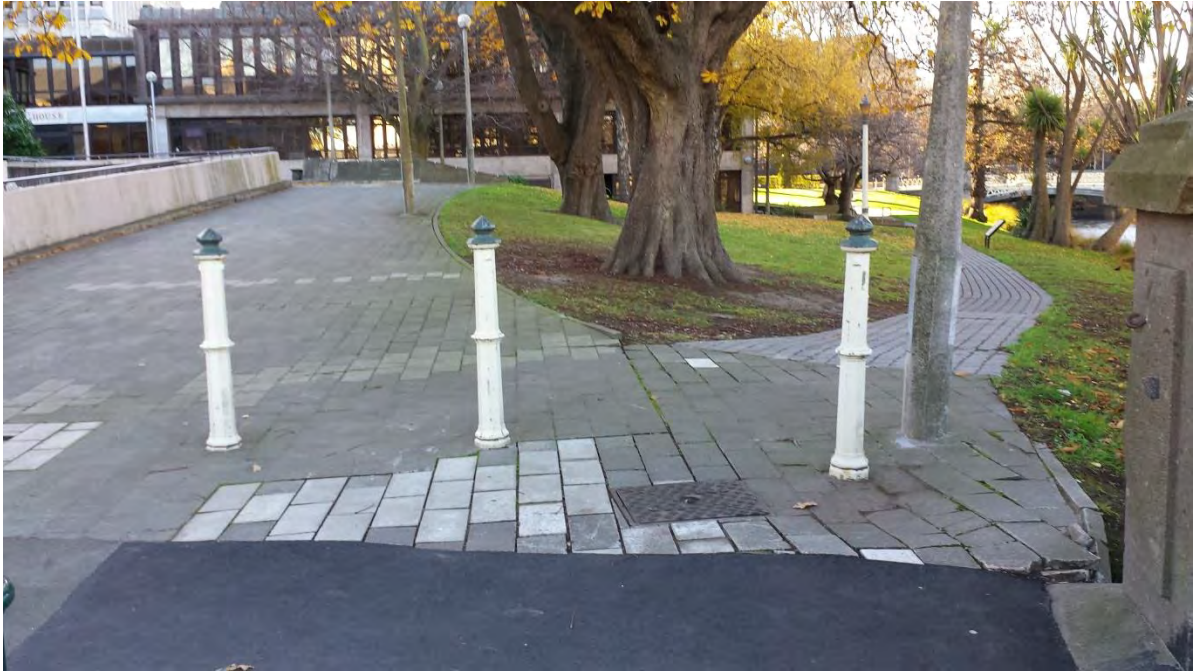
## 7.4.2 PATHWAY ENTRANCE (SOUTH END)

- The bollards contrast to their surrounds, and are over 900mm high.
- Clear space of 900mm is available between all but the right most of the bollards.
- The surface at the entry to this pathway was a mix of asphalt and rough finished pavers, which would give an adequate slip resistance when wet.

- The traverse gradient of the footpath running in front of the entrance to this pathway was 1:15, significantly steeper than the recommended minimum of 1:50.

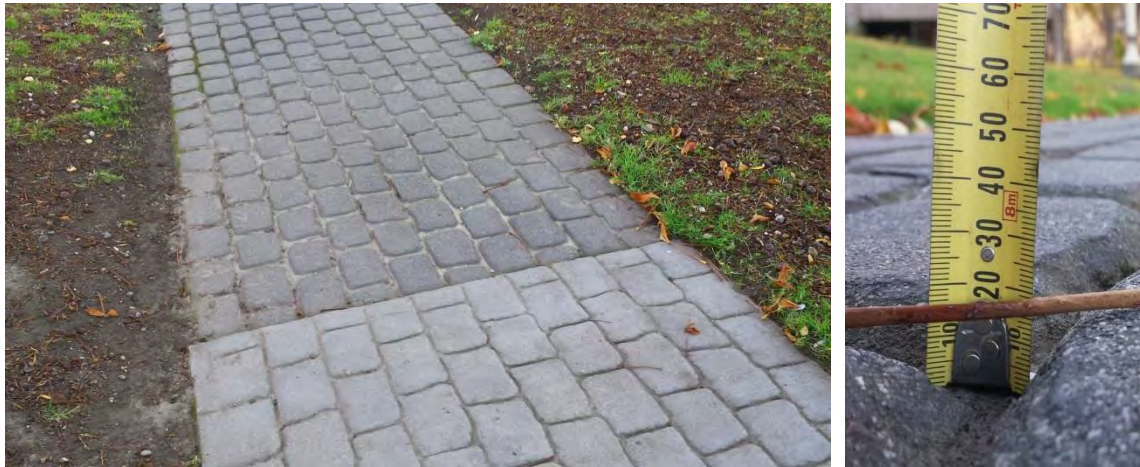
### 7.4.3 PATHWAY

- The surface of the pavers was rough, and would give adequate slip resistance when wet.
- The pathway has a gradient of 1:33 at its northern end.

- The pathway has a ramp gradient of 1:13 at the southern end, and no handrails either side.
- The average width of this pathway was 1.45m wide.
- The average cross fall was hard to measure due to the pavers but would be in the range of 1:30 which is steeper than the recommended minimum of 1:50.
- The pavers had spacing of up to 25mm between their top flat surface, with depths up to 20mm in some places.

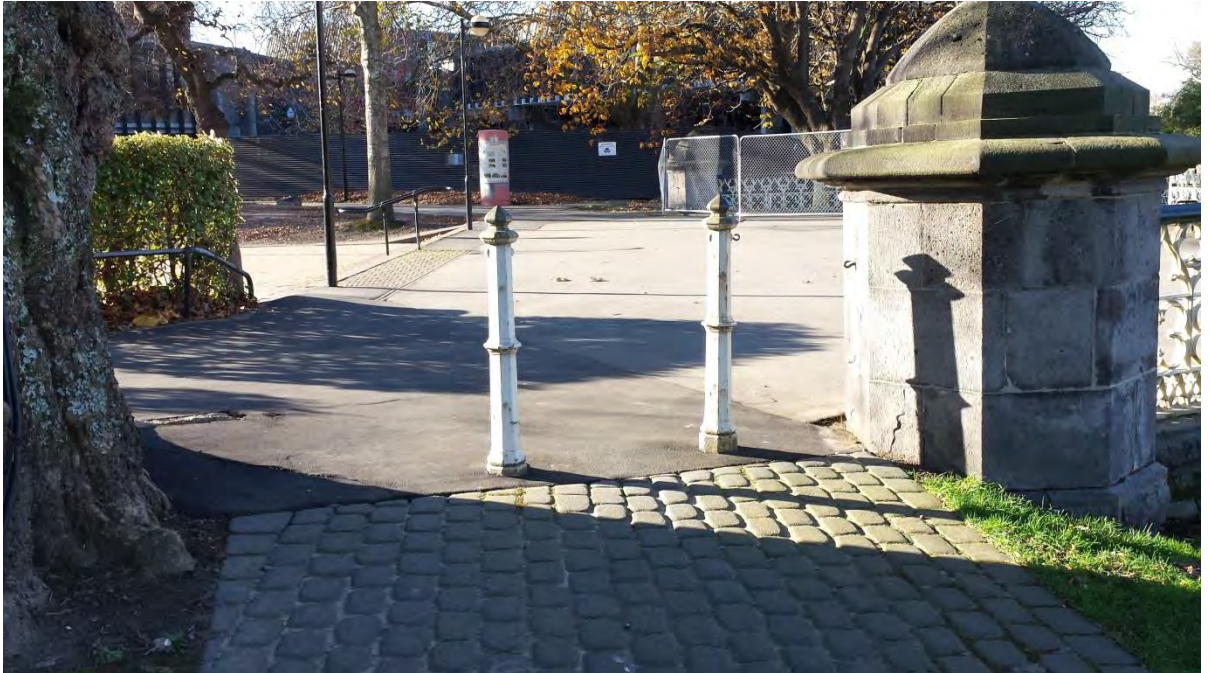
#### 7.4.4 MAIN PATHWAY EXIT (NORTH END) TO HAMISH HAY BRIDGE

- The bollards are over 900mm high.
- Clear space of 900mm is available to the left of both bollards.
- The surface is a mix of asphalt and rough finished pavers, which would give an adequate slip resistance when wet.

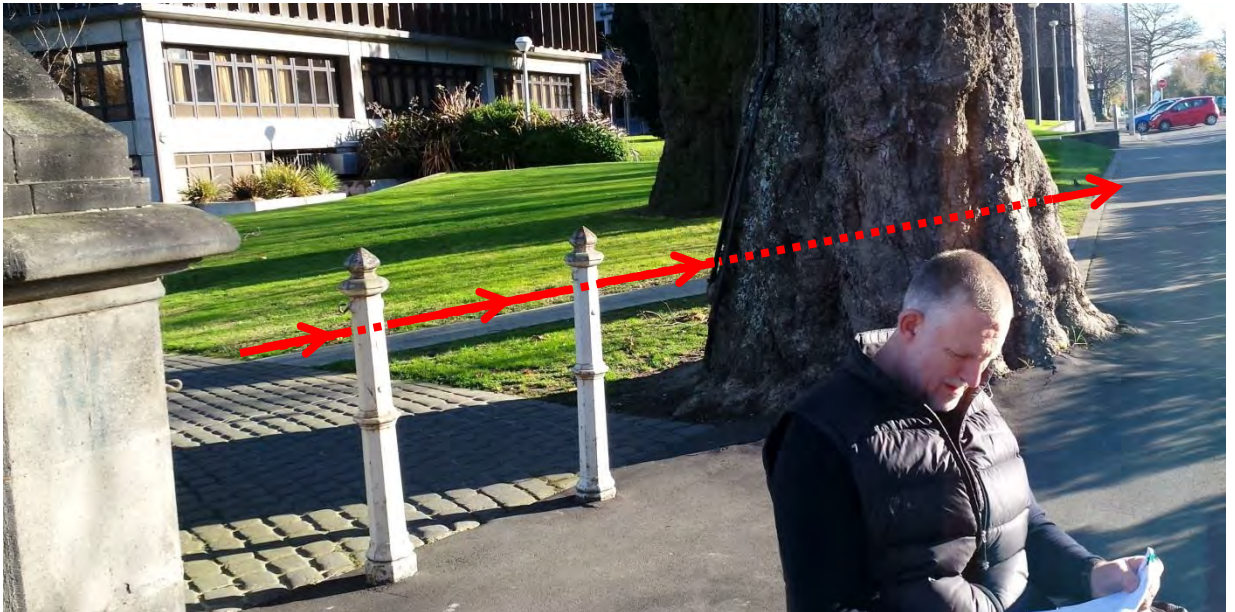
#### 7.4.5 ALTERNATE PATHWAY EXIT (NORTH END) TO CHESTER STREET WEST

- The surface is brushed concrete and would likely give adequate slip resistance when wet.

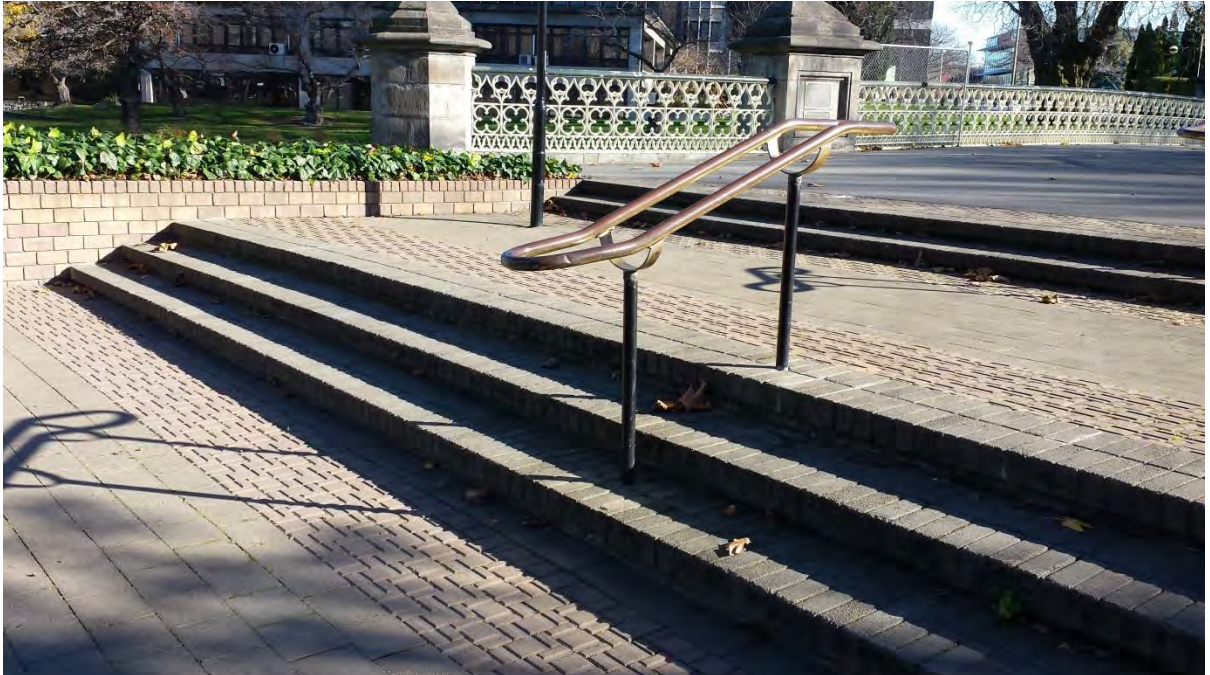
## 7.5.1 SOUTH SIDE STAIRS TO HAMISH HAY BRIDGE

- The riser height was below the maximum of 180mm for an accessible stair.
- The treads were 430mm, which exceeds the minimum of 310mm for an accessible stair.
- A change in texture was provided at both the top and bottom of the stairs (flipped bricks).
- The stairs had a rough brick finish which would give adequate slip resistance when wet.
- The handrail was an appropriate height.
- The dual rail central handrail was an appropriate choice for a central rail which will allow users to pass each other on different sides without their hands colliding.
- The fixing method of the handrail to the vertical posts does not obstruct the passage of the hand.
- The landing between stair flights was an appropriate size.

- The riser height varied between 140-160mm. Accessible stairs must have consistent riser heights.
- The handrail lacked extensions of 300mm past the top riser, and 300mm plus one tread length past the bottom riser.
- For a stairway that has a total width of 13m handrails should be provided at both ends in addition to a central handrail.
- No contrasting nosings were present on the stairs.
- The nosing projected 30mm in some places (others it was flush) this projection creates a trip hazard.
- The front edge of the tread was not rounded.
- The contrast was poor between the surrounding routes and the stairs.

- Ensure that the stair risers are a consistent height.
- Install additional compliant handrails at each end of the stair.
- Replace the existing central handrail with one that meets today's standards (extensions etc).

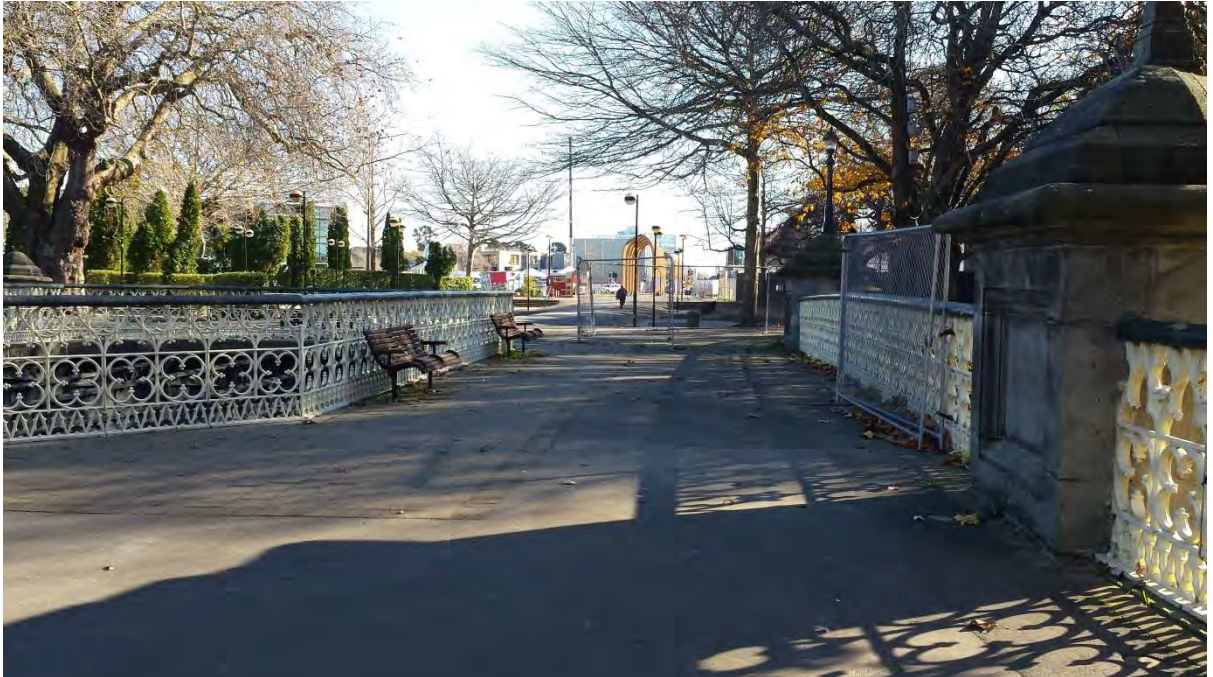
## 7.6.1 HAMISH HAY BRIDGE

- No gradient on the bridge exceeded 1:20, with most areas having a much gentler gradient.
- The surface is asphalt, which would give an adequate slip resistance when wet.

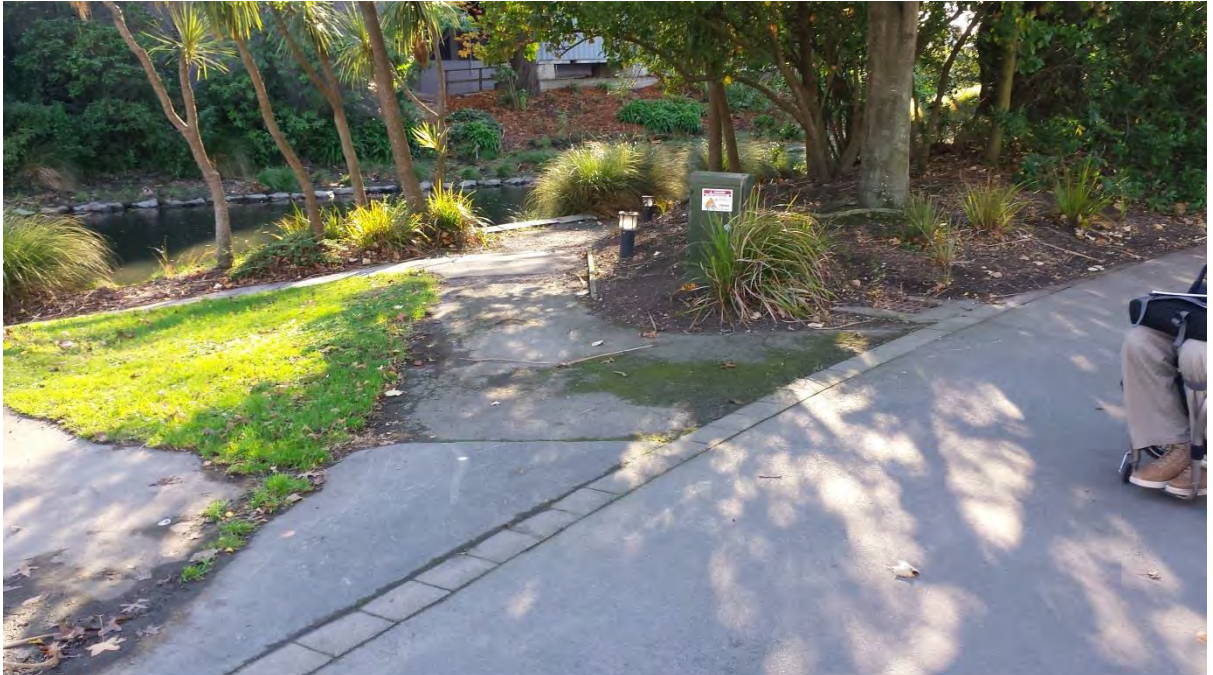
## 7.7.1 ACCESS PATH WEST (RAMP)

- The surface is asphalt, which would give an adequate slip resistance when wet.

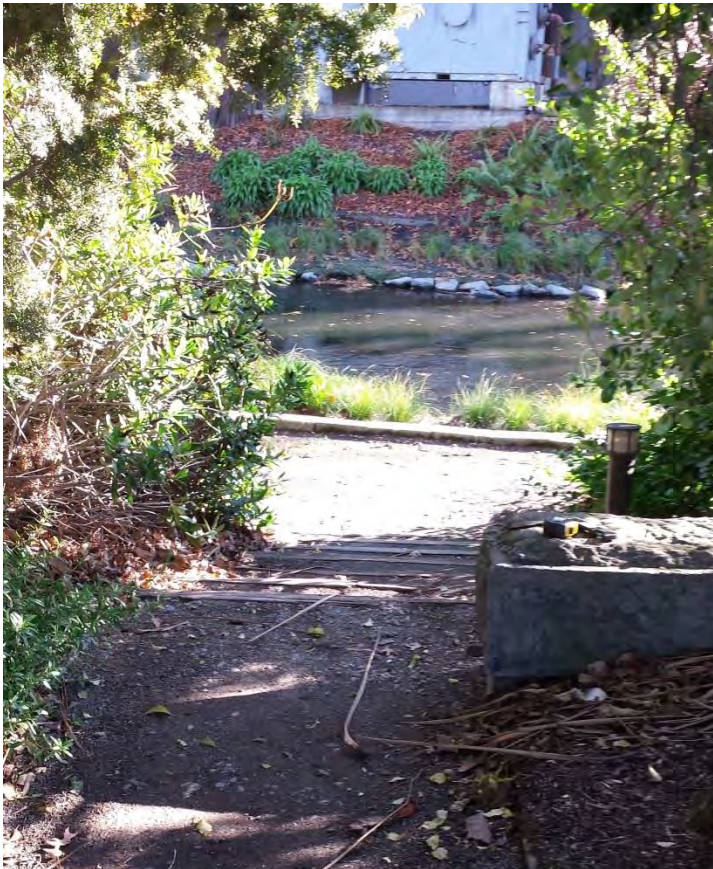
## 7.7.2 ACCESS PATH EAST (STAIR)

**NOTE:** *The stairs here were hard to measure or assess accurately due to the level of degradation/damage that they experienced.*

- The surface is loose metal, and uneven in many places.
- The width of the path and stairs is 1400mm wide.
- No handrail was provided either side of the stairs.

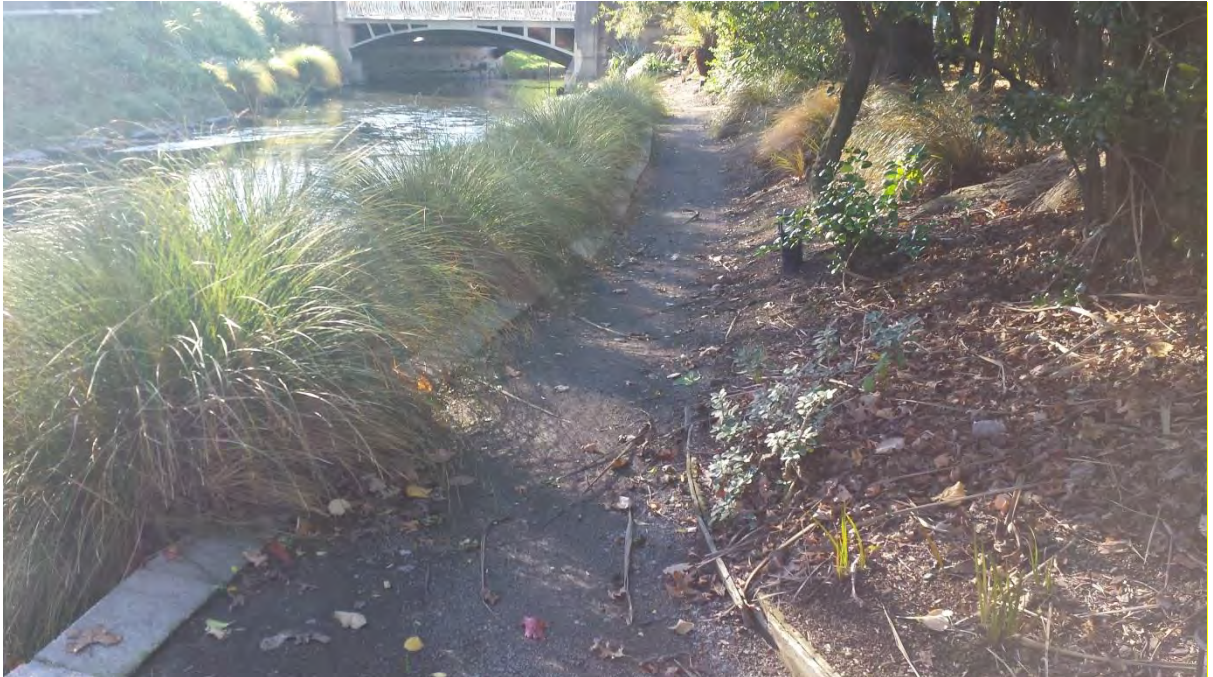
### 7.7.3 RIVERSIDE PATHWAY

- This pathway is a great opportunity to give safe access to the waterside for persons uncomfortable with navigating, or unable to navigate the grassed banks around the rest of the square.

- The surface is loose metal, and uneven in many places.
- The width of the pathway is 1200mm wide at its widest point, and 1000mm at its narrowest.
- No upstand on river edge of path.

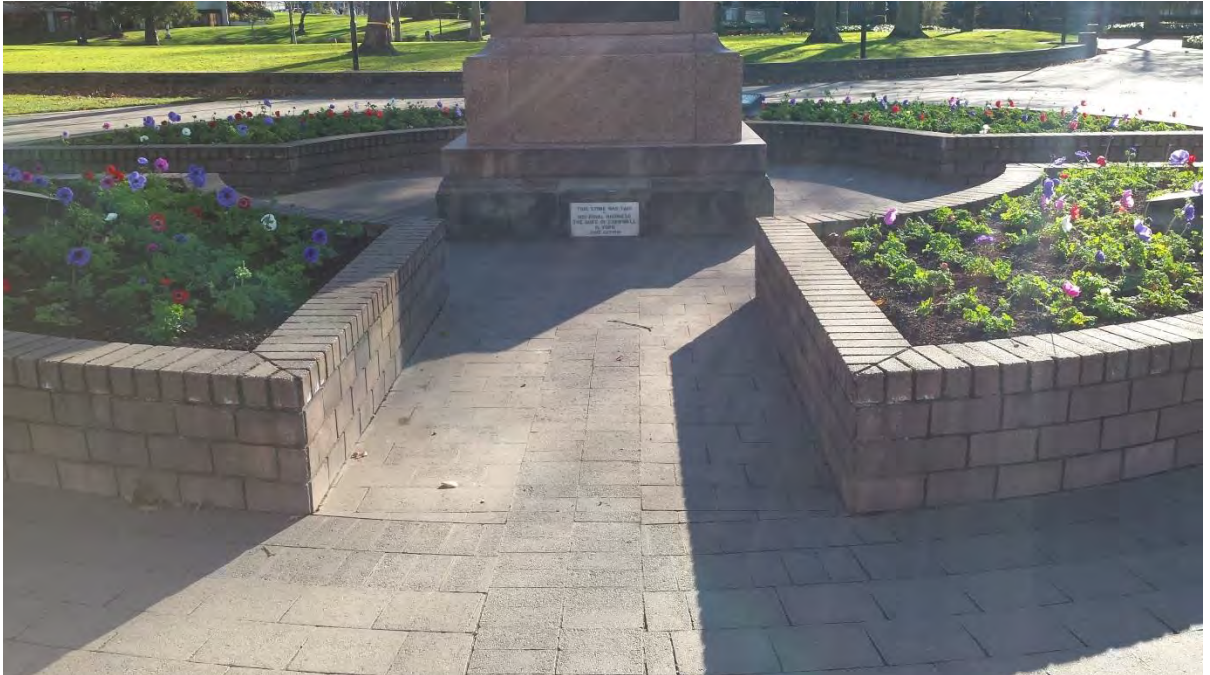
## 7.8.1 ACCESS PATHWAYS TO STATUE

- The surface is rough finished pavers, which would give an adequate slip resistance when wet.
- The clear width of the four pathways leading up to the statue varied between 1500-1600mm

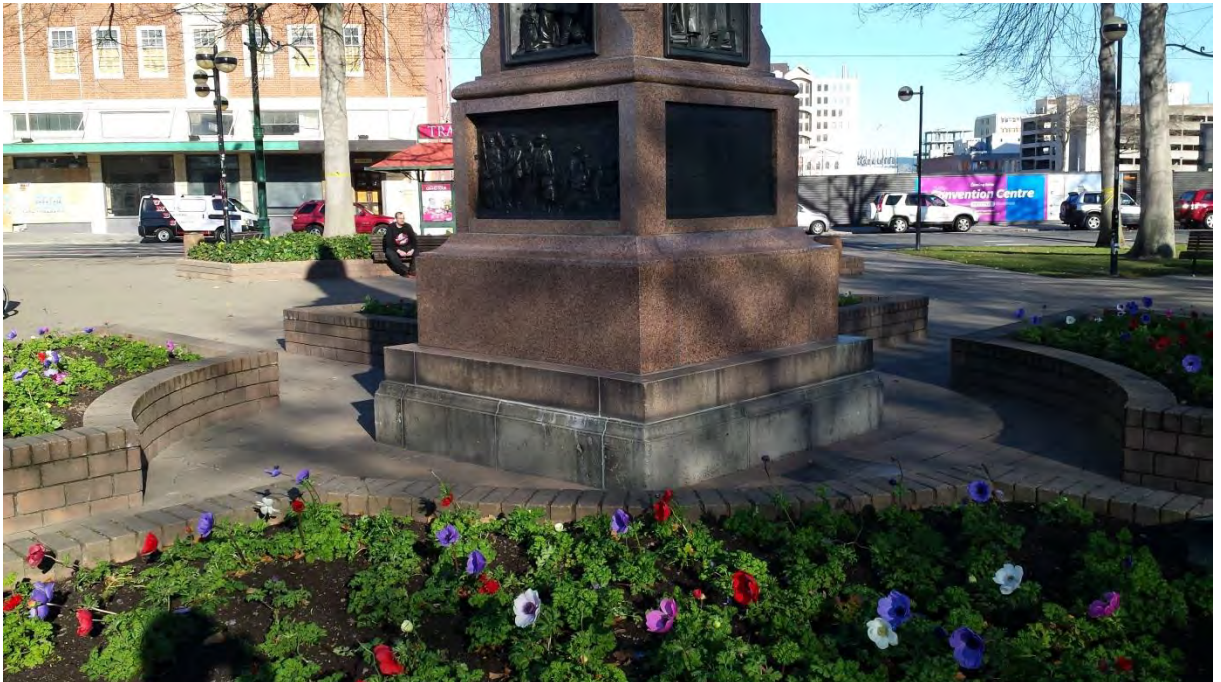
## 7.8.2 ACCESS PATHWAYS AROUND STATUE

- The surface is rough finished pavers, which would give an adequate slip resistance when wet.
- The clear width of the circulation spaces around the statue at their narrowest point are 1200mm (1180mm at one corner)

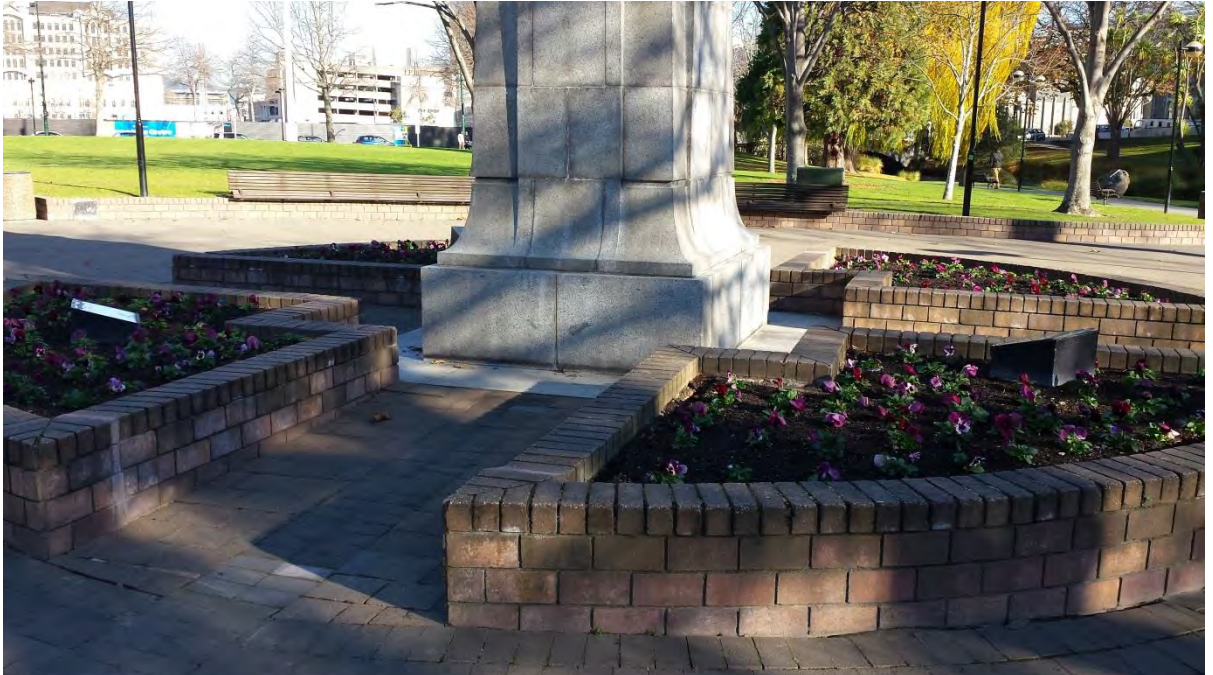
## 7.9.1 ACCESS PATHWAYS TO STATUE

- The surface is rough finished pavers, which would give an adequate slip resistance when wet.
- The clear width of the four pathways leading up to the statue varied between 1500-1600mm

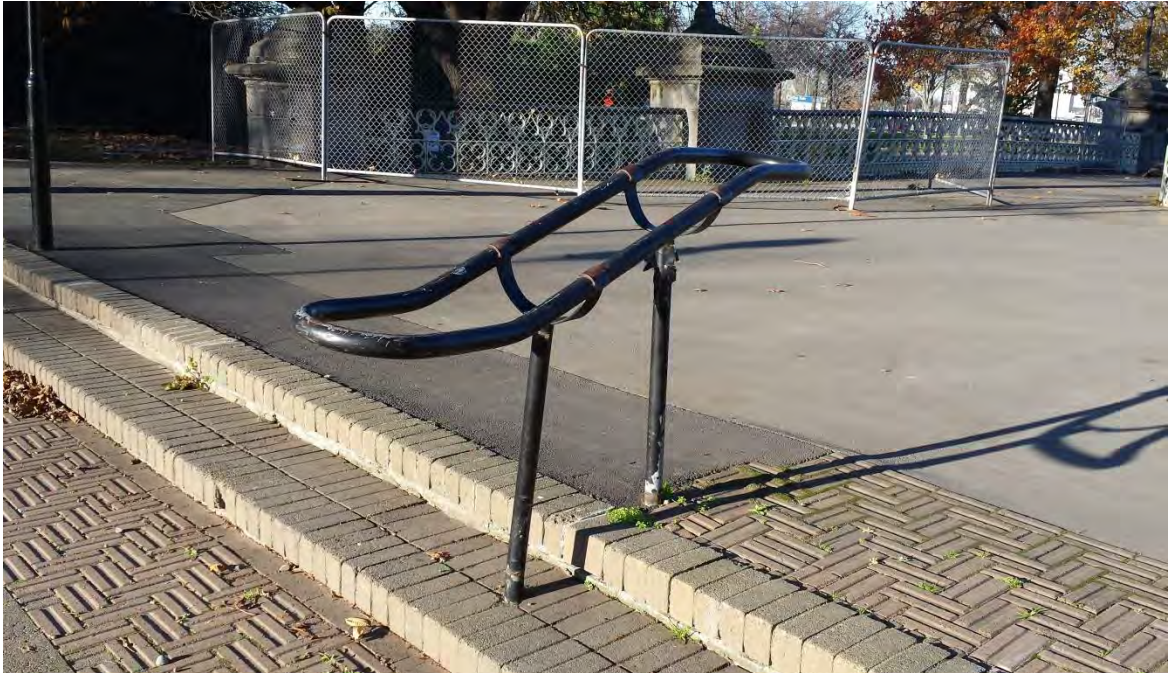
## 7.14.1 NORTH OF HAMISH HAY BRIDGE - BRIDGE STAIR

- The handrail lacked extensions of 300mm past the top riser, and 300mm plus one tread length past the bottom riser.
- For a stairway that has a total width of 4m+ handrails should be provided at both ends in addition to a central handrail.
- No contrasting nosings were present on the stairs.
- The nosing projected 30-40mm in some places (others it was flush) this projection would create a trip hazard.
- The front edge of the tread was not rounded.
- The contrast was poor between the surrounding spaces and the stairs (except where new black asphalt had been used to fill some patches in).
- The fixing method of the handrail to the vertical posts obstructed the passage of the hand.

- Install additional compliant handrails at each end of the stair.
- Replace the existing central handrail with one that meets today's standards (extensions etc).
- Incorporate contrast of colour at the top and bottom of each stair flight.
- Incorporate a contrasting nosing strip into the stair treads.
- Fill in the back of the riser under the 30-40mm projections to eliminate the trip hazard.
