Area-wide geotechnical information summary for CERA zoning review panel

This document contains all the area-wide geotechnical information which was considered by CERA as part of the process for making flat-land zoning decisions, and the subsequent zoning review.

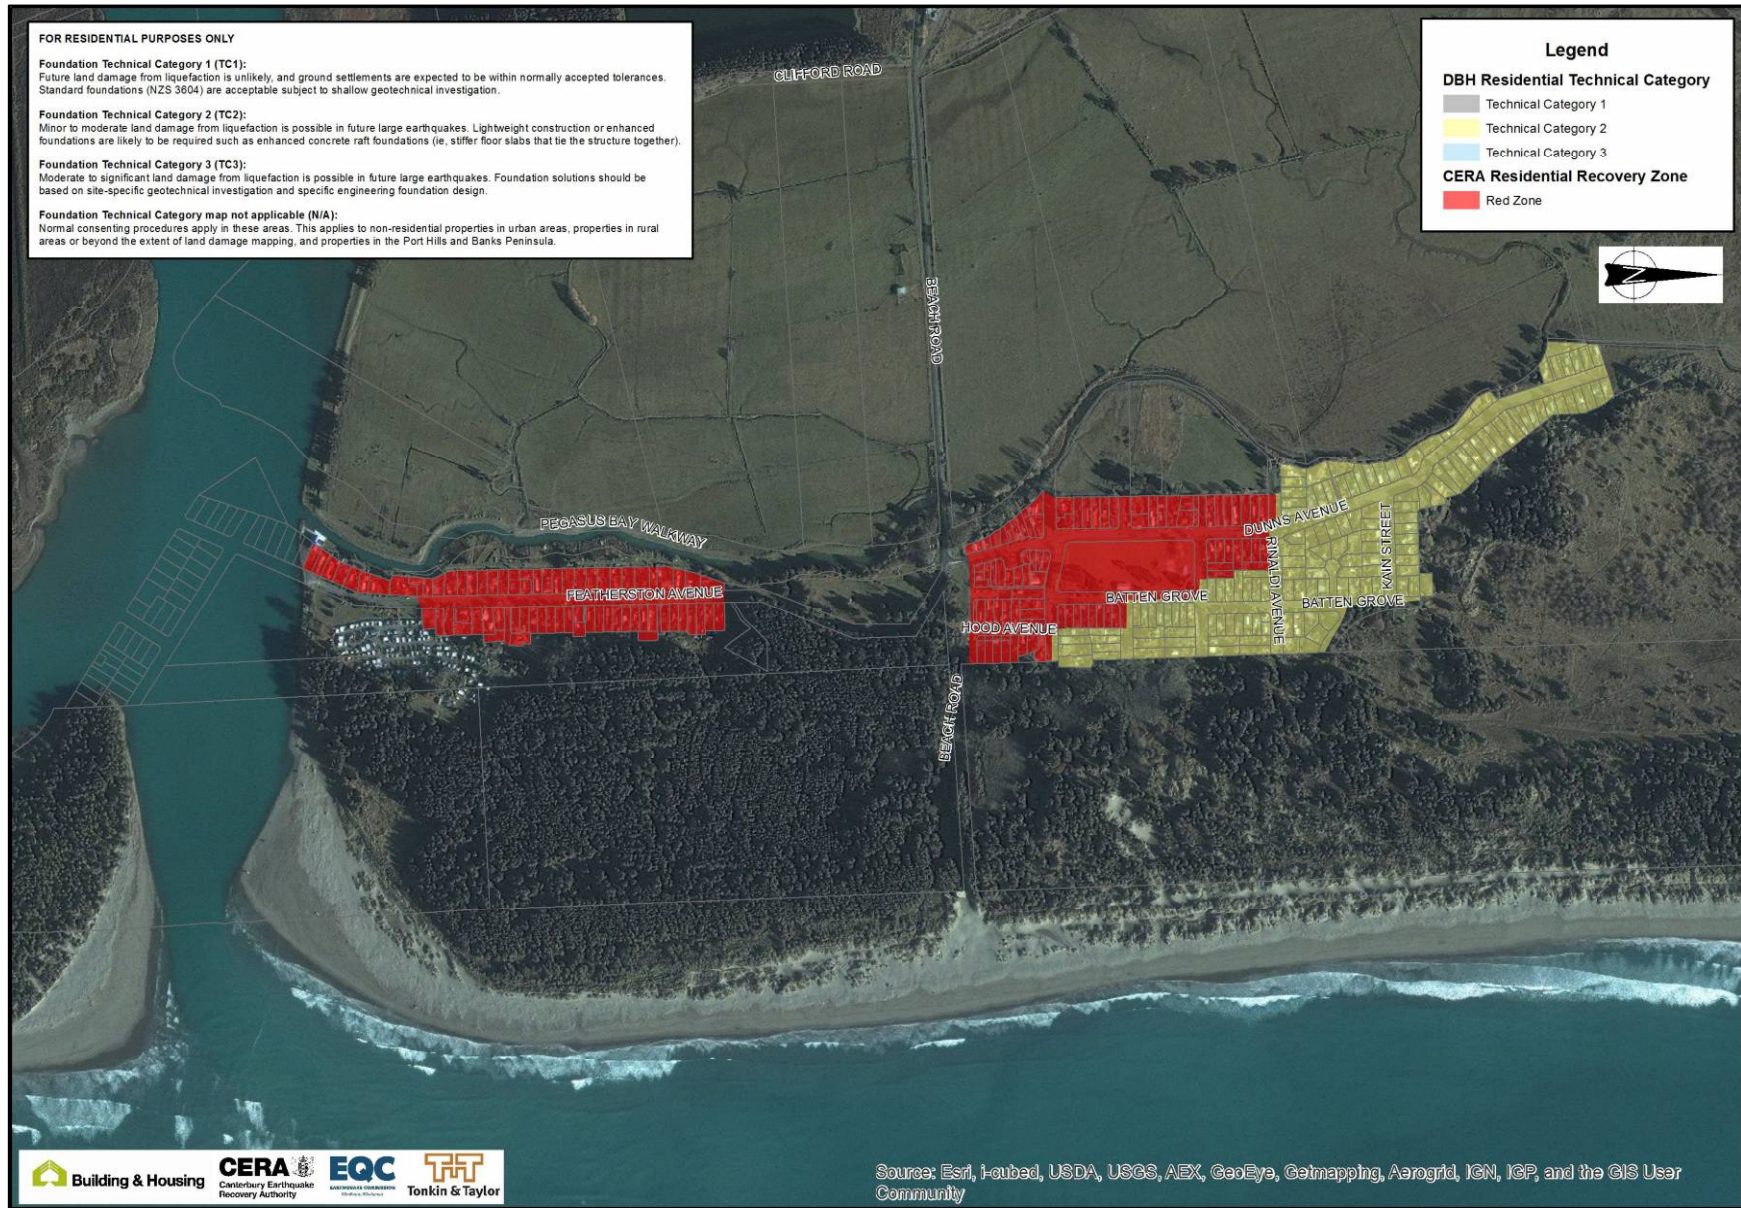
Figure 1 – CERA residential red zone and Department of Building & Housing (DBH) technical categories

Green zones were declared by CERA in areas where damage can be addressed on an individual basis. Many properties in the green zone have experienced significant land and building damage. The important difference between these properties and those in the red zone is that it is possible to address this damage on an individual property-by-property basis. Technical guidance documents have been developed by Building & Housing to provide recommended processes for assessment, repair and rebuilding of homes in all parts of the green zone which have been damaged by the Canterbury earthquakes.

Red zones were declared by CERA in areas where there is area-wide damage (implying an area-wide solution) and an area-wide engineering solution to remediate the land damage would be uncertain, disruptive, not timely, nor cost effective. There was a range of land and building damage experienced across red zone areas – damage was mostly severe, but on some individual properties there may have only been minor damage. The important difference between these properties and those in the green zone is the need to address the engineering challenges faced by the wider area before individual properties can be repaired or rebuilt.

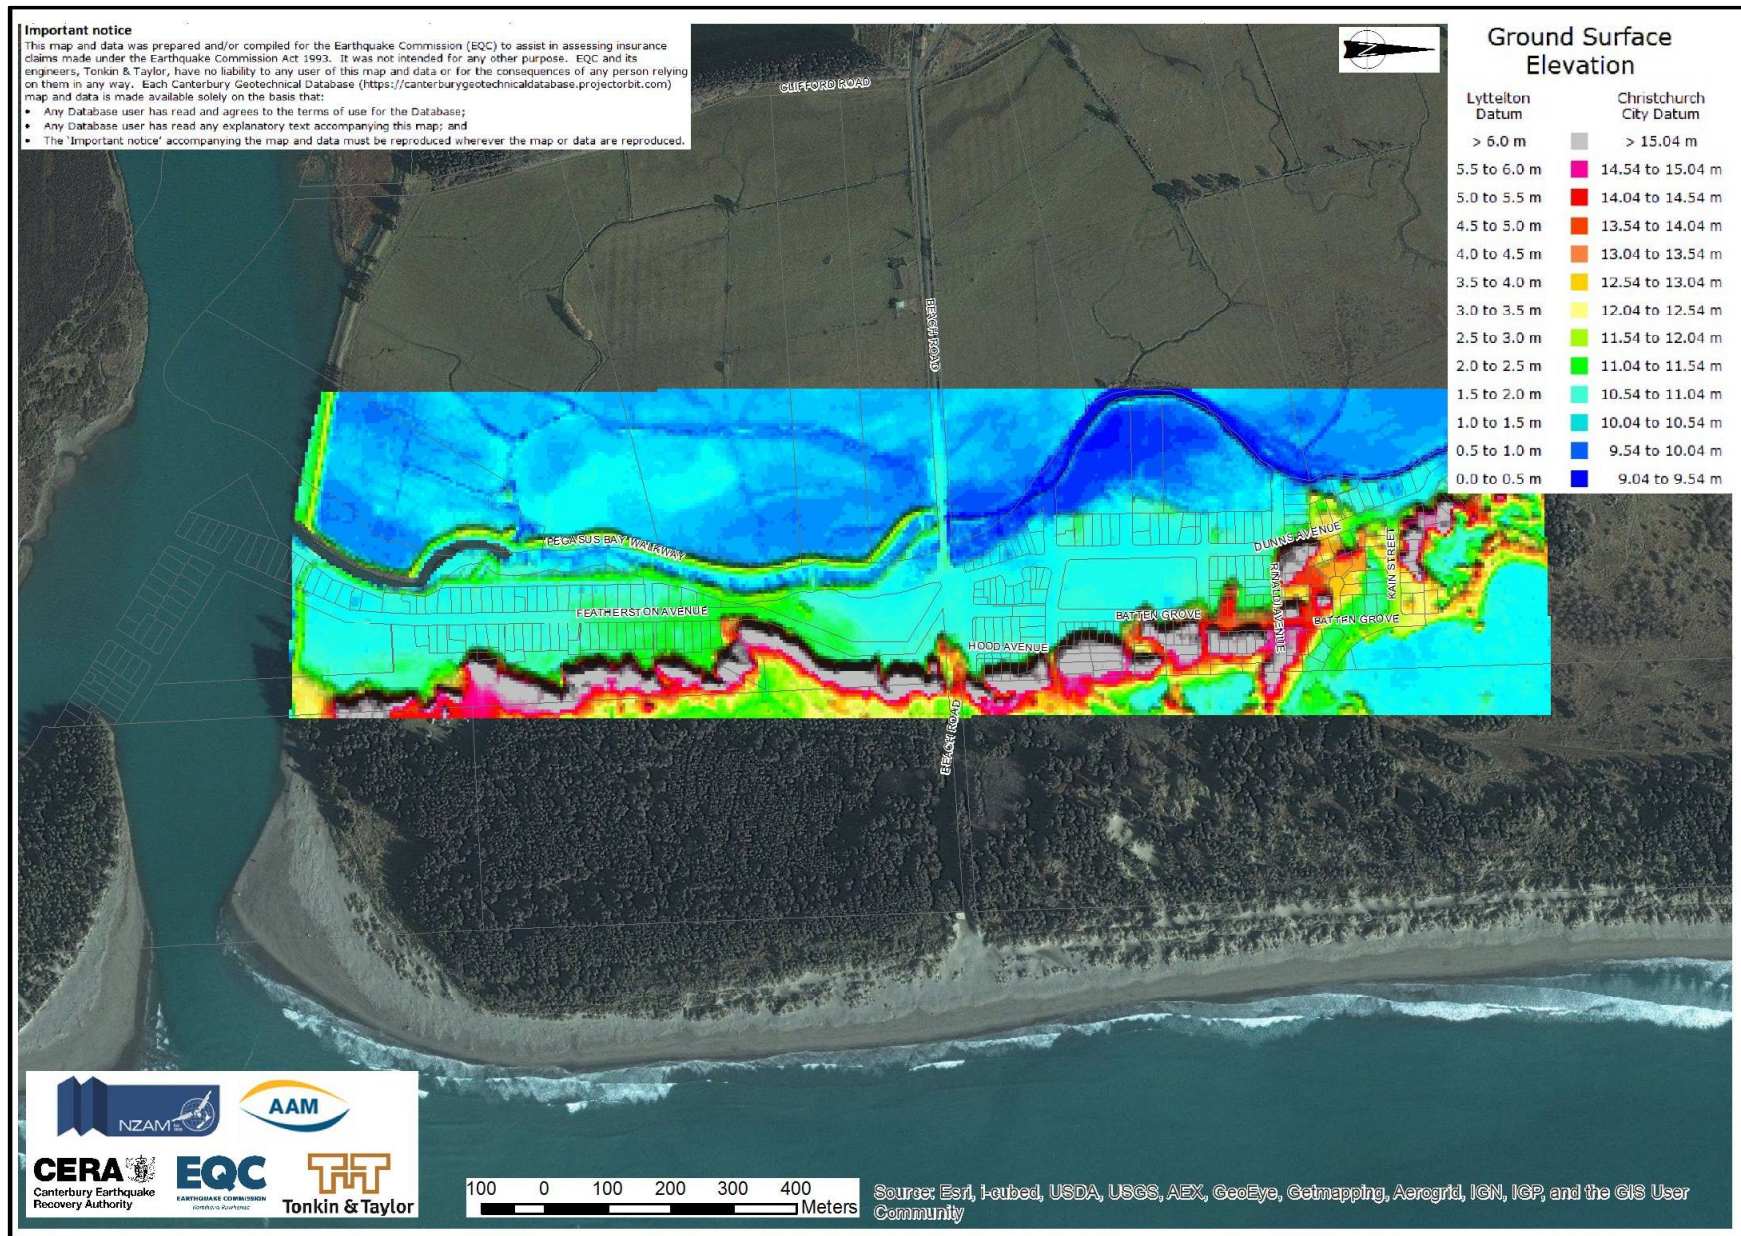
Figure 7 – Ground surface elevation from February 2012 LiDAR survey

Fig 7 Canterbury Geotechnical Database (2012) "*LiDAR and Digital Elevation Models*", Map Layer CGD0500 - 23 May 2012, retrieved 6 July 2012 from <https://canterburygeotechnicaldatabase.projectorbit.com/>
