Area-wide geotechnical information summary for CERA zoning review panel

This document contains all the area-wide geotechnical information which was considered by CERA as part of the process for making flat-land zoning decisions, and the subsequent zoning review.

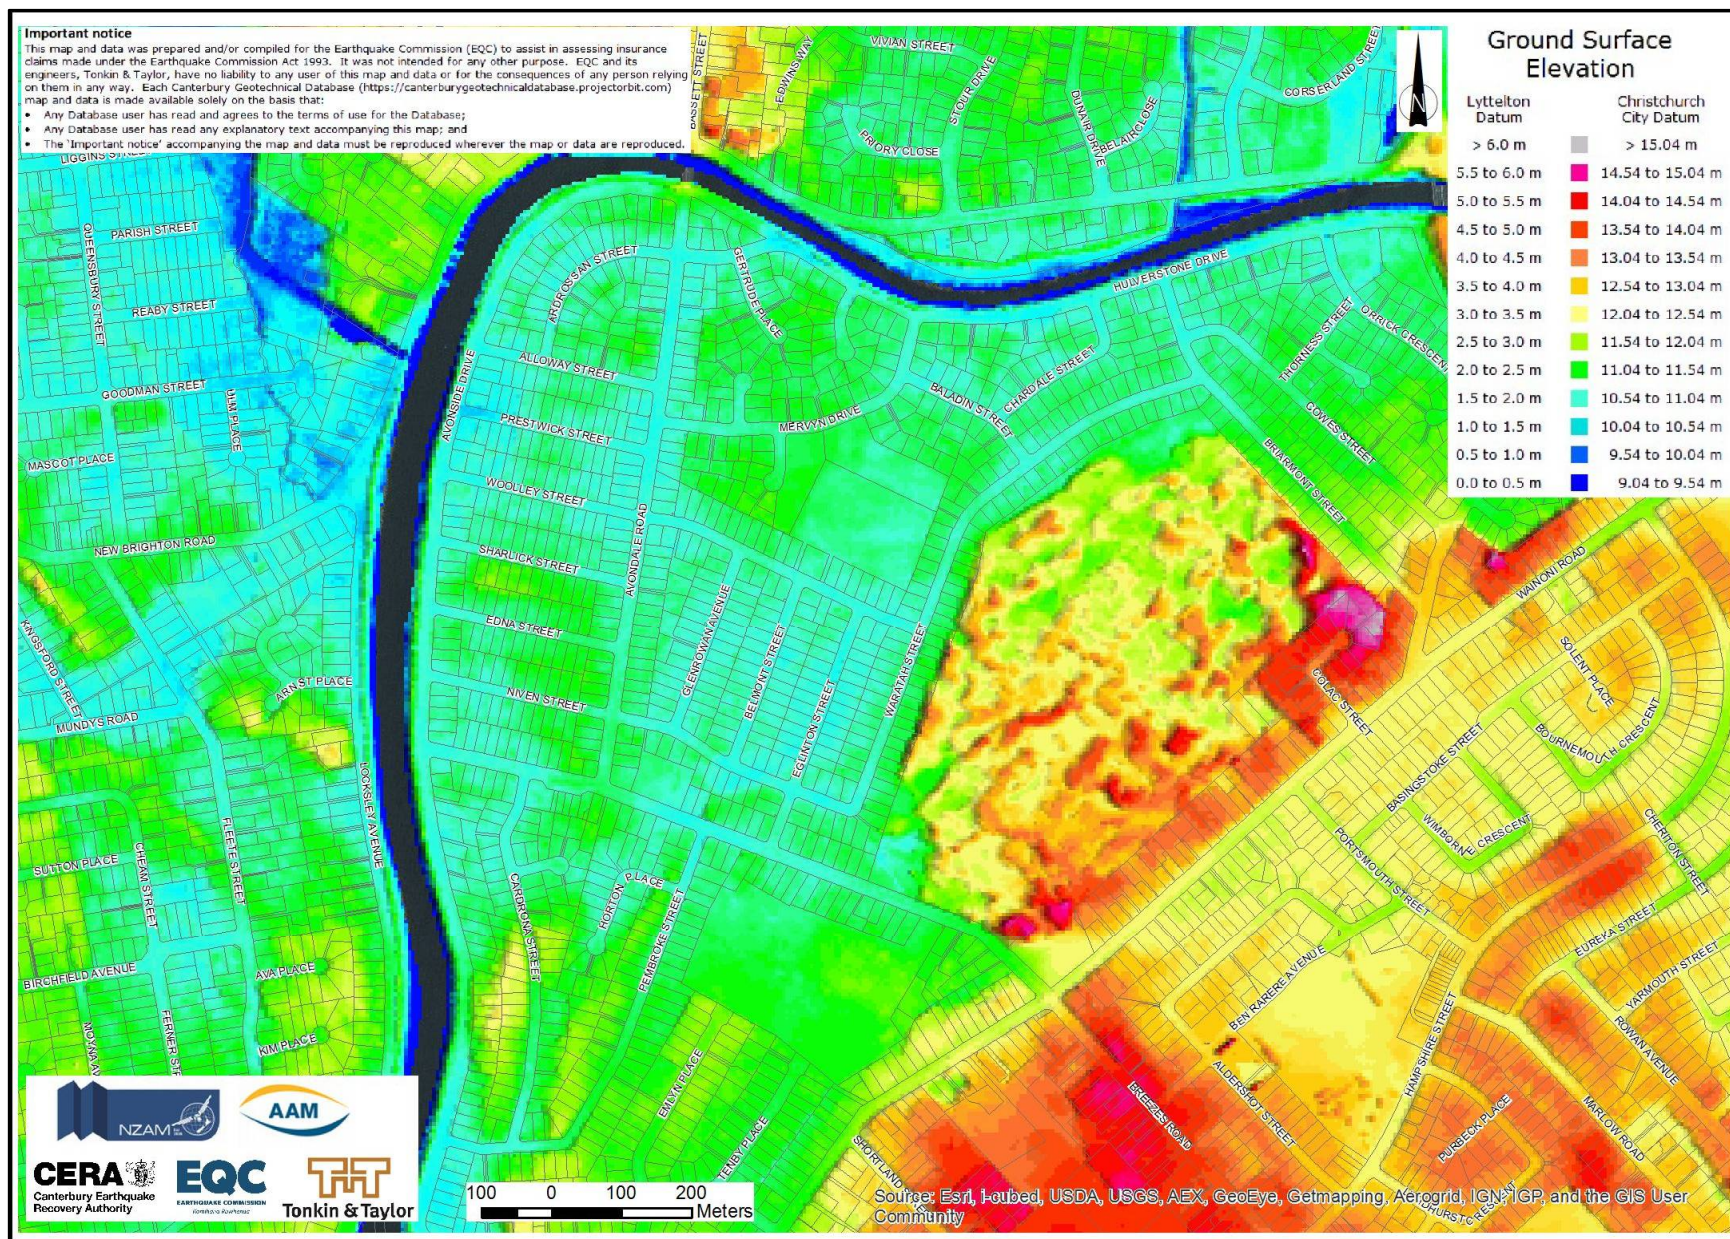
Figure 7 – Ground surface elevation from February 2012 LiDAR survey

Fig 7 Canterbury Geotechnical Database (2012) "*LiDAR and Digital Elevation Models*", Map Layer CGD0500 - 23 May 2012, retrieved 6 July 2012 from <https://canterburygeotechnicaldatabase.projectorbit.com/>
