**ACCESSIBILITY AUDIT  
VICTORIA SQUARE  
AVON RIVER  
CHRISTCHURCH**

**EXISTING SQUARE  
SITE AUDIT**

**ACCESSIBILITY AUDIT  
VICTORIA SQUARE – EXISTING SITE AUDIT  
AVON RIVER, CHRISTCHURCH**

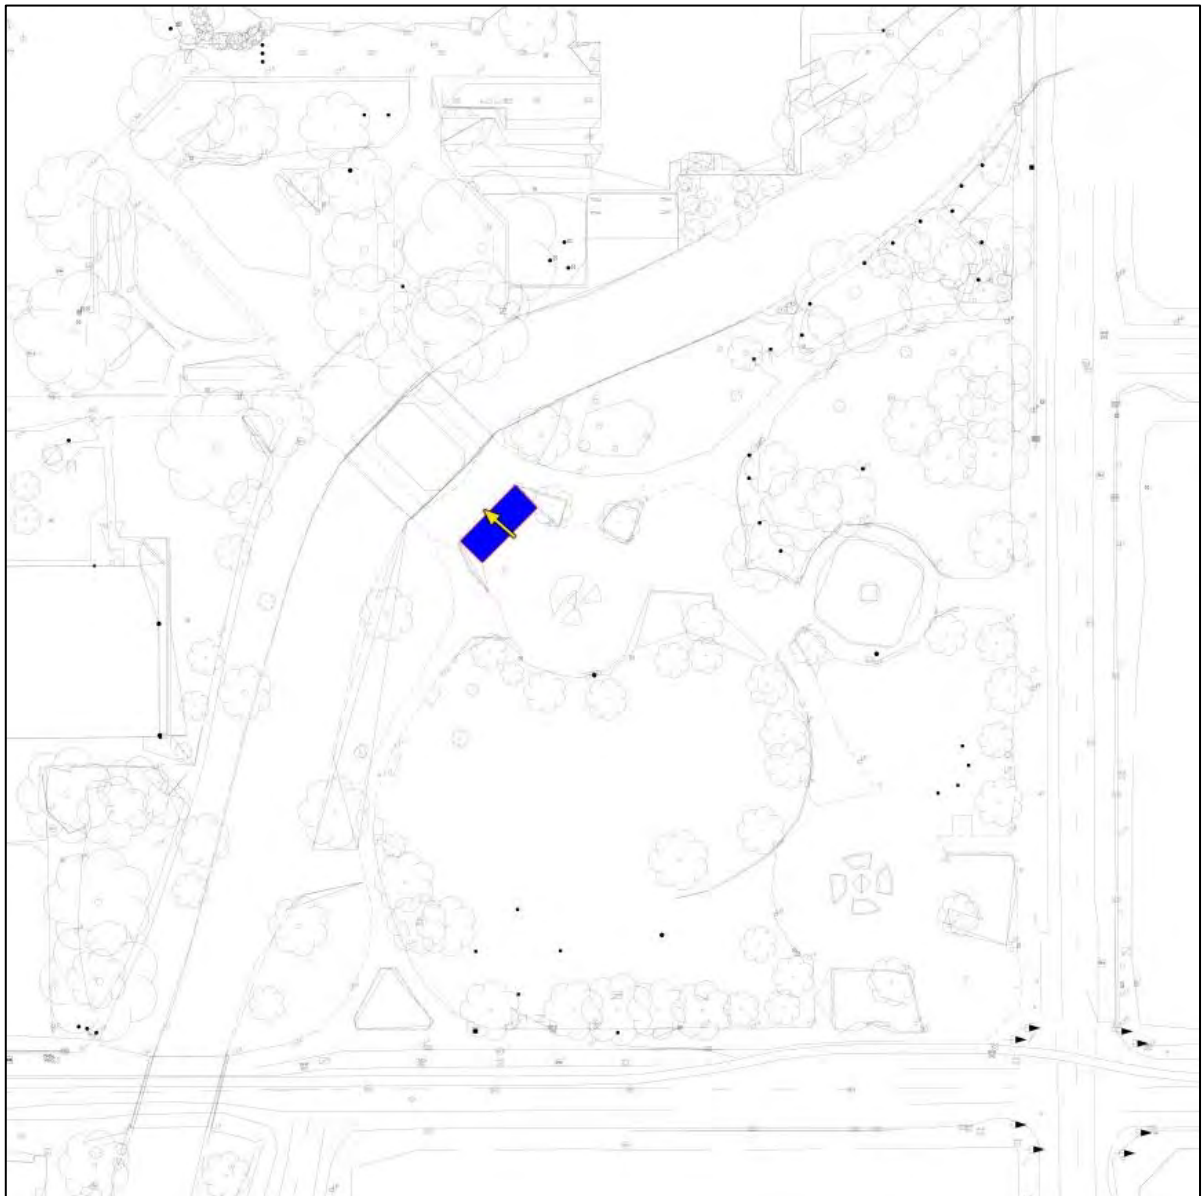
## 7.5 STAIRS TO HAMISH HAY BRIDGE – SOUTH SIDE

- The riser height varied between 140-160mm. Accessible stairs must have consistent riser heights.
- The handrail lacked extensions of 300mm past the top riser, and 300mm plus one tread length past the bottom riser.
- For a stairway that has a total width of 13m handrails should be provided at both ends in addition to a central handrail.
- No contrasting nosings were present on the stairs.
- The nosing projected 30mm in some places (others it was flush) this projection creates a trip hazard.
- The front edge of the tread was not rounded.
- The contrast was poor between the surrounding routes and the stairs.

- Ensure that the stair risers are a consistent height.
- Install additional compliant handrails at each end of the stair.
- Replace the existing central handrail with one that meets today's standards (extensions etc).

- Incorporate contrast of colour at the top and bottom of each stair flight.
- Incorporate a contrasting nosing strip into the stair treads.

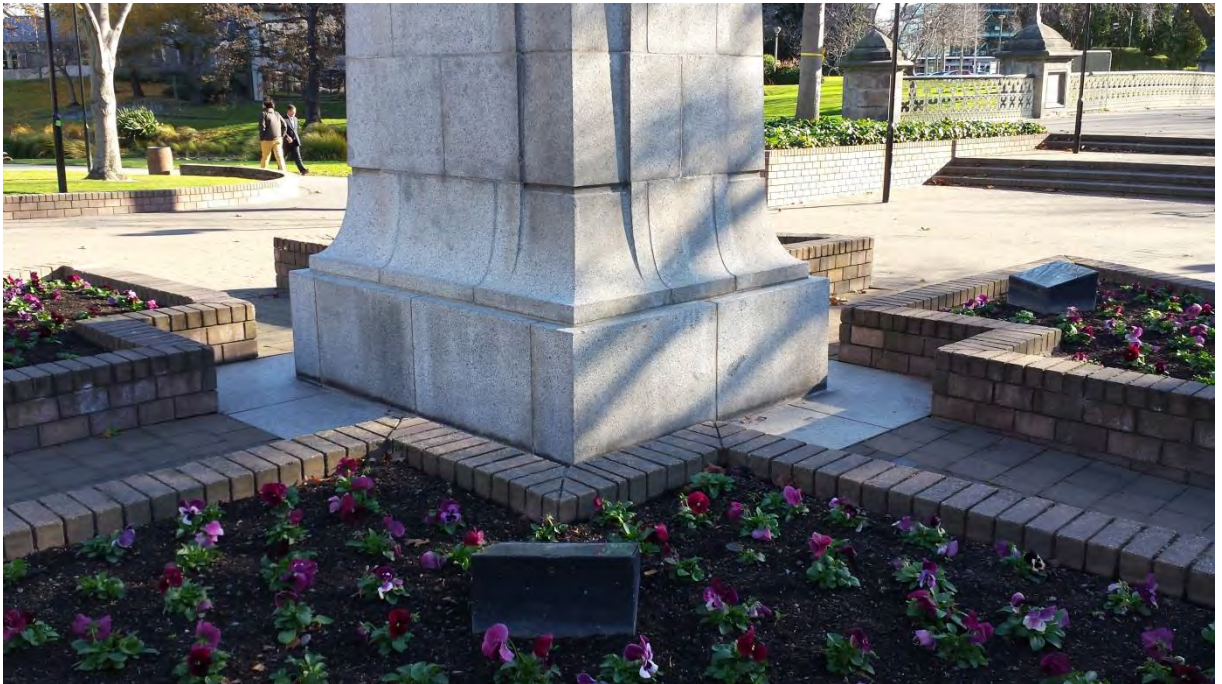
## 7.9.2 ACCESS PATHWAYS AROUND STATUE

- The surface is rough finished granite paving slabs, which would give an adequate slip resistance when wet.

- Take the design approach used by the Victoria Statue and make the internal corners of the garden curved rather than square. Ensure a clear width of 1200mm is achieved at the tightest points.

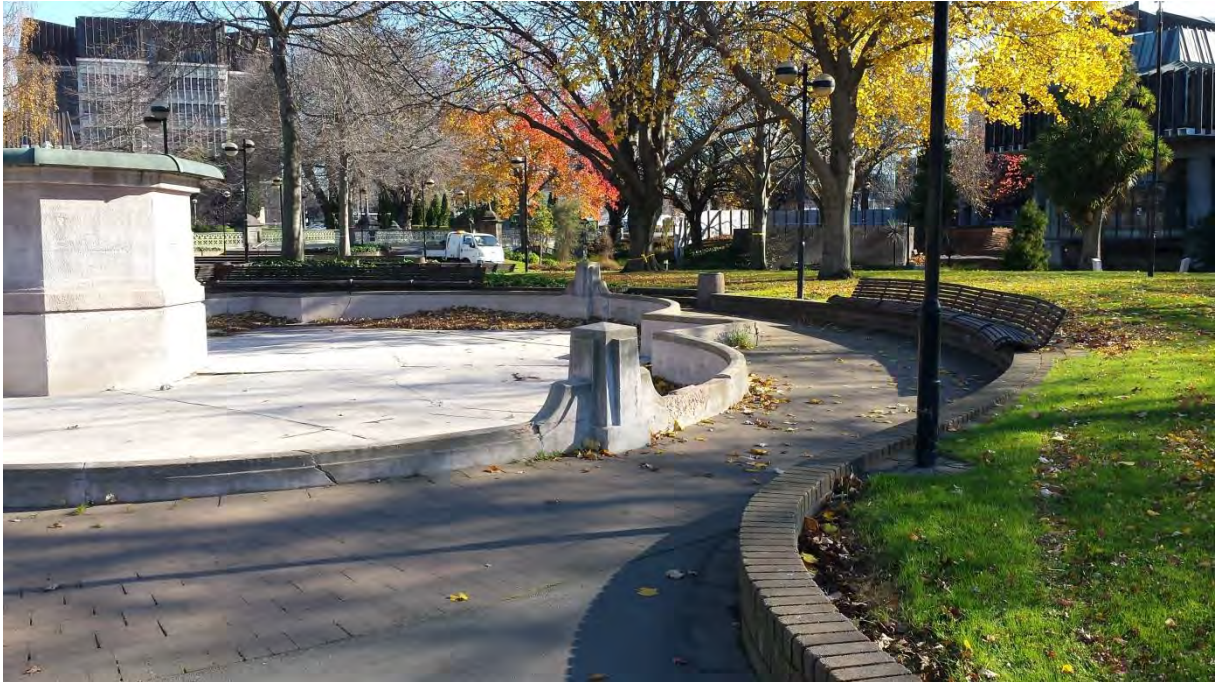
## 7.10.2 ACCESS PATHWAYS AROUND FOUNTAIN

- The surface is rough finished pavers, which would give an adequate slip resistance when wet.
- The clear width of the pathway around the fountain varies between 1650-2400mm at its narrowest points.

- Consider inclusion of recessed refuge and seating areas off to the side of the pathways around the fountain. Such areas would create a safe level platform outside of the pedestrian flow for relaxing and enjoying the water feature for wheelchair users, persons with mobility aides and parents with strollers.

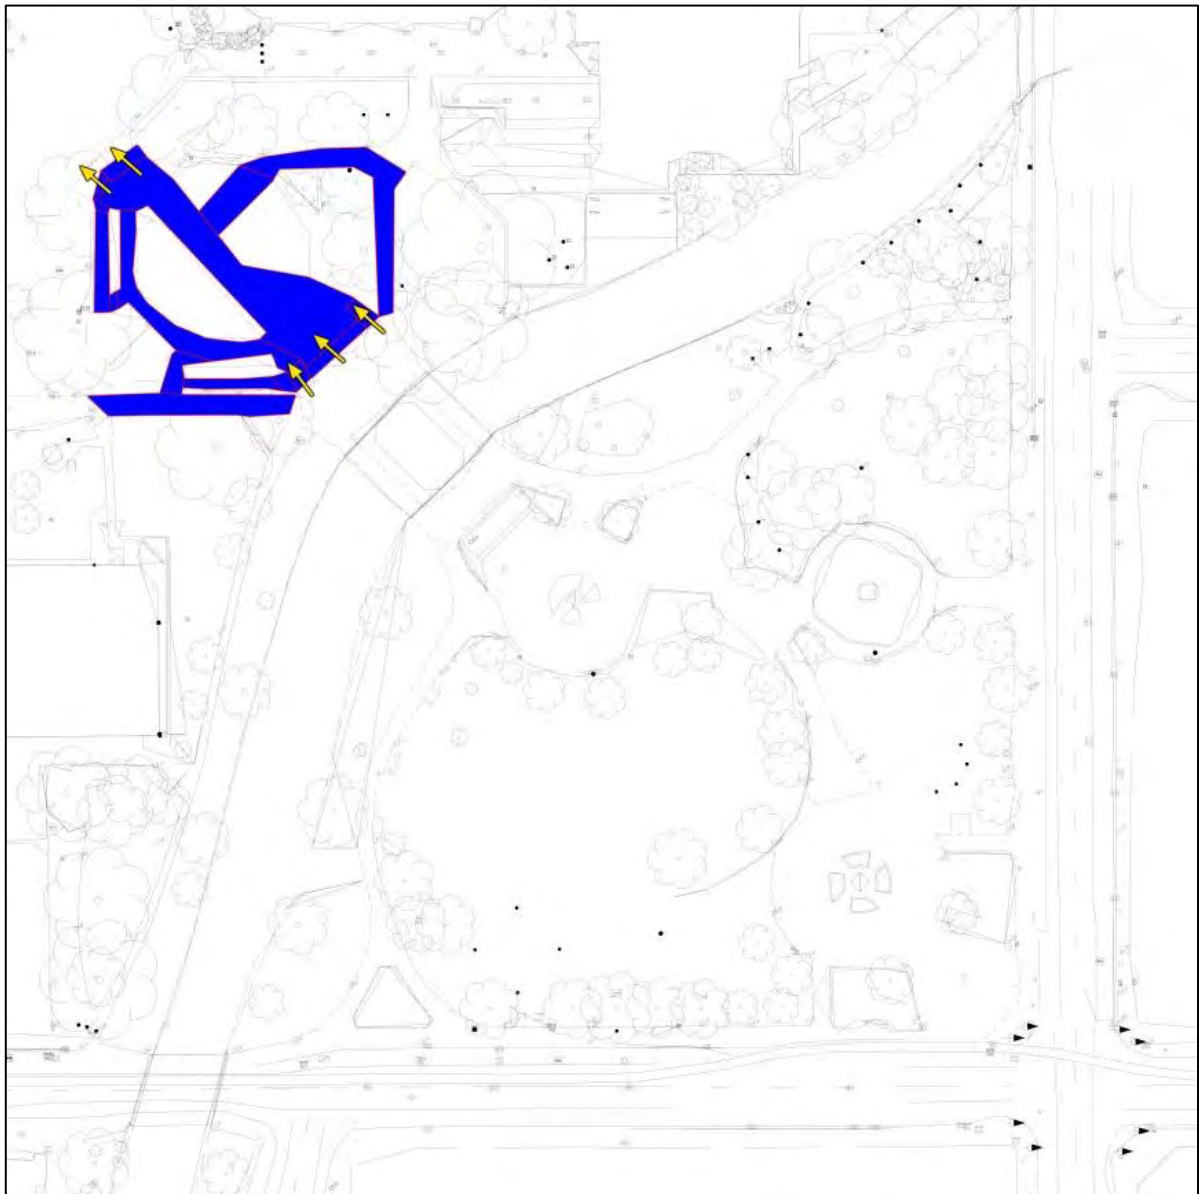
## 7.14 NORTH OF HAMISH HAY BRIDGE

This area had signs of significant earthquake damage, and has been temporarily repaired to some extent. Two of the key features of this area are the Town Hall located outside the square's boundary to the East, and the Floral Clock located within the square to the North West of the Hamish Hay Bridge.

- The handrail lacked extensions of 300mm past the top riser, and 300mm plus one tread length past the bottom riser.
- For a stairway that has a total width of 4m+ handrails should be provided at both ends in addition to a central handrail.
- No contrasting nosings were present on the stairs.
- The nosing projected 30-40mm in some places (others it was flush) this projection would create a trip hazard.
- The front edge of the tread was not rounded.
- The contrast was poor between the surrounding spaces and the stairs (except where new black asphalt had been used to fill some patches in).
- The fixing method of the handrail to the vertical posts obstructed the passage of the hand.

- Install additional compliant handrails at each end of the stair.
- Replace the existing central handrail with one that meets today's standards (extensions etc).
- Incorporate contrast of colour at the top and bottom of each stair flight.
- Incorporate a contrasting nosing strip into the stair treads.
- Fill in the back of the riser under the 30-40mm projections to eliminate the trip hazard.

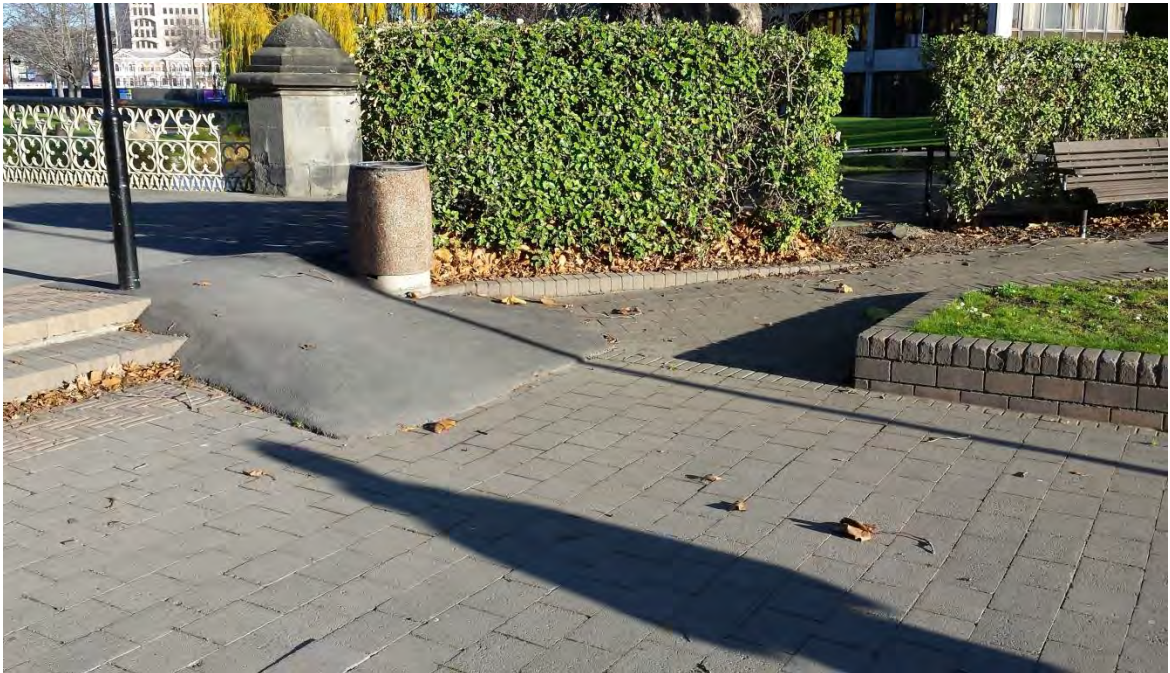
### 7.14.3 NORTH OF HAMISH HAY BRIDGE – BRIDGE RAMP 2

- The width of this ramp was 1.2m wide.
- The surface was asphalt, and would give adequate slip resistance when wet.

- Consider replacement of this ramp or improvement of it as part of the reconstruction design.

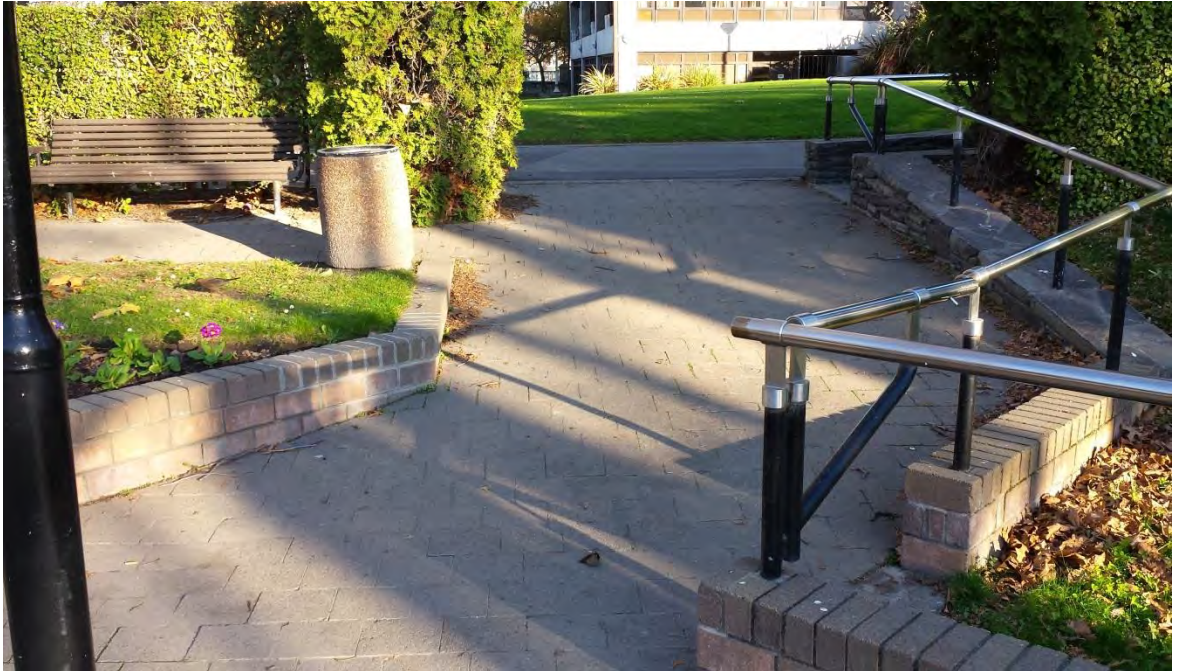
#### 7.14.4 RAMP OFF PATHWAY TO CHESTER STREET WEST

- The width of this ramp was 2.4m wide.
- The surface was a rough finish paver, and would give adequate slip resistance when wet.

- Consider replacement of this ramp or improvement of it as part of the reconstruction design.

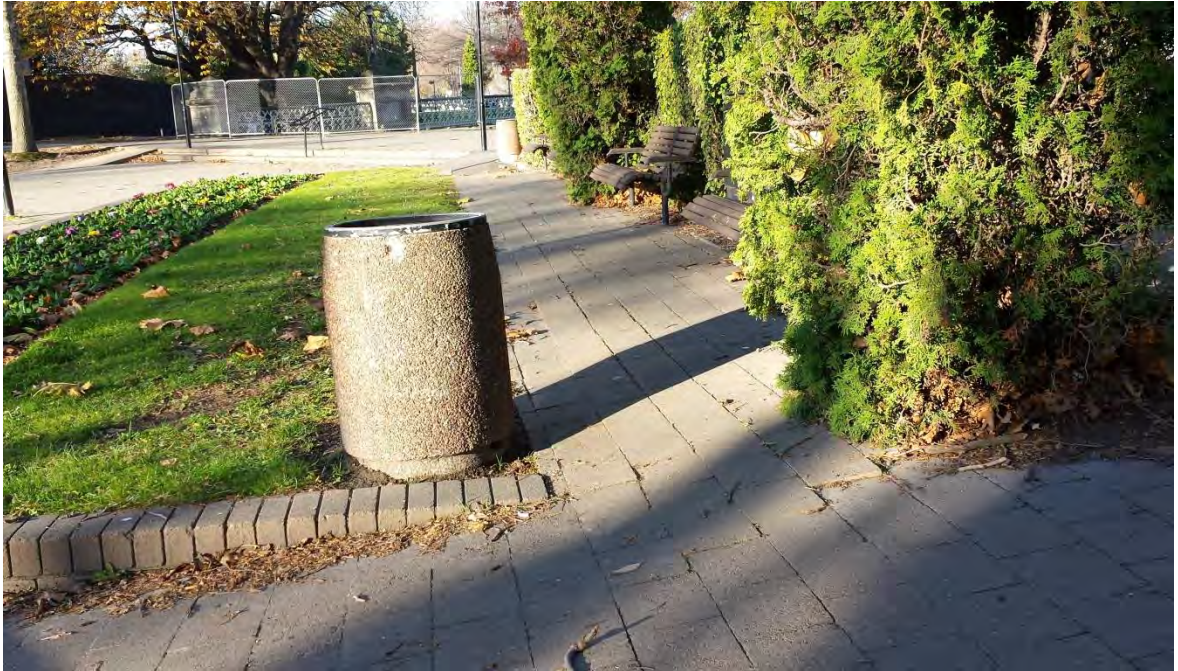
### 7.14.5 NORTH OF HAMISH HAY BRIDGE – EAST PATHWAY

- The surface was a rough finish paver, and would give adequate slip resistance when wet.

- Consider replacement of this pathway or improvement of it as part of the reconstruction design.

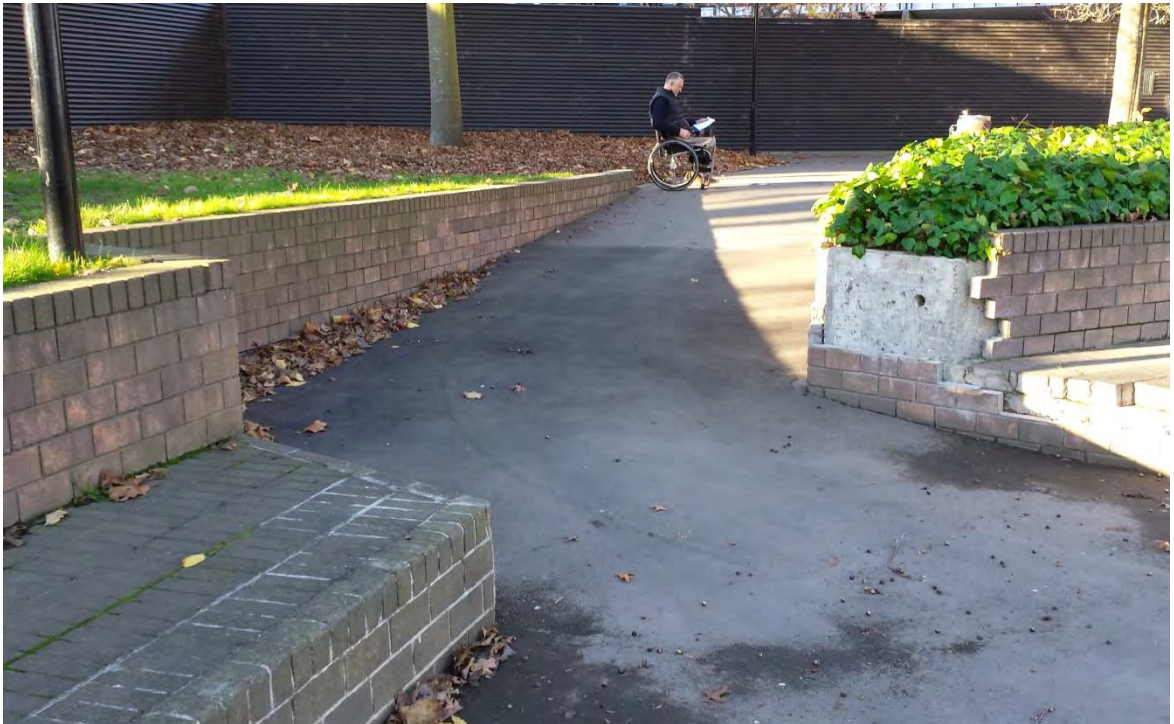
#### 7.14.6 NORTH OF HAMISH HAY BRIDGE – NORTH EASTERN RAMP

- The width of this ramp was 3.1m wide
- The ramps longitudinal gradient was averaged at 1:14
- The surface was asphalt, and would give adequate slip resistance when wet

- Consider replacement of this ramp or improvement of it as part of the reconstruction design.

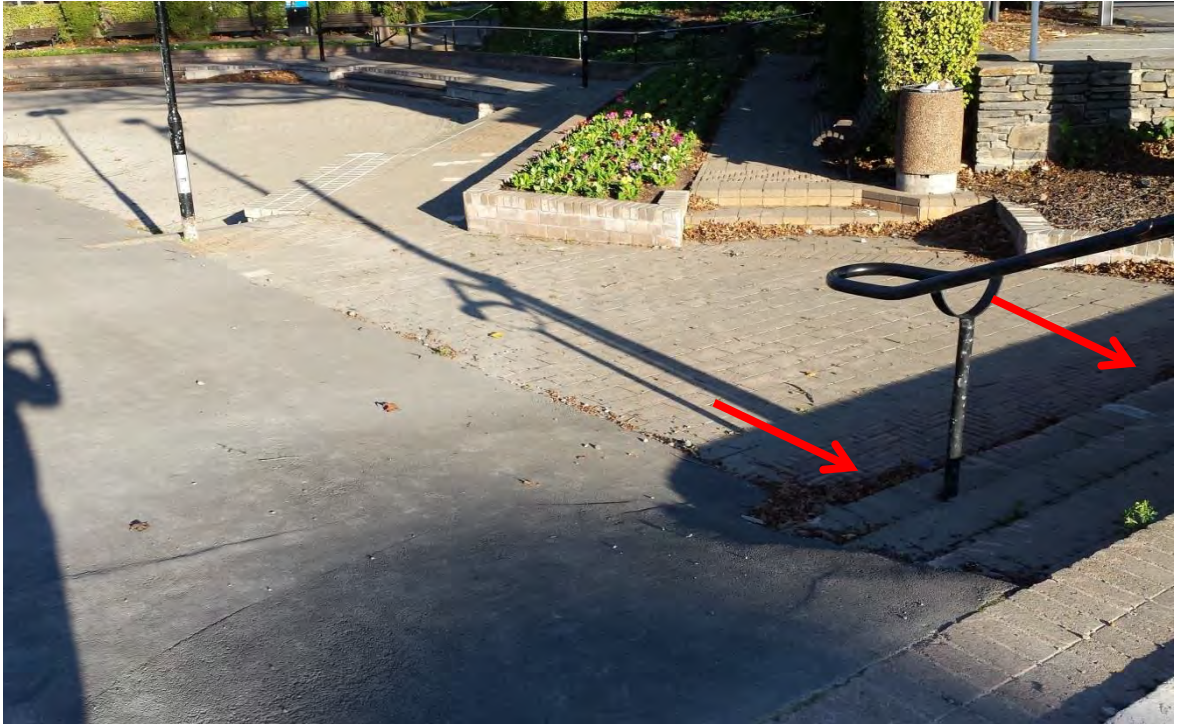
## 7.14.7 NORTH OF HAMISH HAY BRIDGE – NORTH STAIR

- The riser height was below the maximum of 180mm for an accessible stair.
- The treads were 420mm, which exceeds the minimum of 310mm for an accessible stair.
- A change in texture was provided at both the top and bottom of the stairs for the majority of the full width (flipped bricks).
- The stairs had a rough brick finish which would give adequate slip resistance when wet.
- The dual rail central handrail was an appropriate choice for a central rail which will allow users to pass each other on different sides without their hands colliding.

- Install additional compliant handrails at each end of the stair.
- Replace the existing central handrail with one that meets today's standards (extensions etc).
- Incorporate contrast of colour at the top and bottom of each stair flight.
- Incorporate a contrasting nosing strip into the stair treads.
- Fill in the back of the riser under the 30mm projections to eliminate the trip hazard.

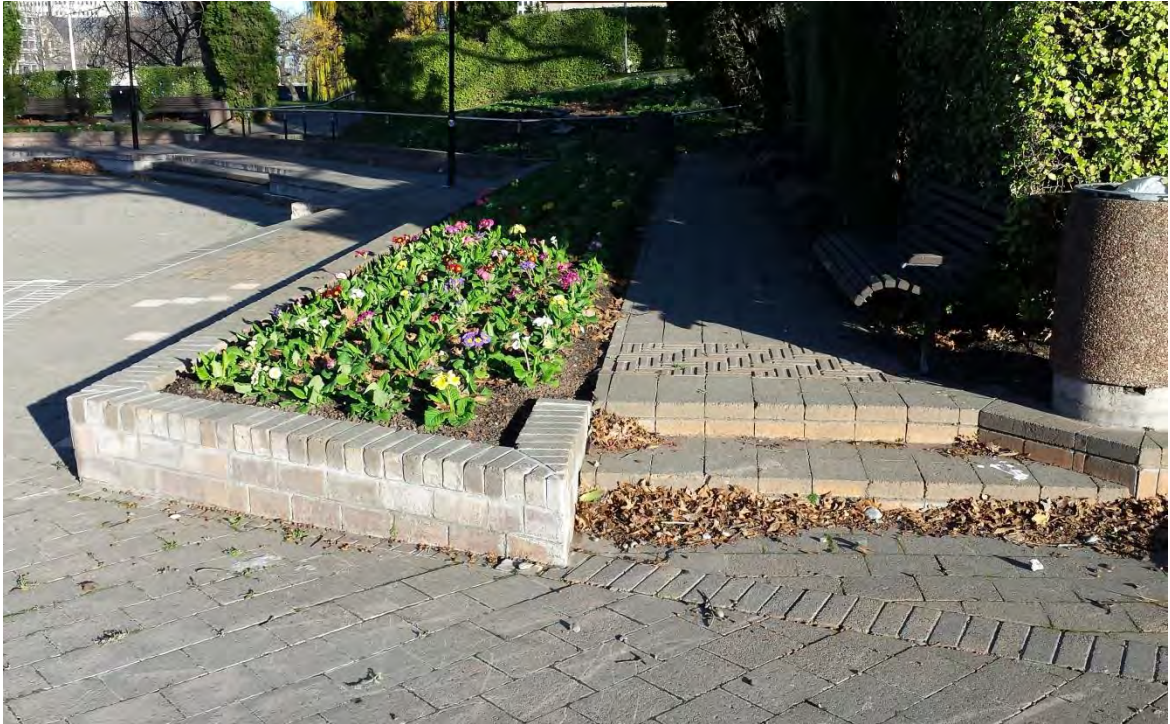
## 7.14.8 NORTH OF HAMISH HAY BRIDGE – NORTH WEST STAIR

- The riser height was below the maximum of 180mm for an accessible stair.
- The treads were 440mm, which exceeds the minimum of 310mm for an accessible stair.
- A change in texture was provided at the top of the stairs (flipped bricks).
- The stairs had a rough brick finish which would give adequate slip resistance when wet.

- Replace the stair with an accessible ramp.

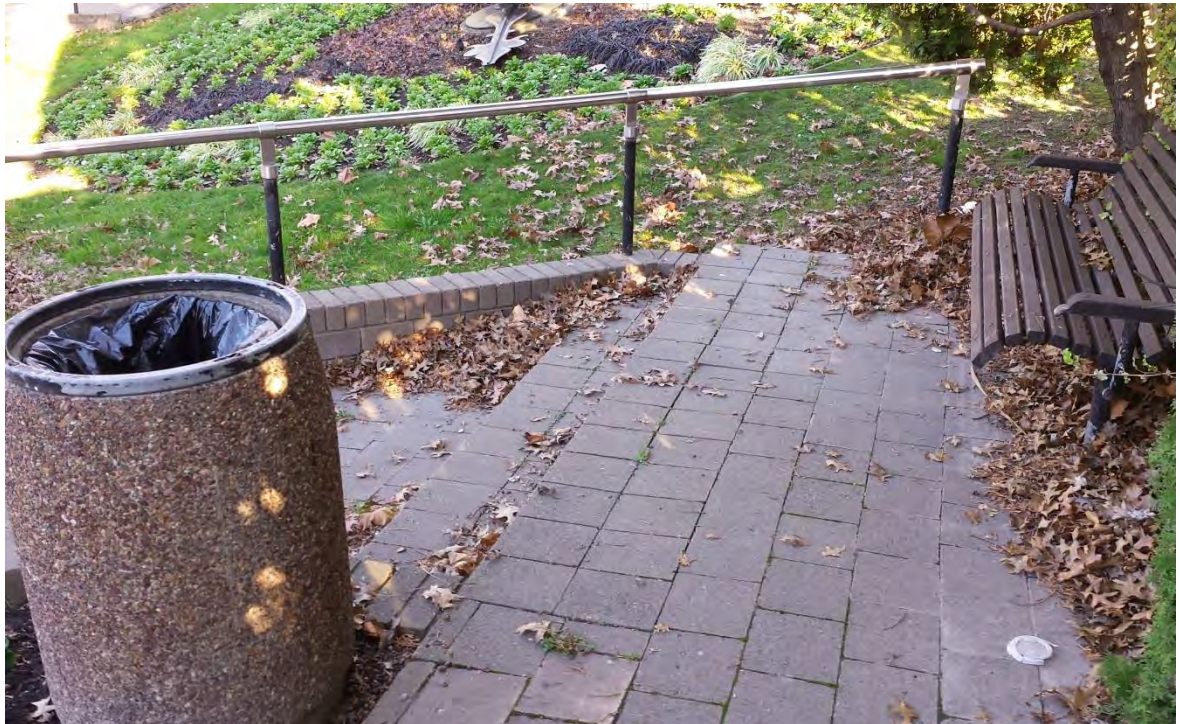
### 7.14.9 NORTH OF HAMISH HAY BRIDGE – NORTH WEST PATH (UPPER)

- The surface was a rough finish paver, and would give adequate slip resistance when wet.

- Consider incorporating a threshold ramp, or fully ramped access way to this section of path as part of the redevelopment.

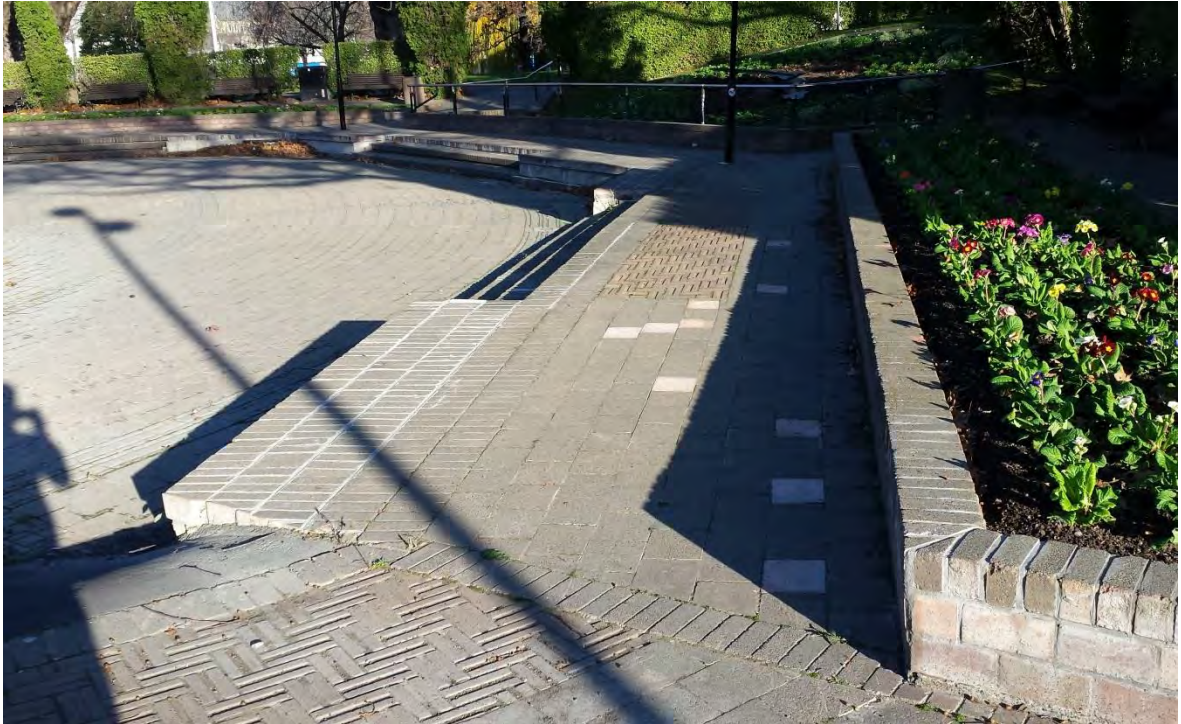
#### 7.14.10 NORTH OF HAMISH HAY BRIDGE – NORTH WEST PATH (NORTH END)

- The surface was a rough finish paver, and would give adequate slip resistance when wet.
- The width of this pathway was 2660mm wide, and 2000mm at its narrowest point.

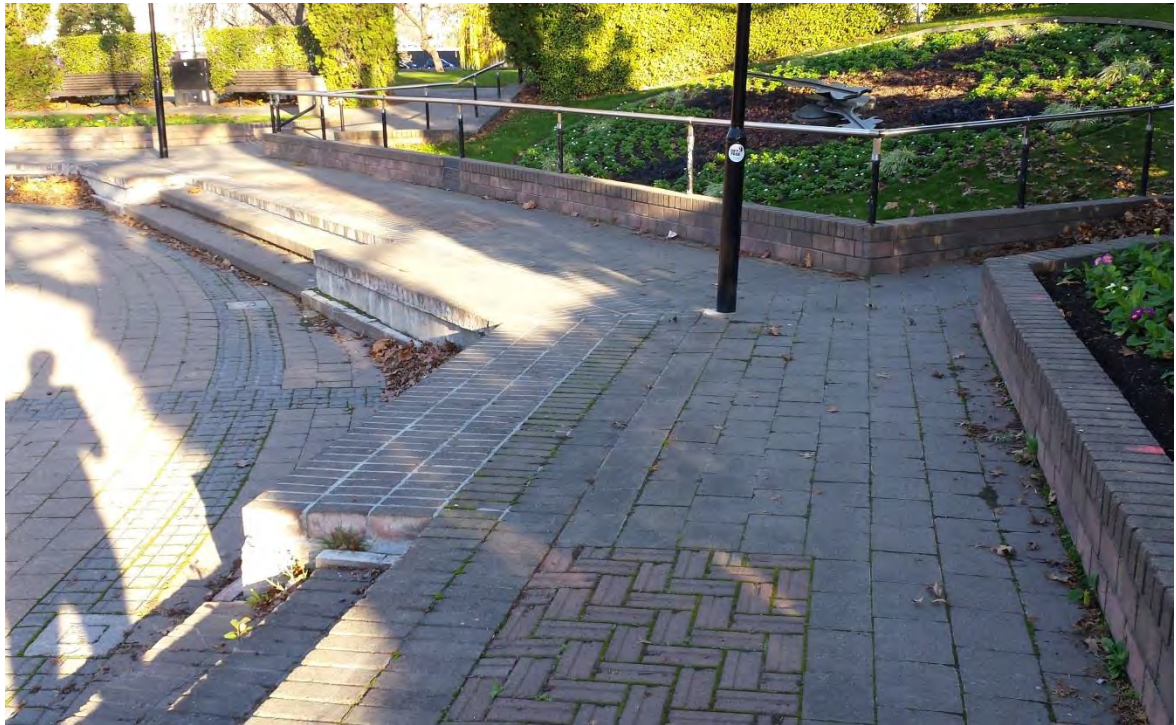
### 7.14.11 NORTH OF HAMISH HAY BRIDGE – NORTH WEST PATH (MIDDLE)

- The surface was a rough finish paver, and would give adequate slip resistance when wet.
- The width of this pathway was 2660mm wide, and 2000mm at its narrowest point.

- Consider upgrading/replacement of this pathway as part of the reconstruction design, specifically with regard to increasing visibility of edges and minimising the risk of a wheeled mobility device toppling over an edge.
- Investigate the possibility of relocating the light pole out of its central pathway location.

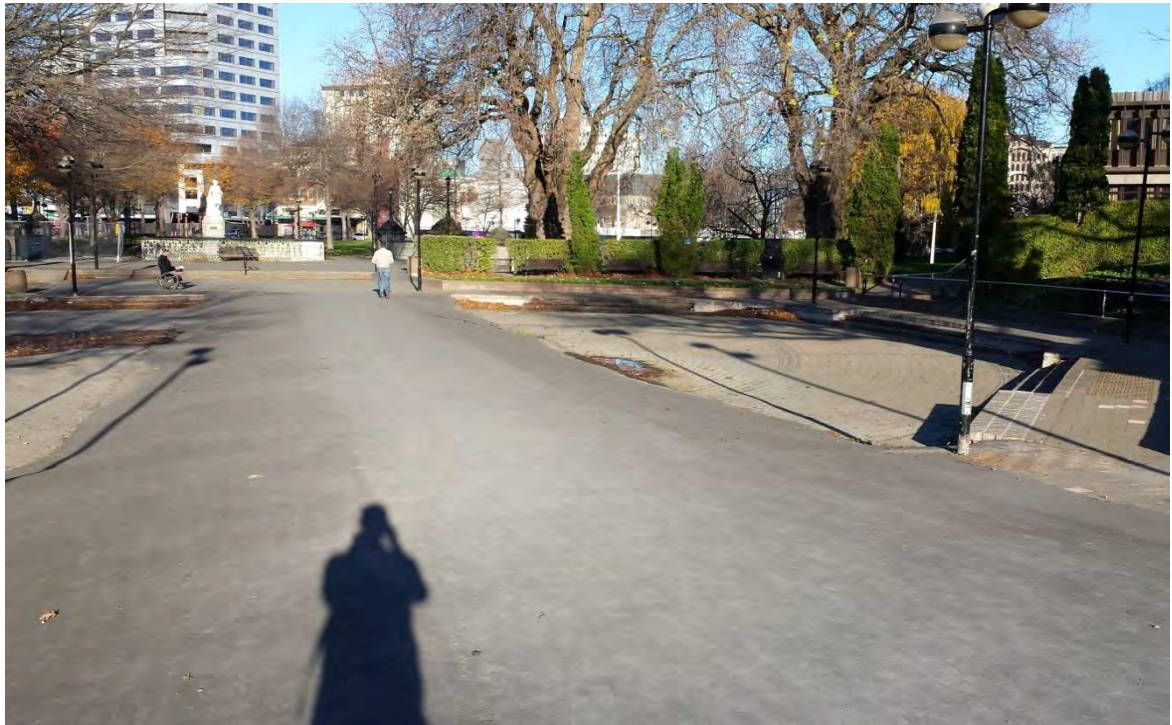
## 7.14.12 NORTH OF HAMISH HAY BRIDGE – ASPHALT MOUND PATHWAY

- The surface was asphalt, and would give adequate slip resistance when wet.
- Provides a near accessible 'direct' connection between the north and south areas or northern Victoria Square.
